ANEXO 13 (a) –
RELATÓRIO FOTOGRÁFICO ELABORADO
PELA EQUIPE DE FISCALIZAÇÃO DA SECID
ACERCA DAS INCONFORMIDADES
CONSTATADAS NA EXECUÇÃO DO
CONTRATO Nº 060/2012/SECOA
(PARTE 1)

INCONFORMIDADES CONTRATO 060 / 2012

AVENIDA LAVA PÉS

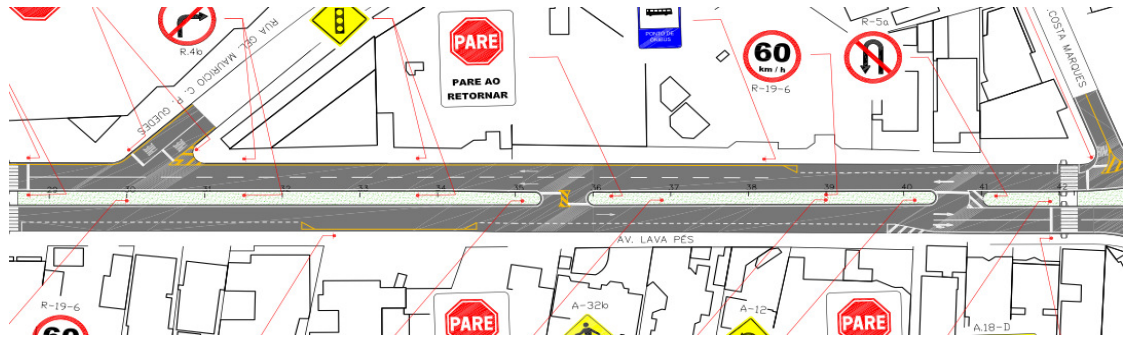
ITEM	ACHADO	FOTOGRAFIA
22	Trinca transversal	 
23	Trinca transversal	 
24	Trinca transversal

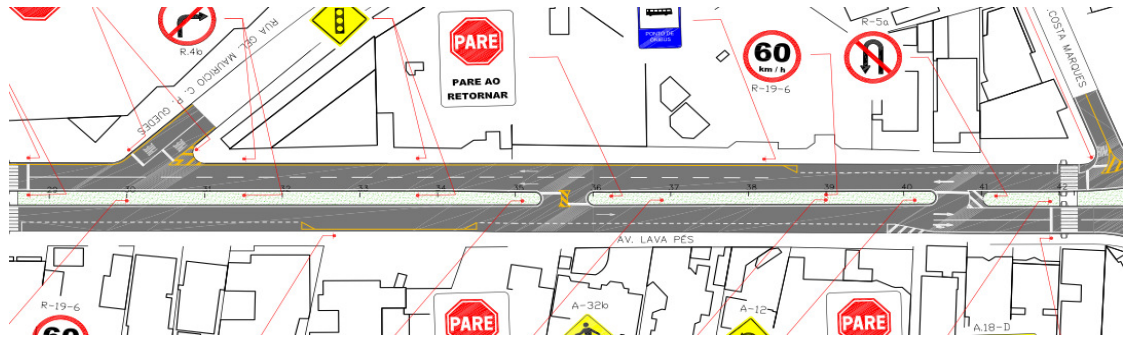
ITEM	ACHADO	FOTOGRAFIA
25	Trinca transversal

26	Trinca transversal

27	Trinca transversal

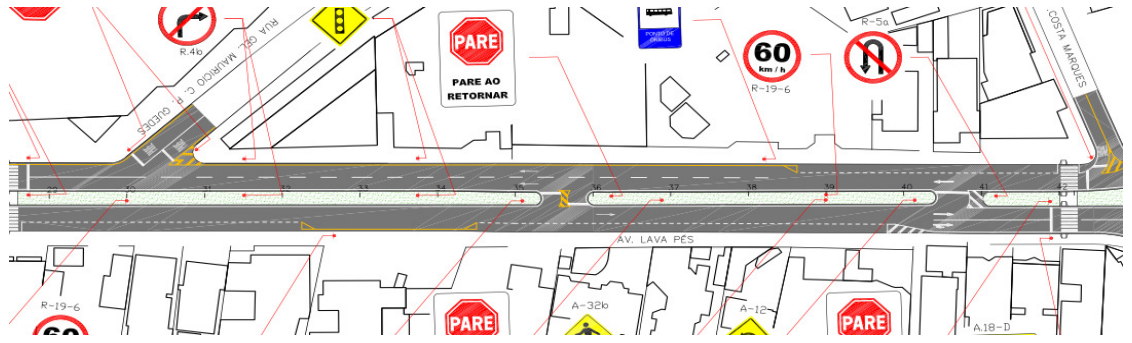
ITEM	ACHADO	FOTOGRAFIA
28	Trinca transversal	 
29	Trinca transversal	 
30	Trinca transversal

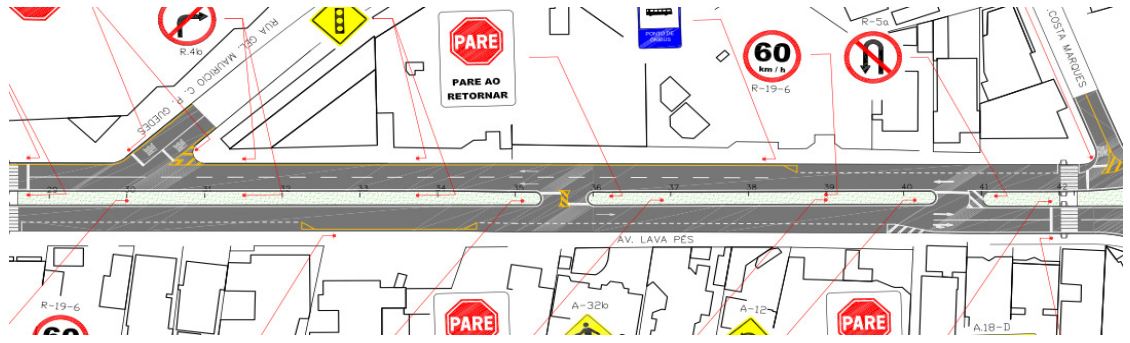
ITEM	ACHADO	FOTOGRAFIA
31	Trinca transversal	 
32	Trinca transversal	 
33	Trinca transversal

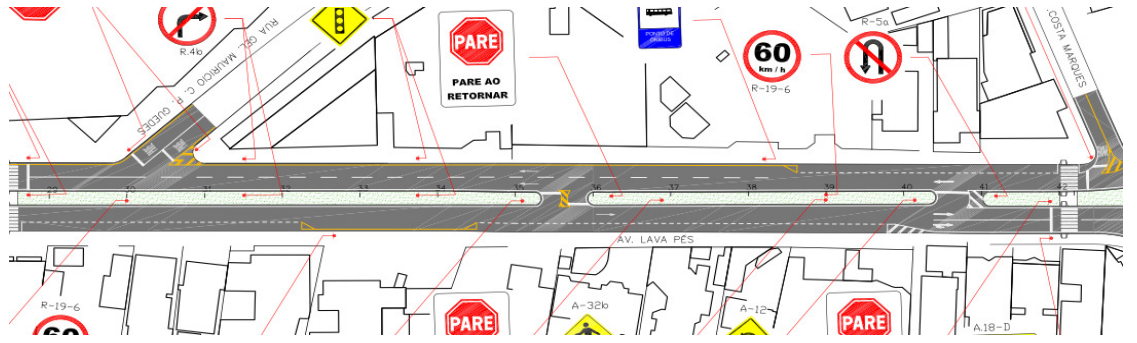
ITEM	ACHADO	FOTOGRAFIA
34	Trinca transversal	 
35	Trinca transversal	 
36	Trinca transversal

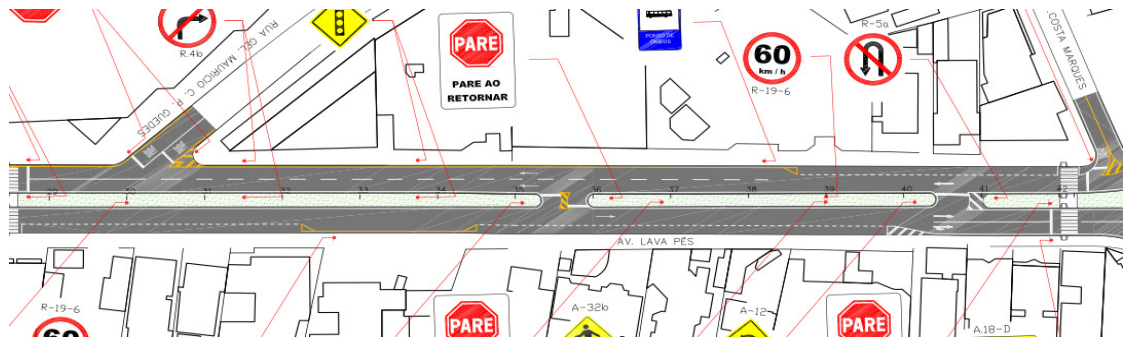
ITEM	ACHADO	FOTOGRAFIA
40	Trinca transversal

41	Trinca transversal

42	Segregação

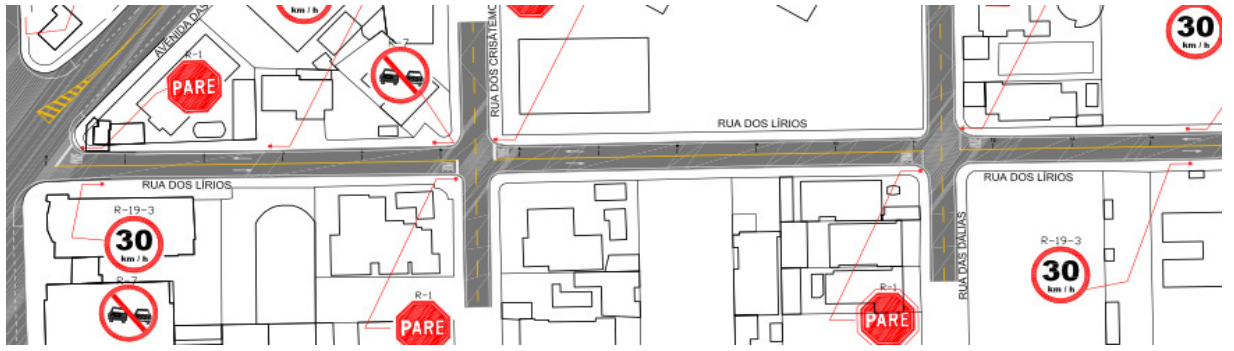
ITEM	ACHADO	FOTOGRAFIA
40	Fissura no pavimento asfáltico - trinca tipo "bloco"

41	Fissura no pavimento asfáltico - trinca tipo "couro de jacaré"

42	Fissura no pavimento asfáltico - trinca tipo "couro de jacaré"

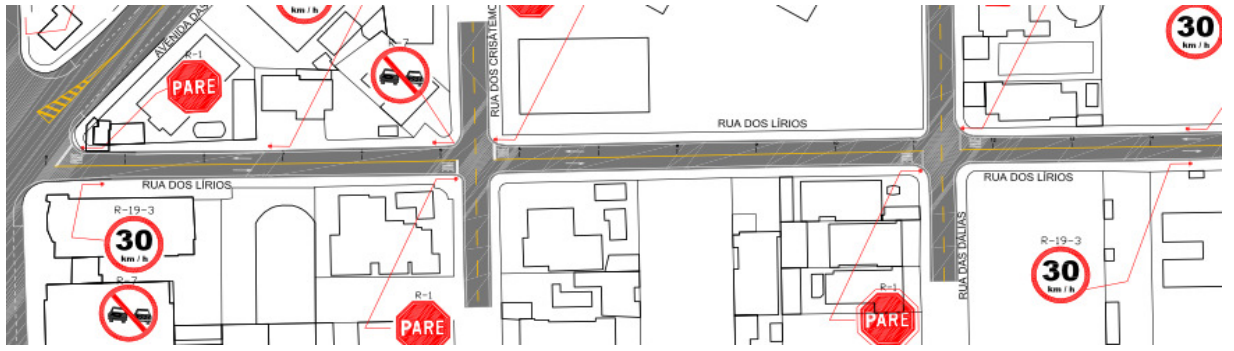
ITEM	ACHADO	FOTOGRAFIA
43	Fissura no pavimento asfáltico - trinca tipo "couro de jacaré"

44	Remendo profundo

45	Trinca longitudinal

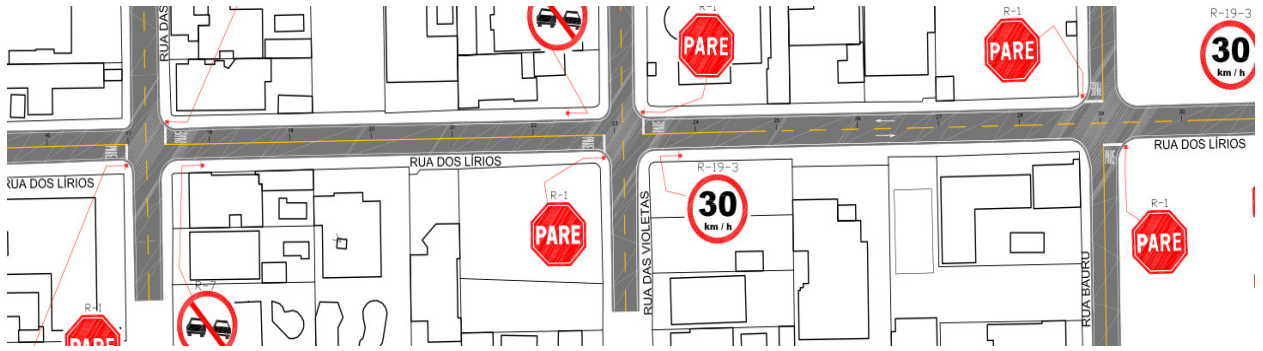
ITEM	ACHADO	FOTOGRAFIA
4	Trinca transversal

5	Segregação	 
6	Trinca transversal

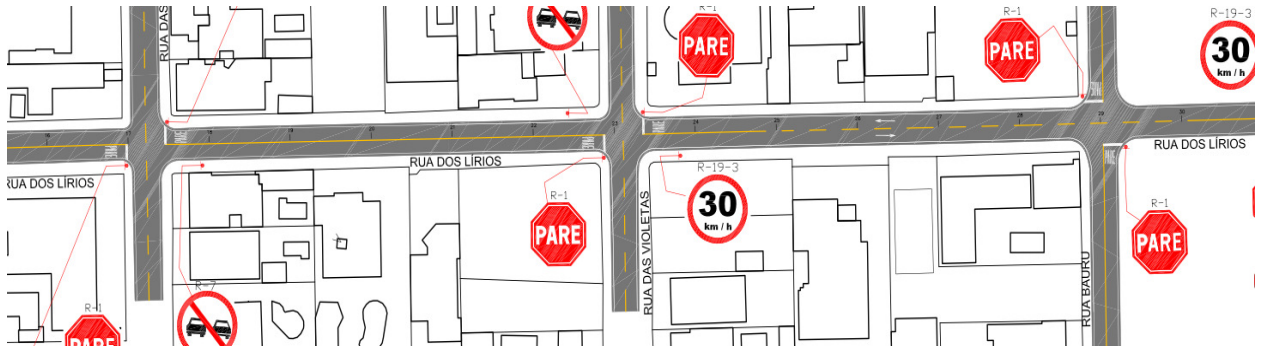
ITEM	ACHADO	FOTOGRAFIA
7	Segregação	A close-up photograph of asphalt pavement. The surface is dark grey and shows signs of wear and segregation, with some lighter-colored areas and small pits.
8	Fissura no pavimento asfáltico - trinca tipo "bloco"	A close-up photograph of asphalt pavement. A distinct crack is visible, forming a rectangular shape. The crack is circled with a bright yellow oval.
9	Segregação	A close-up photograph of asphalt pavement, similar to item 7, showing signs of segregation and surface irregularities.

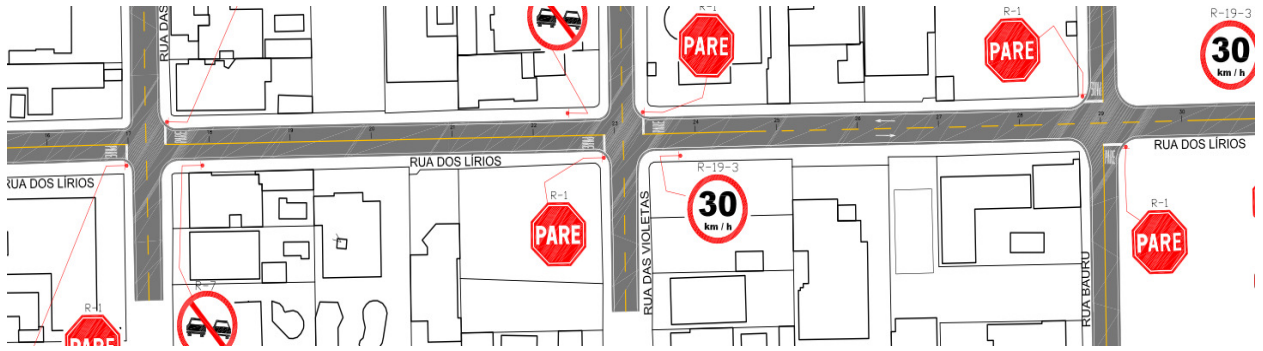
ITEM	ACHADO	FOTOGRAFIA
10	Fissura no pavimento asfáltico - trinca tipo "bloco"	A close-up photograph of asphalt pavement. A yellow oval highlights a specific crack that runs across several asphalt blocks, characteristic of a 'block' type crack.
11	Fissura no pavimento asfáltico - trinca tipo "bloco"	A close-up photograph of asphalt pavement showing a crack similar to the one in item 10, but without a yellow highlight.
12	Trinca transversal	A close-up photograph of asphalt pavement. A yellow oval highlights a transverse crack that runs across the width of the road.

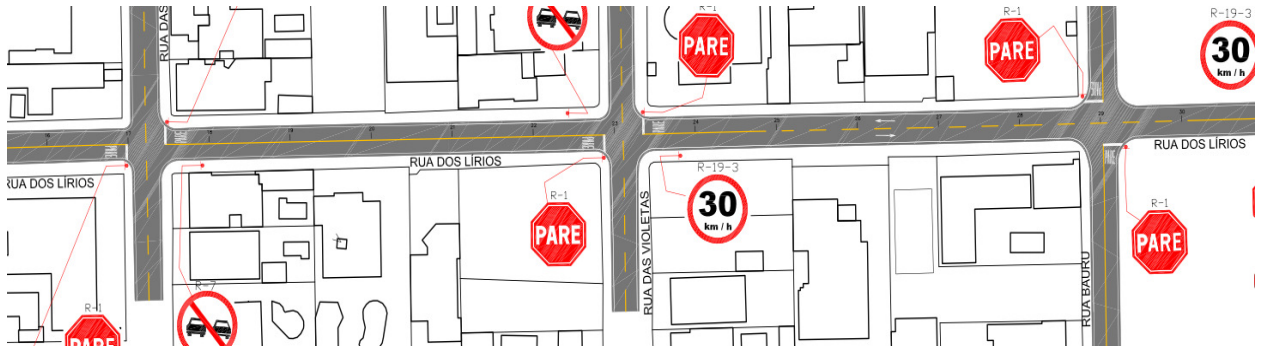
ITEM	ACHADO	FOTOGRAFIA
13	Trinca transversal	A close-up photograph of a dark asphalt surface. A single, thin, horizontal crack runs across the width of the frame. A large, thick red arrow with a yellow outline points from the bottom right towards the crack.
14	Trinca transversal	A photograph of a road surface showing a transverse crack. Two large, thick red arrows with yellow outlines point towards the crack from the left and right sides.
15	Trinca transversal	A photograph of a road surface showing a transverse crack. A single large, thick red arrow with a yellow outline points downwards towards the crack.

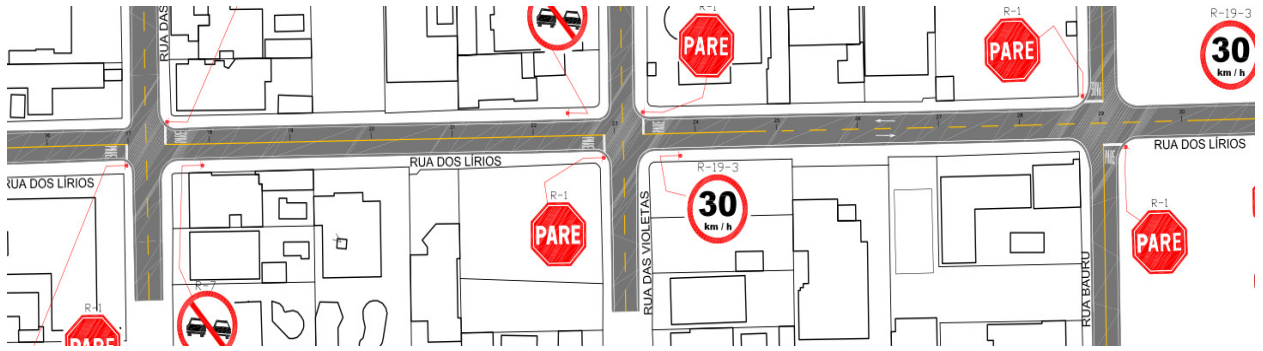
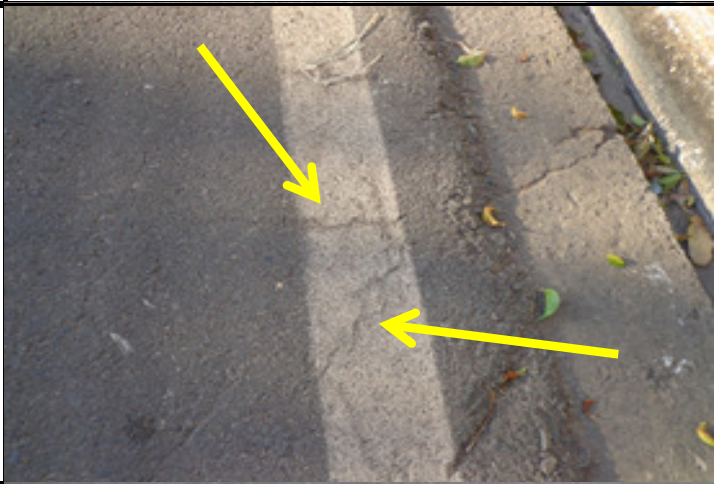
ITEM	ACHADO	FOTOGRAFIA
34	Trinca longitudinal e transversal

35	Trinca transversal

36	Trinca transversal

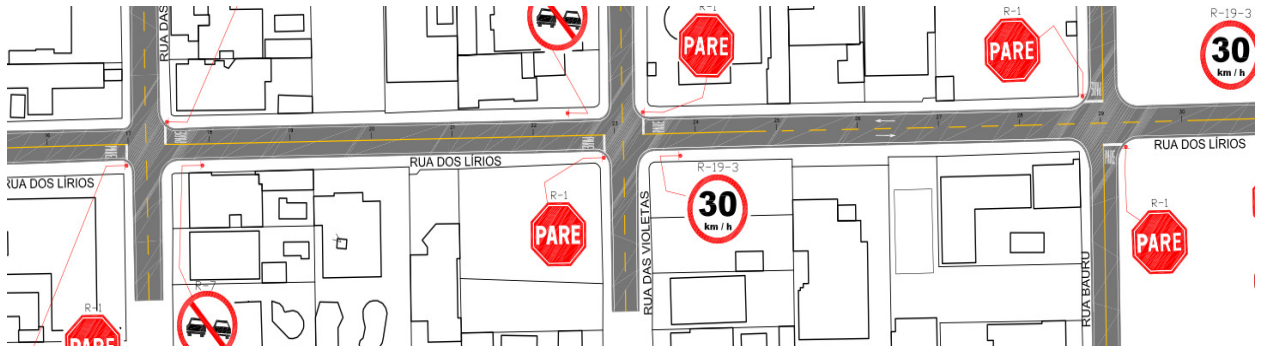
ITEM	ACHADO	FOTOGRAFIA
37	Trinca transversal

38	Trinca longitudinal e transversal

39	Trinca transversal

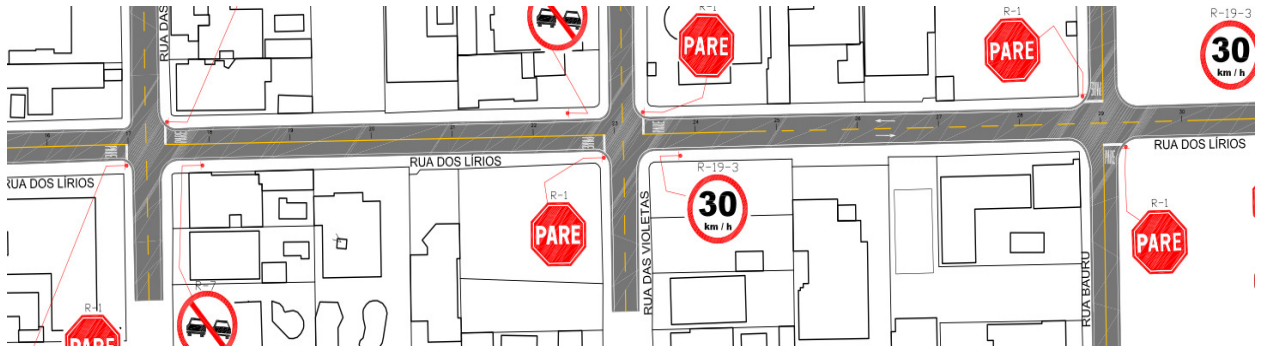
ITEM	ACHADO	FOTOGRAFIA
40	Fissura no pavimento asfáltico - trinca tipo "bloco"	<p>A close-up photograph of asphalt pavement showing a block-type crack. The crack runs vertically through a white painted line on the road. A yellow oval highlights the crack.</p>
41	Trinca transversal	<p>A close-up photograph of asphalt pavement showing a transverse crack. Two yellow arrows point to the crack, which runs horizontally across the road surface.</p>
42	Fissura no pavimento asfáltico - trinca tipo "bloco"	<p>A close-up photograph of asphalt pavement showing a block-type crack. The crack runs vertically through a white painted line on the road. A yellow oval highlights the crack.</p>

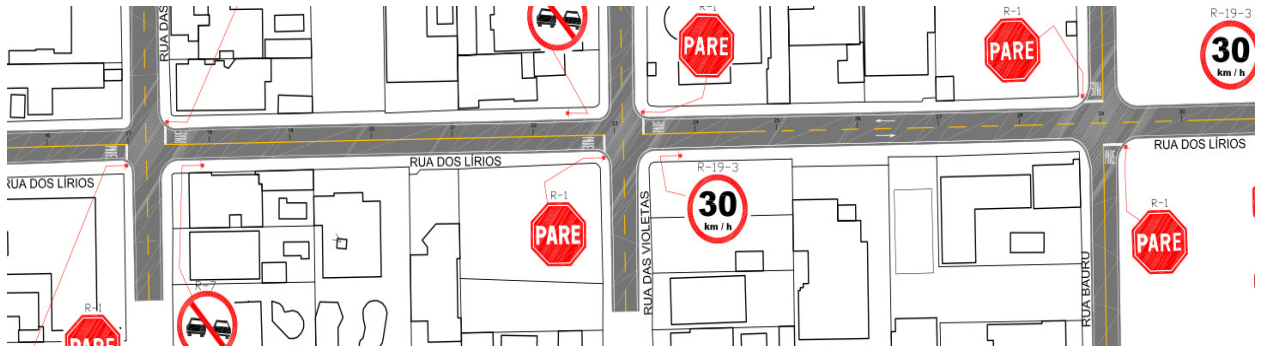
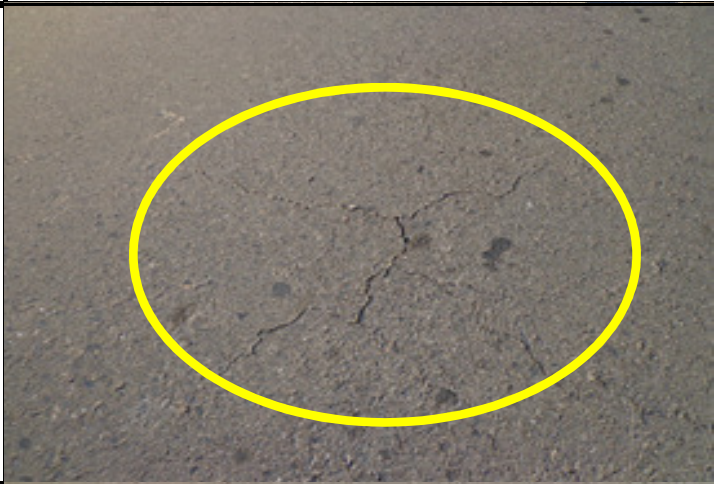
ITEM	ACHADO	FOTOGRAFIA
43	Fissura no pavimento asfáltico - trinca tipo "bloco"

44	Trinca longitudinal e transversal

45	Trinca longitudinal

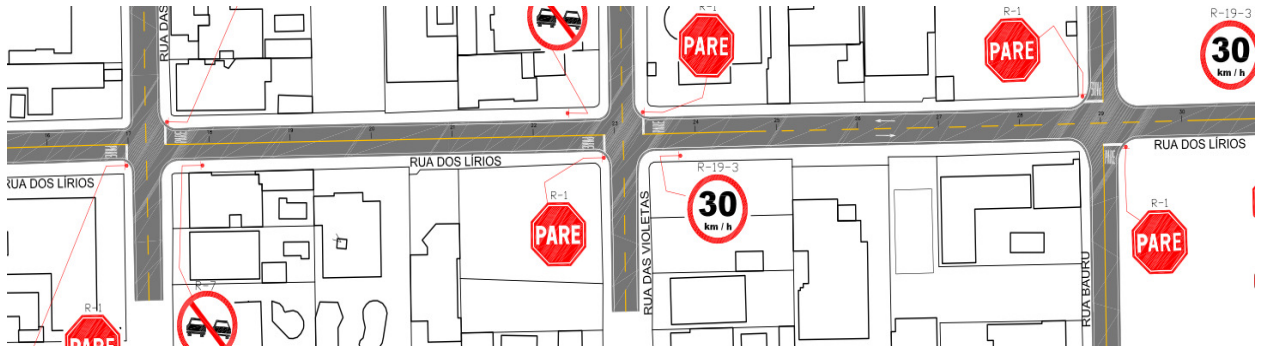
ITEM	ACHADO	FOTOGRAFIA
46	Trinca transversal	A close-up photograph of a dark asphalt surface. A thin, horizontal crack runs across the middle of the frame. A large, thick red arrow with a yellow outline points downwards towards the crack.
47	Trinca transversal	A close-up photograph of a dark asphalt surface. A thin, horizontal crack runs across the middle of the frame. A large, thick red arrow with a yellow outline points downwards towards the crack.
48	Trinca transversal	A close-up photograph of a dark asphalt surface. A thin, horizontal crack runs across the middle of the frame. The crack is circled with a thick yellow oval.

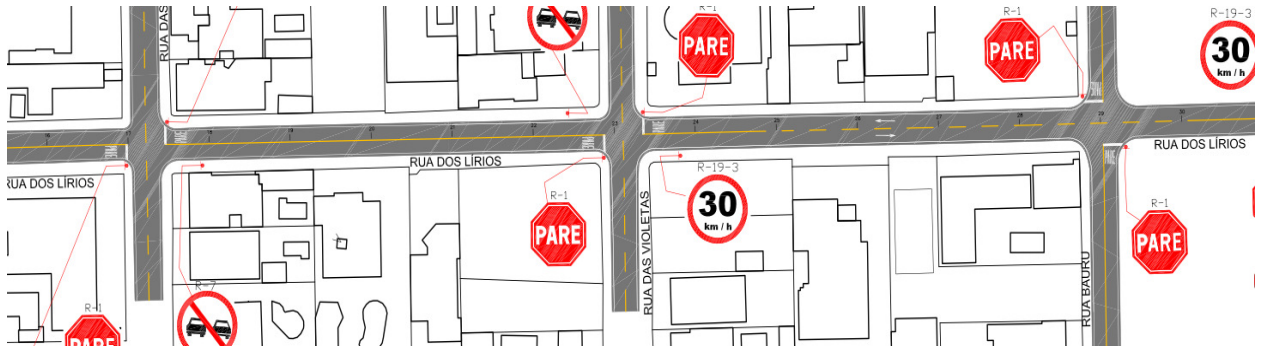
ITEM	ACHADO	FOTOGRAFIA
49	Trinca transversal	 
50	Trinca transversal	 
51	Trinca transversal

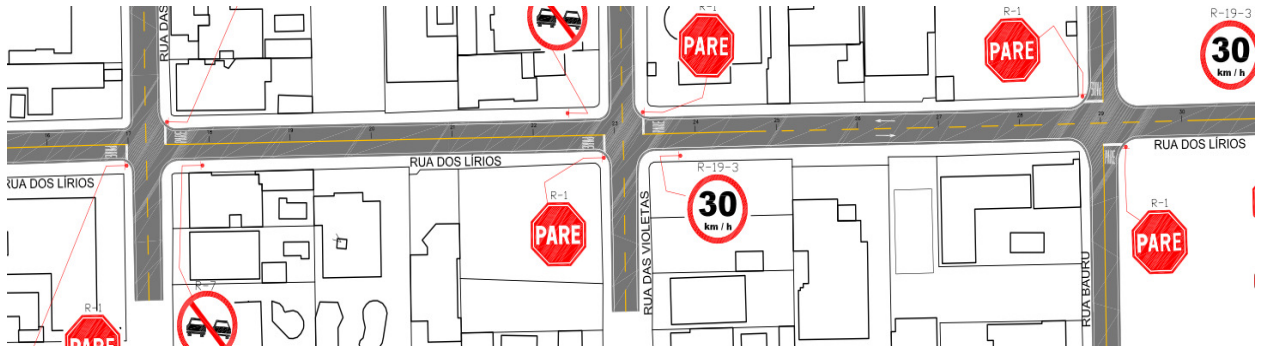
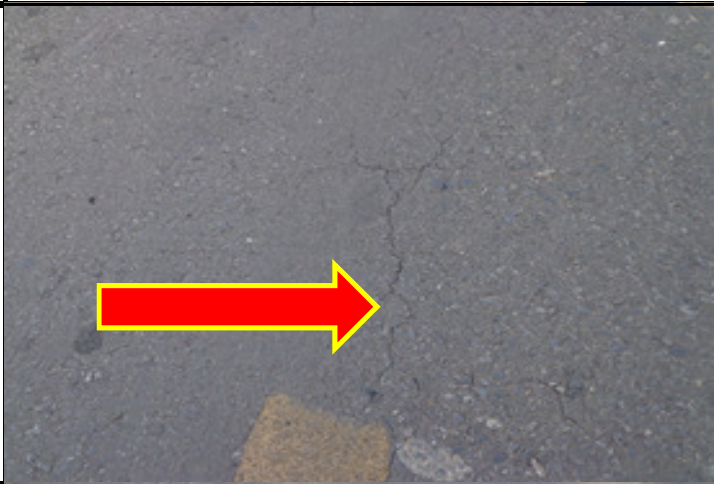
ITEM	ACHADO	FOTOGRAFIA
52	Trinca longitudinal

53	Fissura no pavimento asfáltico - trinca tipo "bloco"

54	Fissura no pavimento asfáltico - trinca tipo "bloco"

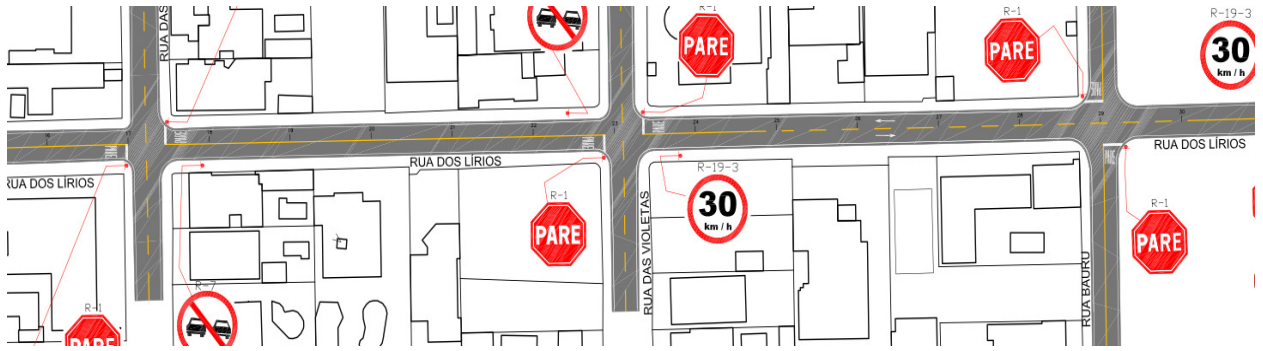
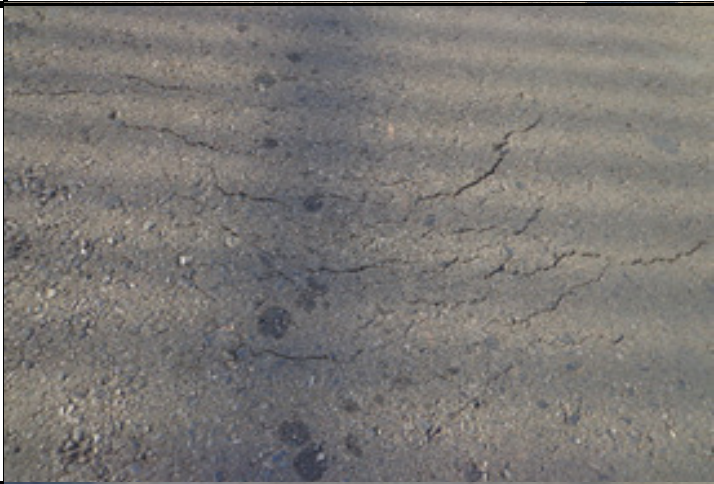
ITEM	ACHADO	FOTOGRAFIA
58	Fissura no pavimento asfáltico - trinca tipo "couro de jacaré"

59	Trinca transversal

60	Fissura no pavimento asfáltico - trinca tipo "bloco"

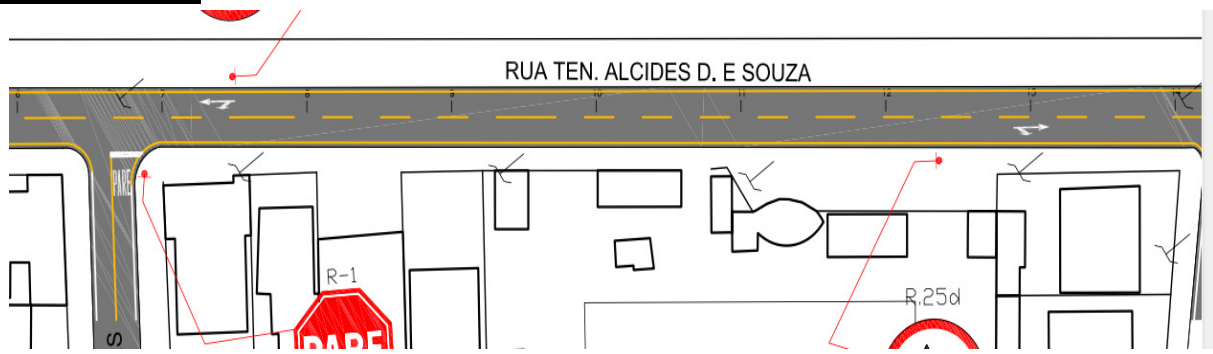
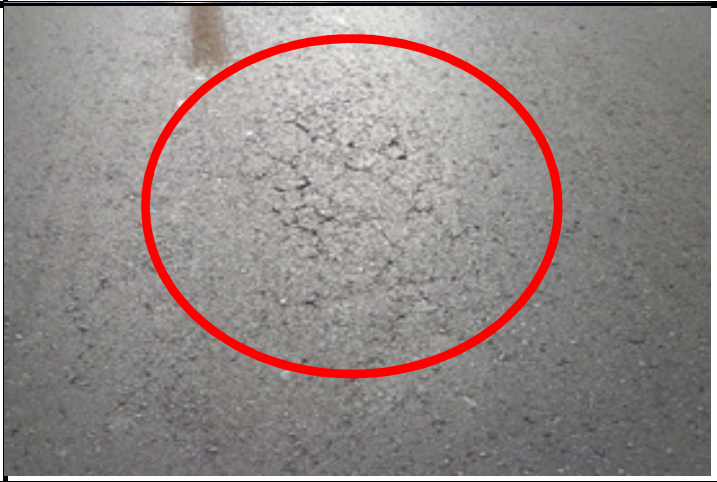
ITEM	ACHADO	FOTOGRAFIA
13	Fissura no pavimento asfáltico - trinca tipo "couro de jacaré"

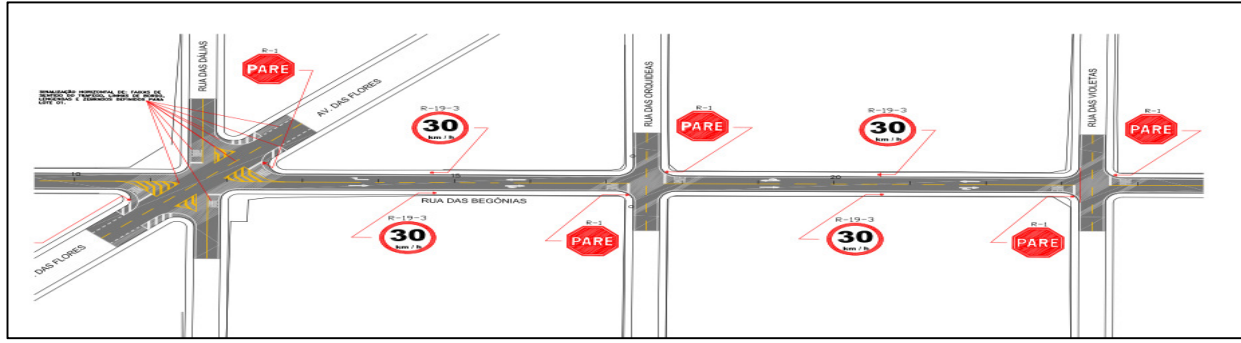
ITEM	ACHADO	FOTOGRAFIA
1	Trinca longitudinal	 
2	Segregação

3	Trinca transversal

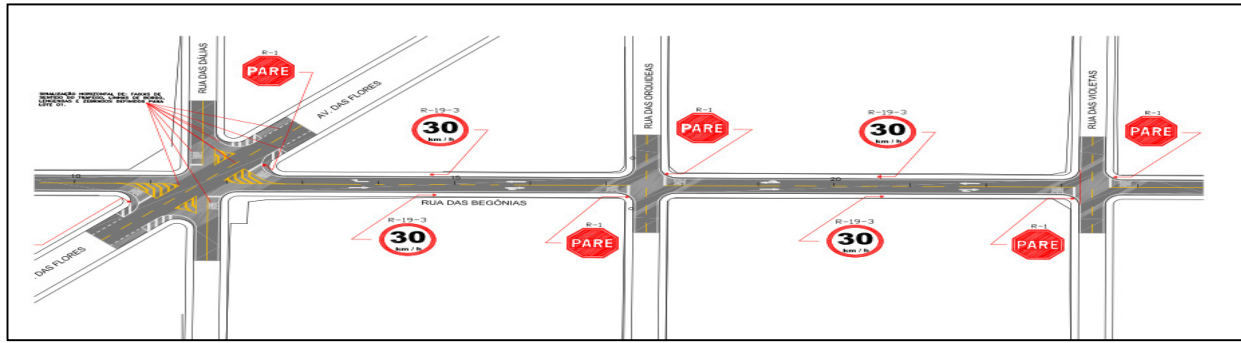
ITEM	ACHADO	FOTOGRAFIA
7	Trinca longitudinal	 
8	Trinca longitudinal	 
9	Segregação

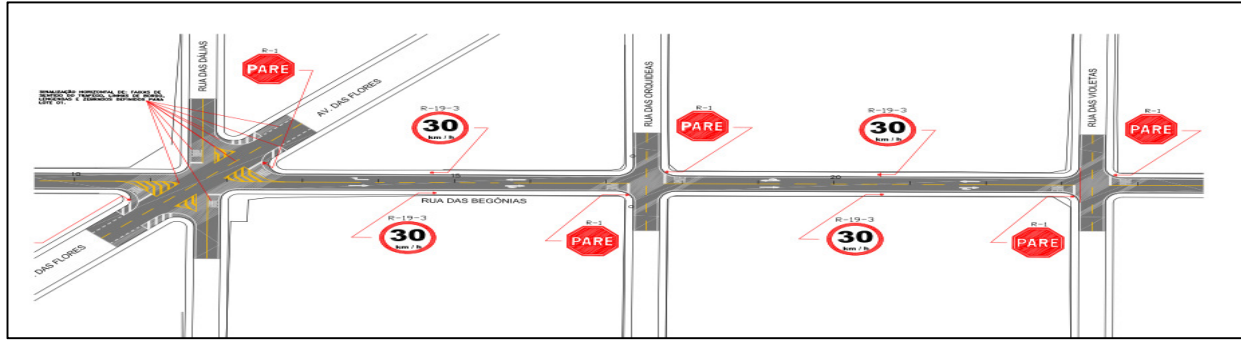
ITEM	ACHADO	FOTOGRAFIA
10	Trinca longitudinal	A close-up photograph of the asphalt road surface. A vertical crack runs through the pavement. A red arrow with a yellow outline points to the crack.
11	Trinca longitudinal	A close-up photograph of the asphalt road surface. A vertical crack runs through the pavement. A red arrow with a yellow outline points to the crack.
12	Trinca longitudinal	A close-up photograph of the asphalt road surface. A vertical crack runs through the pavement. A red arrow with a yellow outline points to the crack.

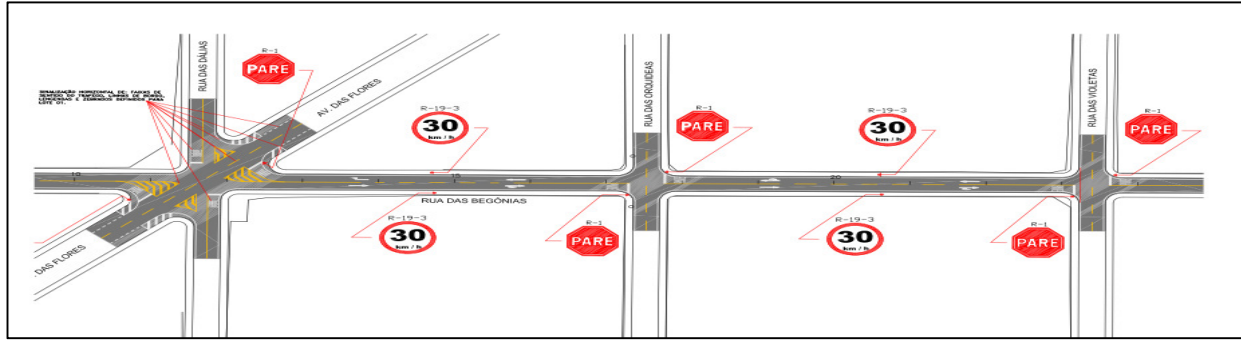
ITEM	ACHADO	FOTOGRAFIA
13	Trinca longitudinal	
14	Trinca longitudinal	
15	Trinca longitudinal

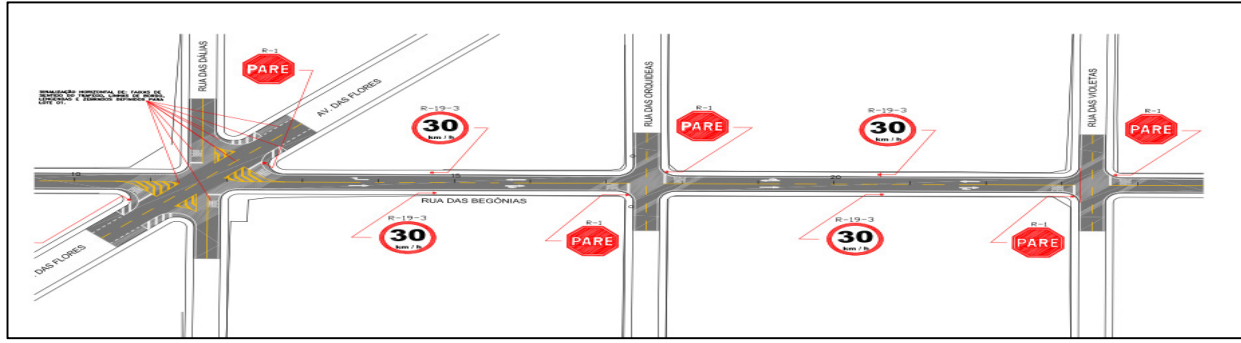
ITEM	ACHADO	FOTOGRAFIA
16	Trinca longitudinal	
17	Trinca longitudinal	
18	Trinca longitudinal
