ANEXO 13 (b) –  
RELATÓRIO FOTOGRÁFICO ELABORADO  
PELA EQUIPE DE FISCALIZAÇÃO DA SECID  
ACERCA DAS INCONFORMIDADES  
CONSTATADAS NA EXECUÇÃO DO  
CONTRATO Nº 060/2012/SECOPA  
(PARTE 1)

# INCONFORMIDADES CONTRATO 060 / 2012

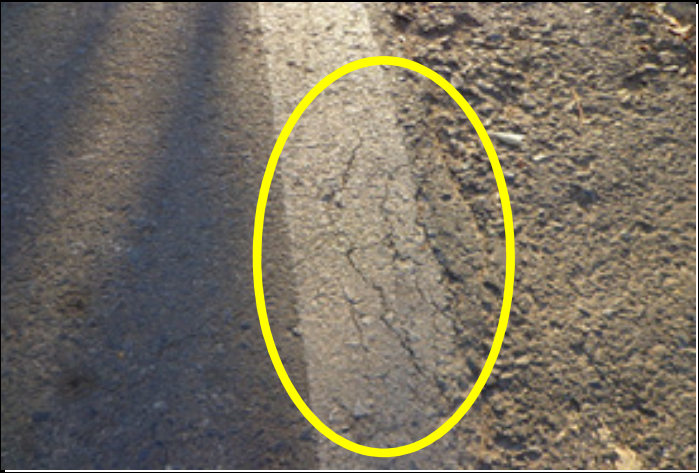
20	Trinca longitudinal

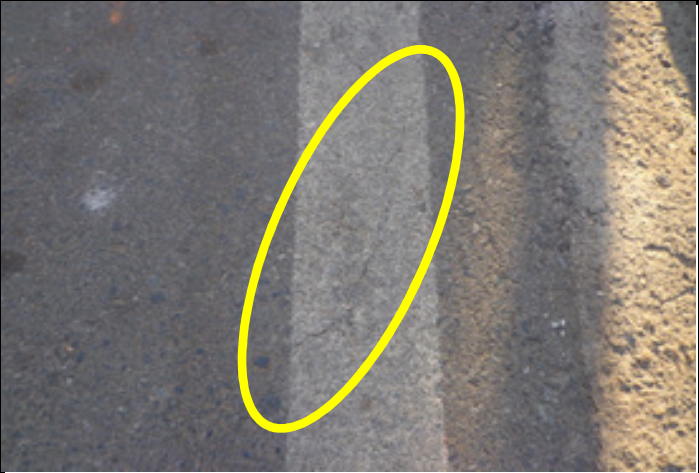
21	Trinca transversal

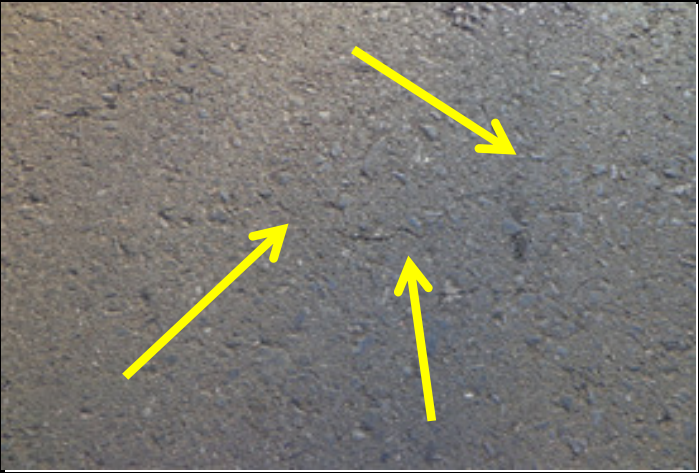
23	Panela ou buraco

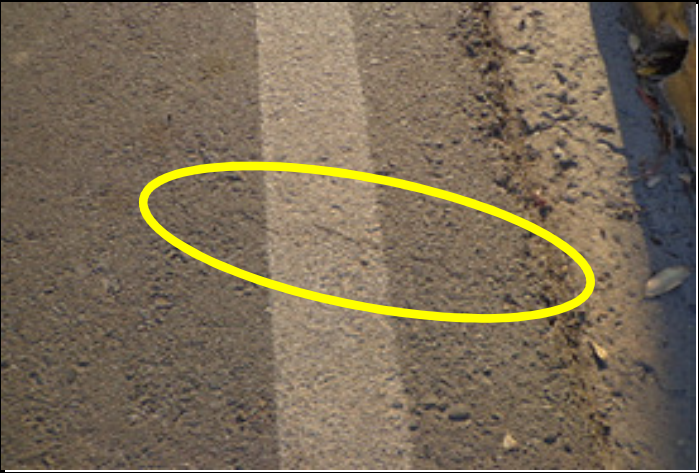
32	Trinca transversal

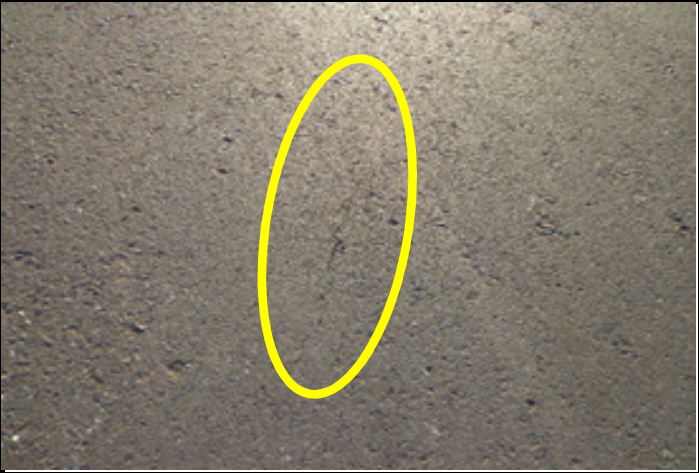
35	Fissura no pavimento asfáltico - trinca tipo "bloco"

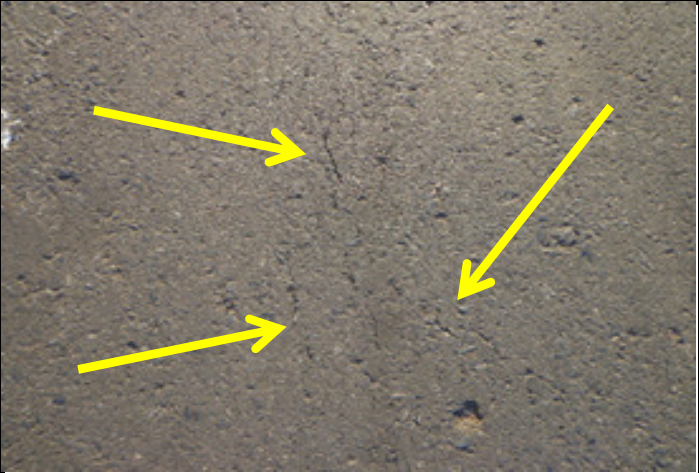
36	Panela ou buraco

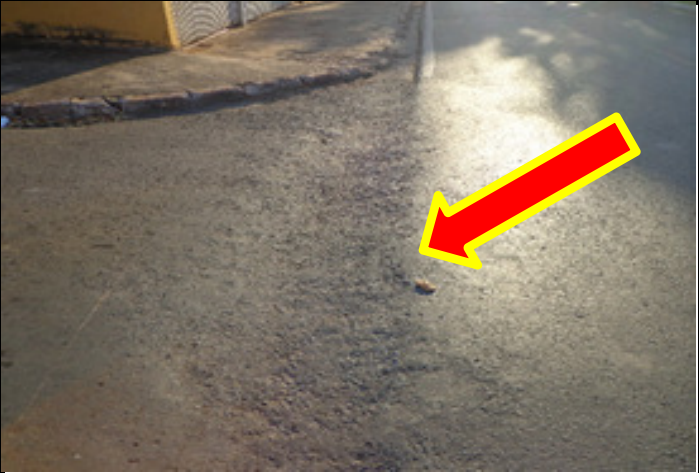
39	Afundamento plástico

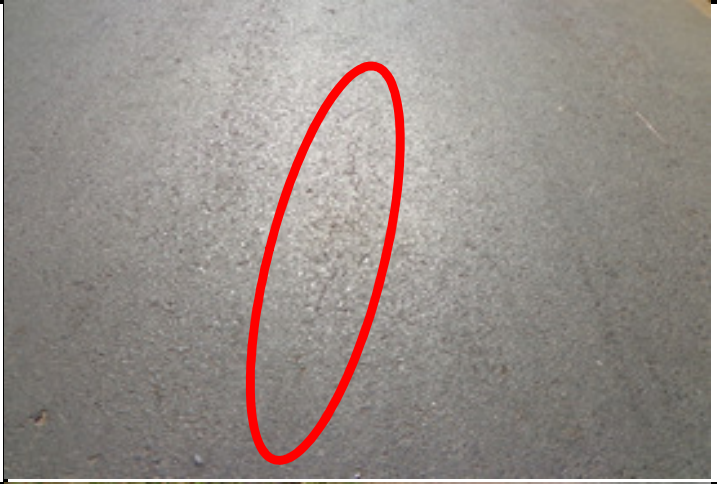
2	Segregação

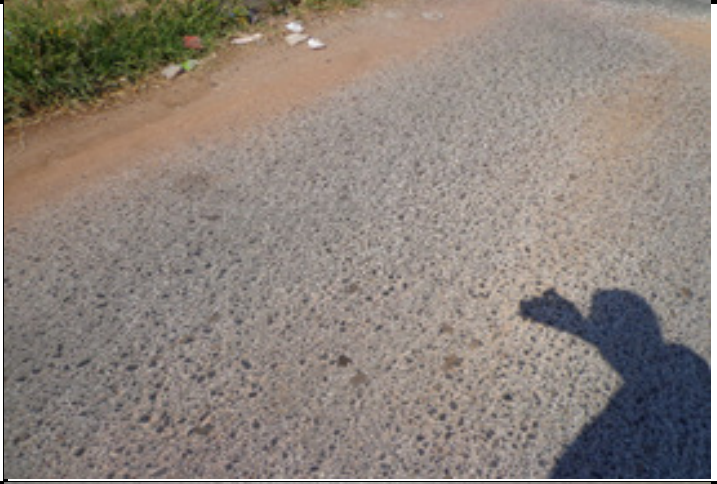
3	Trinca longitudinal

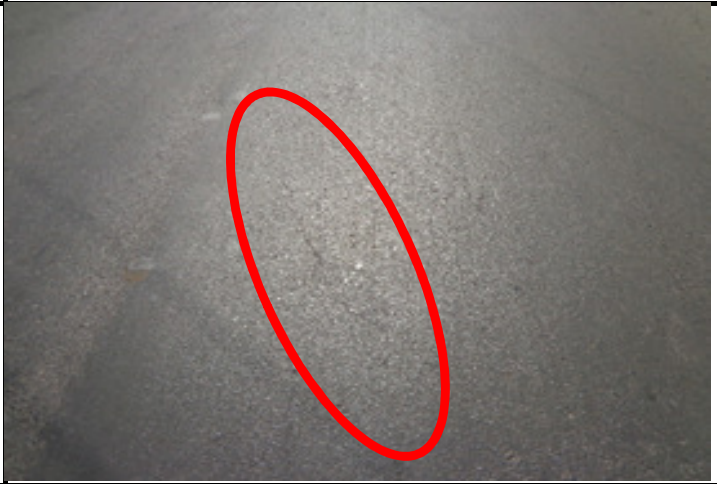
9	Trinca transversal
