ANEXO 13 (c) –  
RELATÓRIO FOTOGRÁFICO ELABORADO  
PELA EQUIPE DE FISCALIZAÇÃO DA SECID  
ACERCA DAS INCONFORMIDADES  
CONSTATADAS NA EXECUÇÃO DO  
CONTRATO Nº 060/2012/SECOPA  
(PARTE 1)

# INCONFORMIDADES CONTRATO 060 / 2012

## RUA GENERAL RABELLO

## RUA DOS GIRASSÓIS

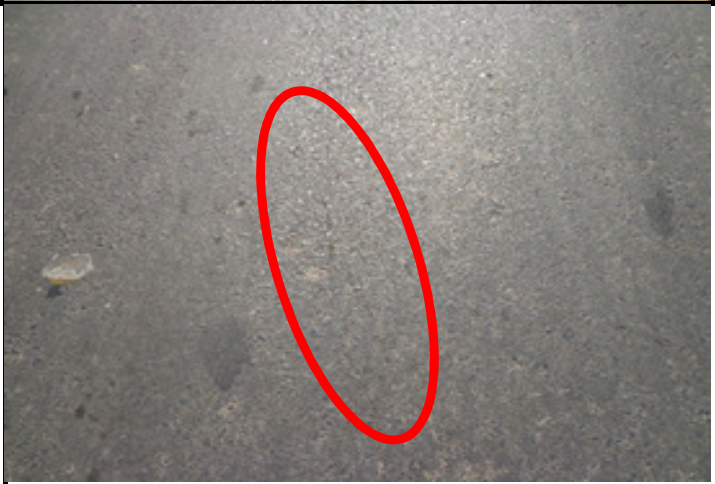
ITEM	ACHADO	FOTOGRAFIA
16	Trinca longitudinal

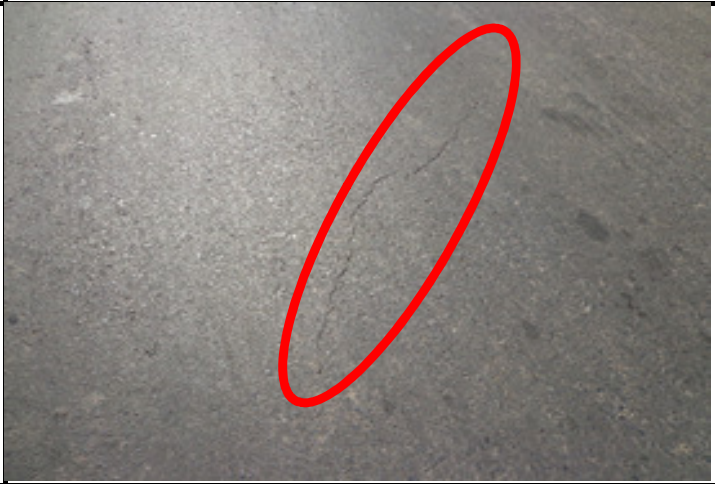
17	Trinca transversal

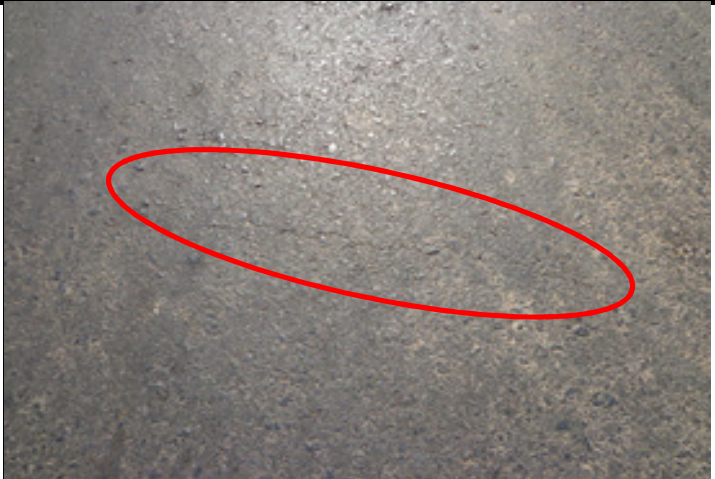
18	Trinca transversal

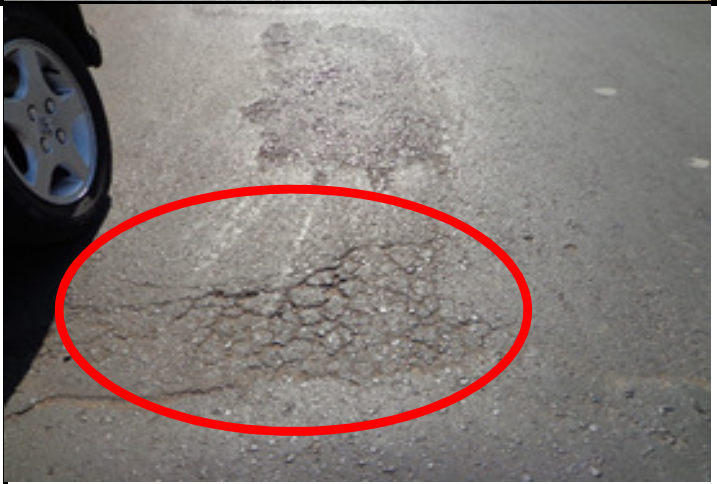
ITEM	ACHADO	FOTOGRAFIA
22	Fissura no pavimento asfáltico - trinca tipo "couro de jacaré"

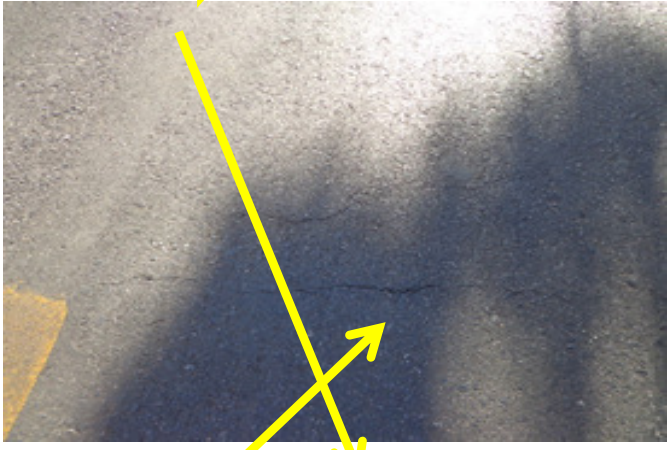
ITEM	ACHADO	FOTOGRAFIA
13	Trinca transversal

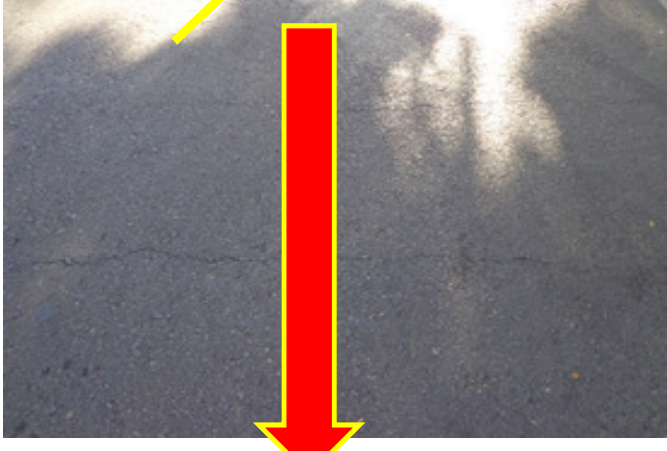
14	Trinca transversal

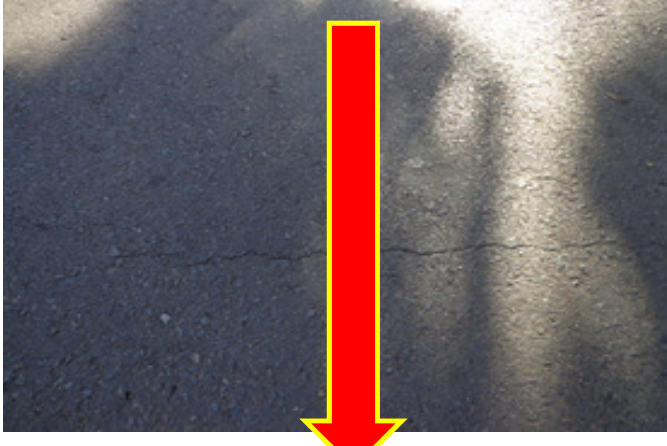
15	Trinca transversal

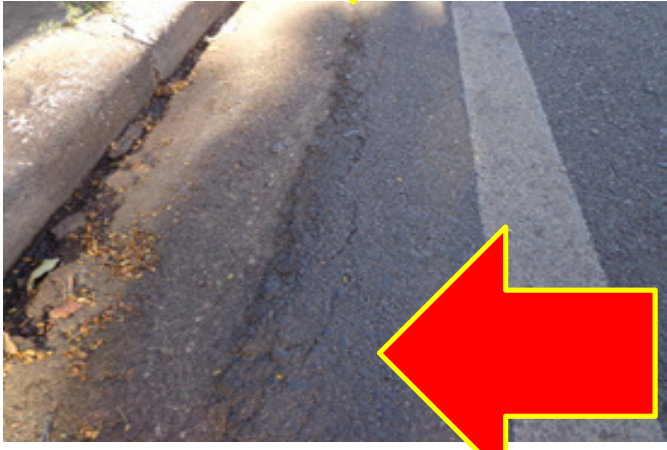
ITEM	ACHADO	FOTOGRAFIA
16	Trinca longitudinal

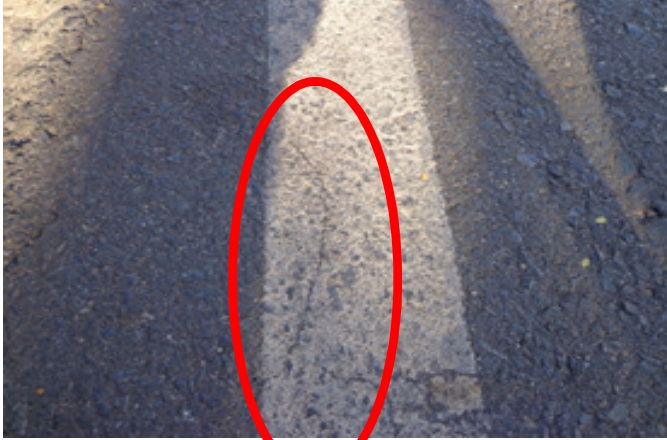
17	Trinca longitudinal

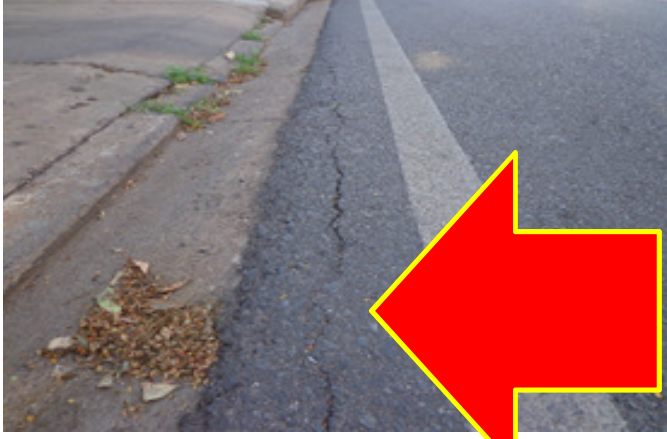
18	Trinca longitudinal

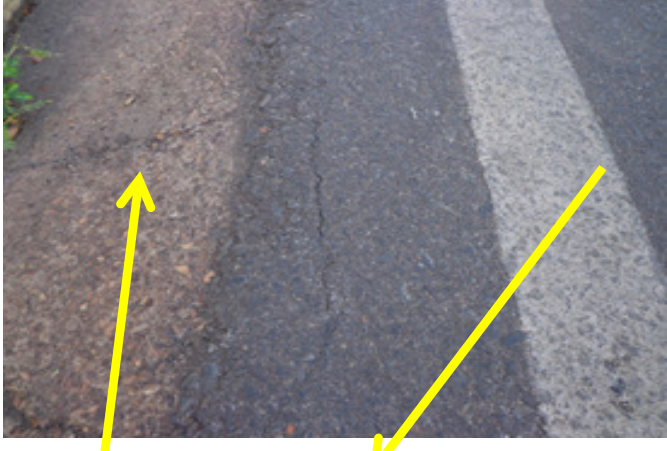
ITEM	ACHADO	FOTOGRAFIA
22	Trinca longitudinal e transversal	 
23	Trinca longitudinal e transversal

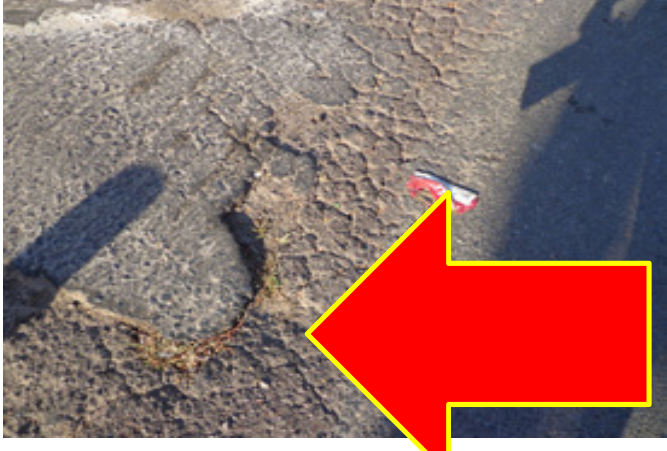
ITEM	ACHADO	FOTOGRAFIA
25	Remendo profundo	 
26	Remendo profundo

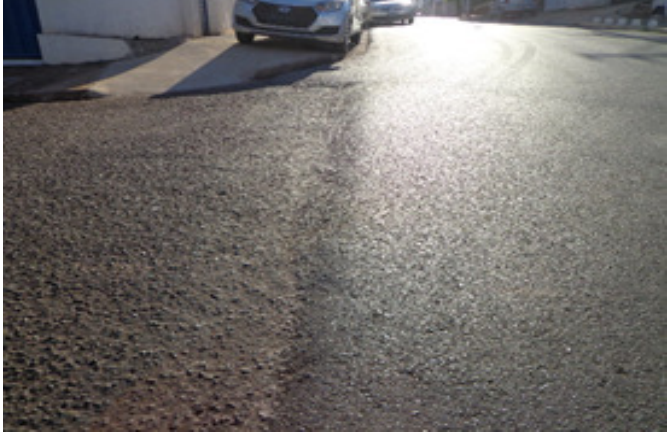
27	Remendo profundo

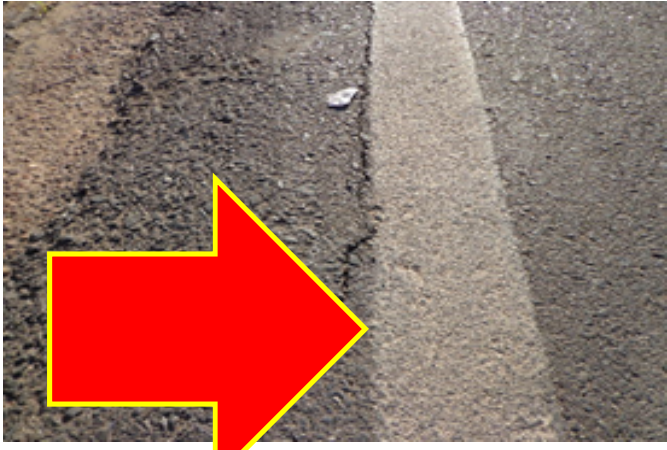
ITEM	ACHADO	FOTOGRAFIA
28	Trinca longitudinal

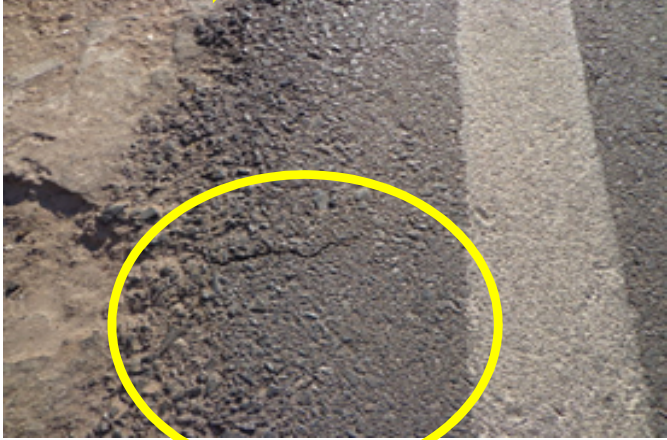
29	Trinca transversal

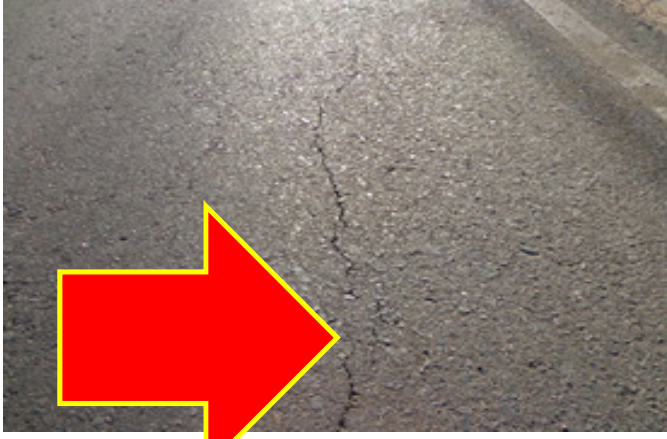
30	Trinca longitudinal

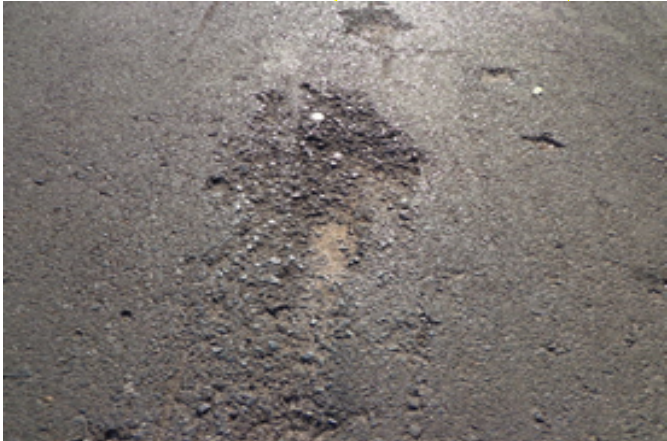
ITEM	ACHADO	FOTOGRAFIA
40	Segregação

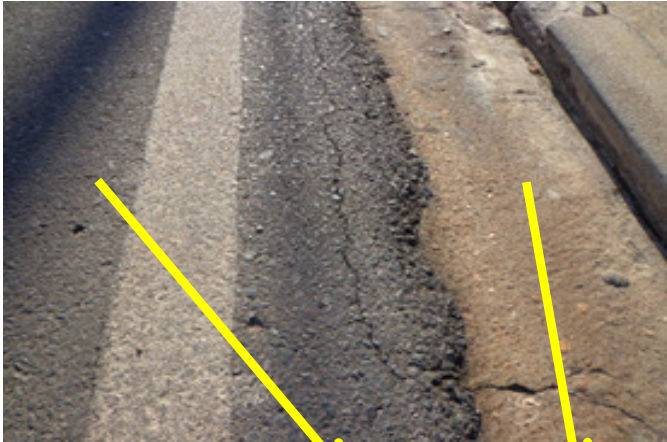
<p>A close-up photograph of the asphalt surface showing a dark, irregularly shaped area of segregation or pothole formation. Two small yellow arrows at the top point towards the affected area.</p>
41	Trinca longitudinal e transversal

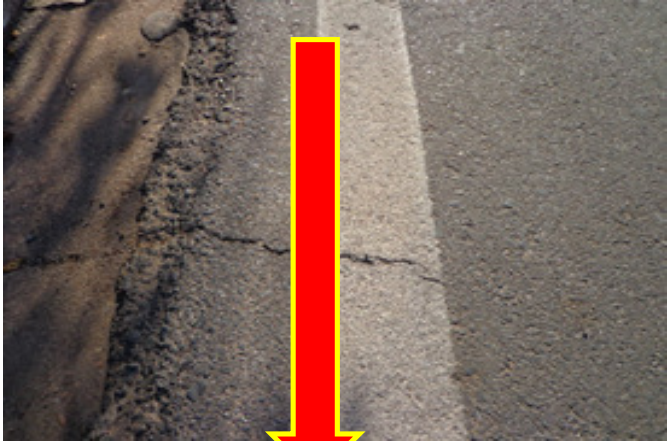
<p>A photograph showing a longitudinal crack in the asphalt. A transverse crack is also visible, intersecting the longitudinal one. Two yellow arrows point to these cracks.</p>
42	Trinca transversal

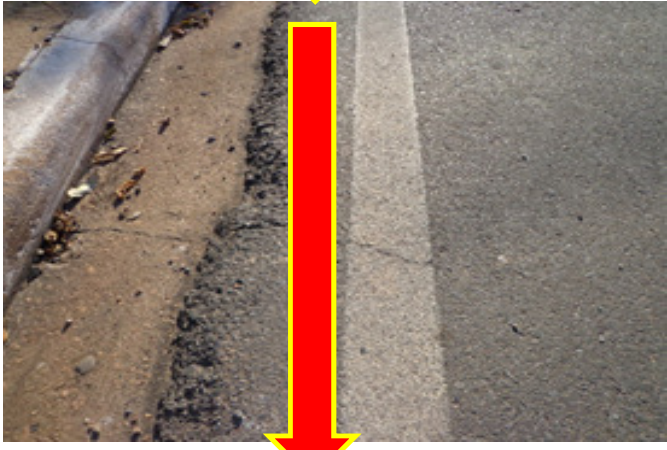
ITEM	ACHADO	FOTOGRAFIA
43	Trinca transversal

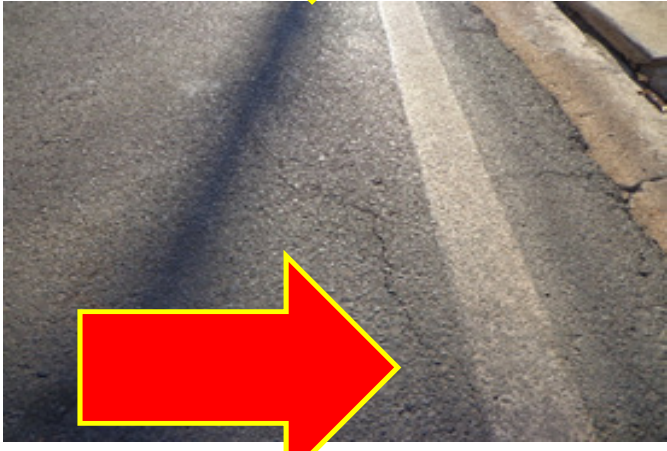
44	Trinca longitudinal

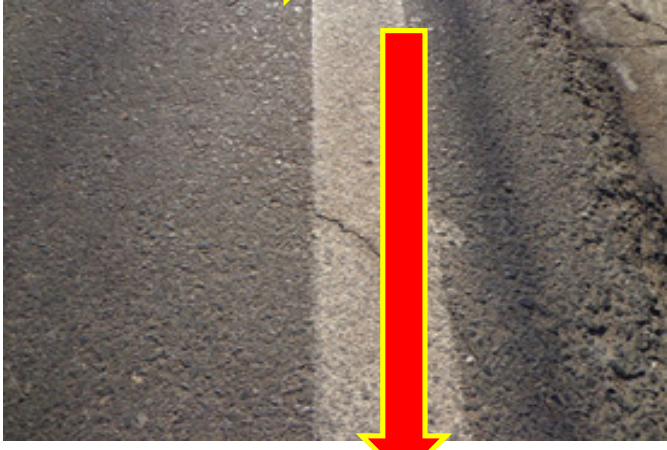
45	Trinca longitudinal
