ANEXO 14 (c)
RELATÓRIO FOTOGRÁFICO ELABORADO
PELA EQUIPE DE FISCALIZAÇÃO DA SECID
ACERCA DAS INCONFORMIDADES
CONSTATADAS NA EXECUÇÃO DO
CONTRATO Nº 060/2012/SECOPA
(PARTE 2)

INCONFORMIDADES CONTRATO 060 / 2012

AV. SÃO SEBASTIÃO

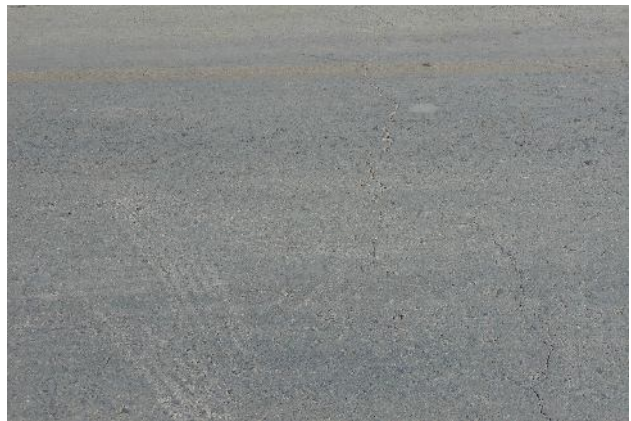
ITEM	ACHADO	FOTOGRAFIA
20	Trincas Longitudinais

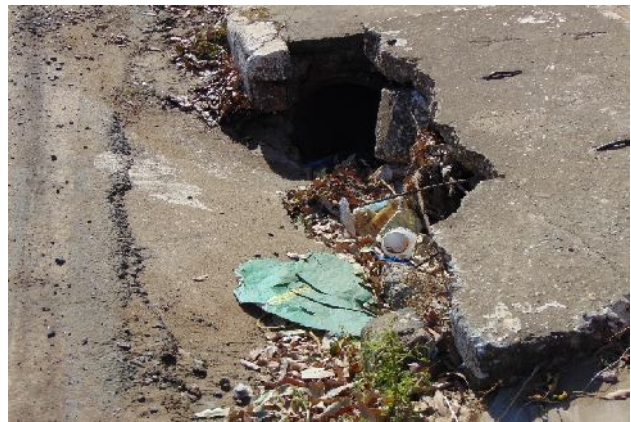
21	Trampa de boca de lobo quebrada

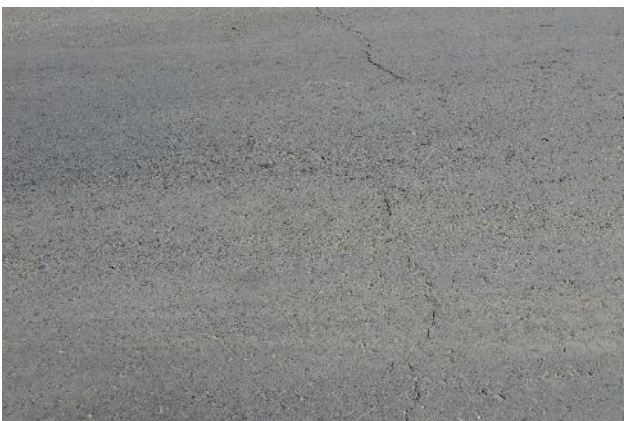
22	Trincas Longitudinais

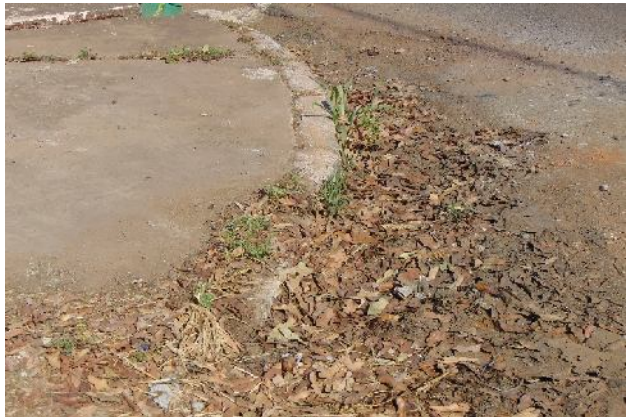
ITEM	ACHADO	FOTOGRAFIA
23	Meio Fio danificado e inexecução de sargeta

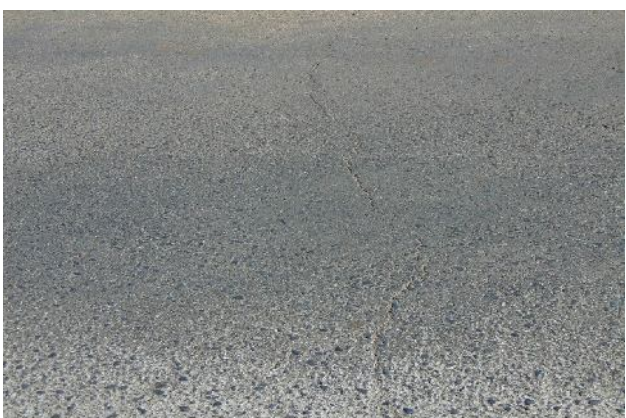
A photograph showing a close-up of a concrete curb and gutter. The curb is cracked and uneven, and the gutter is filled with dirt and debris, indicating damage and poor maintenance.
24	Trincas Longitudinais

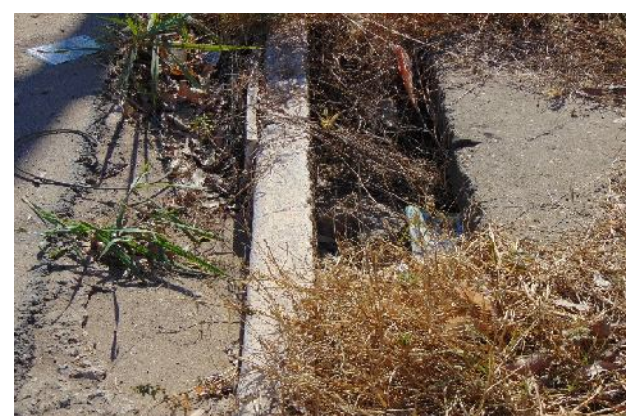
A photograph showing a close-up of asphalt pavement. Several long, parallel cracks are visible, running across the width of the road, indicating structural damage.
25	Tampa de boca de lobo quebrada

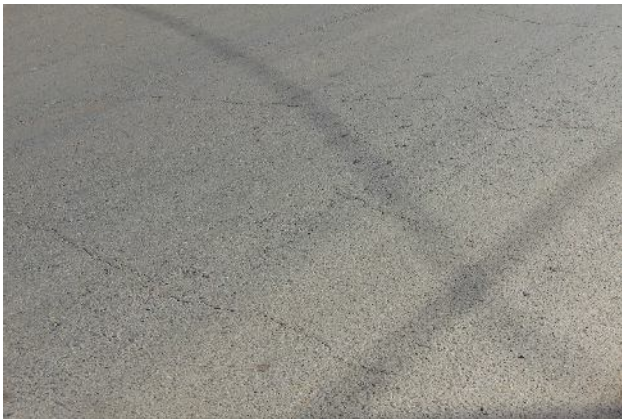
ITEM	ACHADO	FOTOGRAFIA
26	Trincas Longitudinais e Transversais

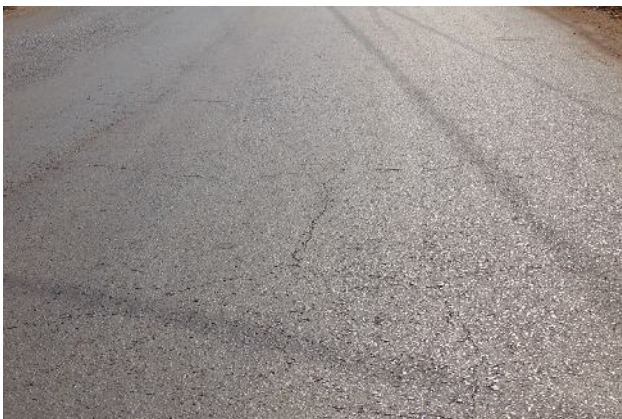
27	Trincas Longitudinais e Transversais

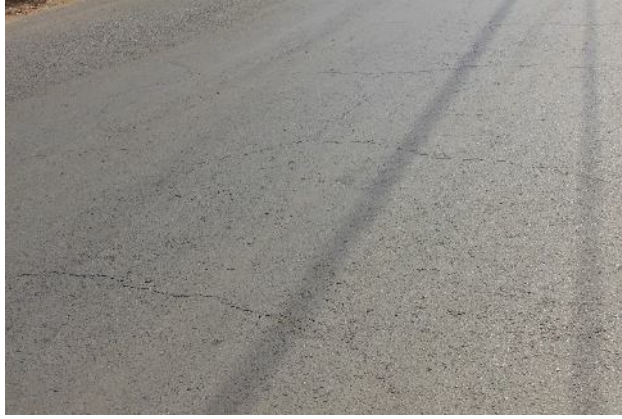
28	Trincas Longitudinais e Transversais

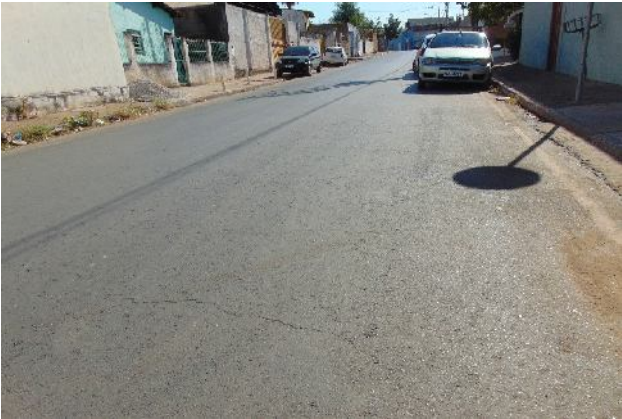
ITEM	ACHADO	FOTOGRAFIA
29	Trincas Transversais

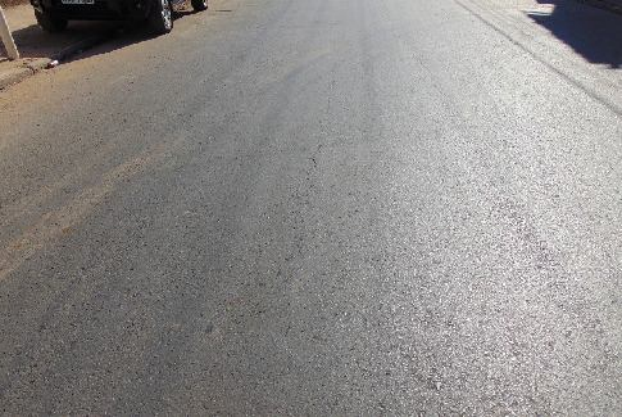
A photograph of a paved road surface showing several transverse cracks. The road is flanked by buildings and parked cars.
30	Trincas Longitudinais

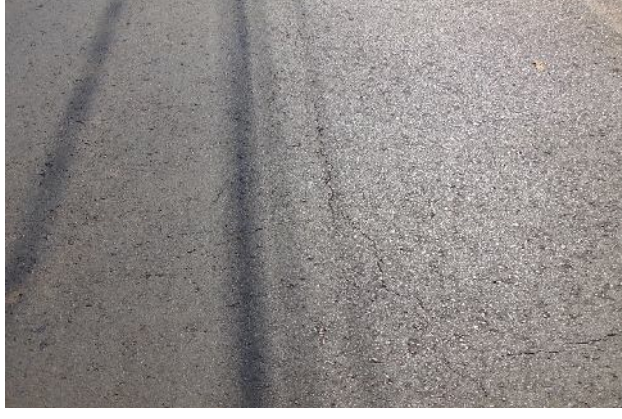
A close-up photograph of a paved road surface showing several longitudinal cracks.
31	Trincas Longitudinais

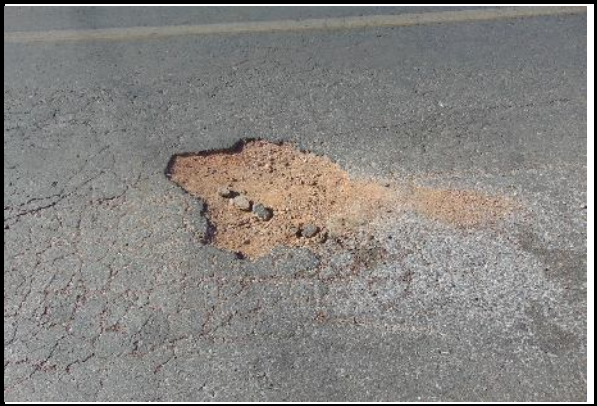
ITEM	ACHADO	FOTOGRAFIA
1	Panelas

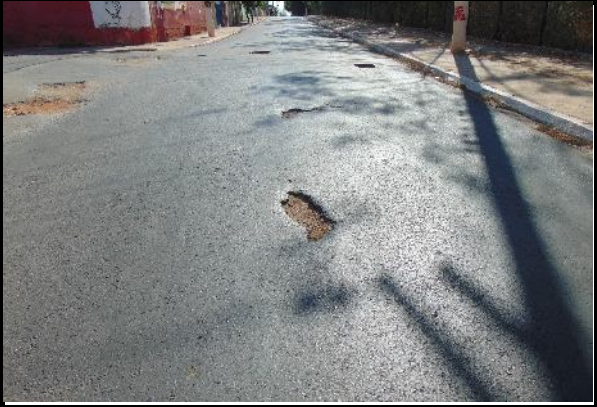
2	Panelas

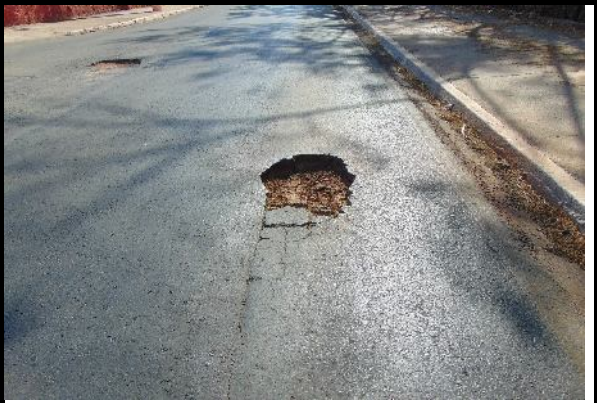
3	Panelas
