ANEXO 13 (c) –  
RELATÓRIO FOTOGRÁFICO ELABORADO  
PELA EQUIPE DE FISCALIZAÇÃO DA SECID  
ACERCA DAS INCONFORMIDADES  
CONSTATADAS NA EXECUÇÃO DO  
CONTRATO Nº 060/2012/SECOPA  
(PARTE 1)

# INCONFORMIDADES CONTRATO 060 / 2012

## RUA GENERAL RABELLO

## RUA DOS GIRASSÓIS

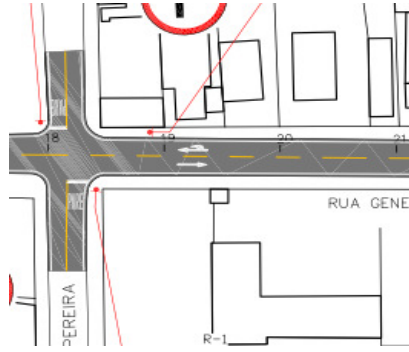
ITEM	ACHADO	FOTOGRAFIA
1	REMENDO MAL EXECUTADO	 
2	AFUNDAMENTO

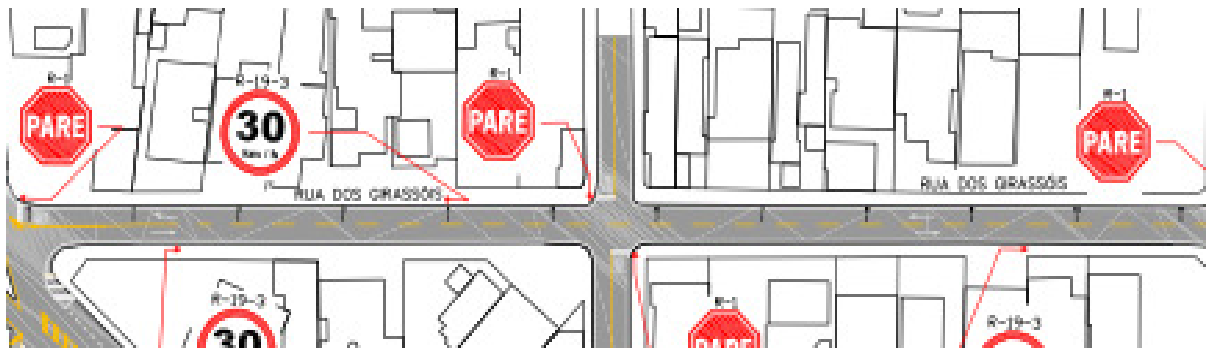
ITEM	ACHADO	FOTOGRAFIA
1	Trinca longitudinal e transversal	
2	Trinca longitudinal	
3	Trinca longitudinal
