ANEXO 13 (a) –
RELATÓRIO FOTOGRÁFICO ELABORADO
PELA EQUIPE DE FISCALIZAÇÃO DA SECID
ACERCA DAS INCONFORMIDADES
CONSTATADAS NA EXECUÇÃO DO
CONTRATO Nº 060/2012/SECOA
(PARTE 1)

INCONFORMIDADES CONTRATO 060 / 2012

AVENIDA LAVA PÉS

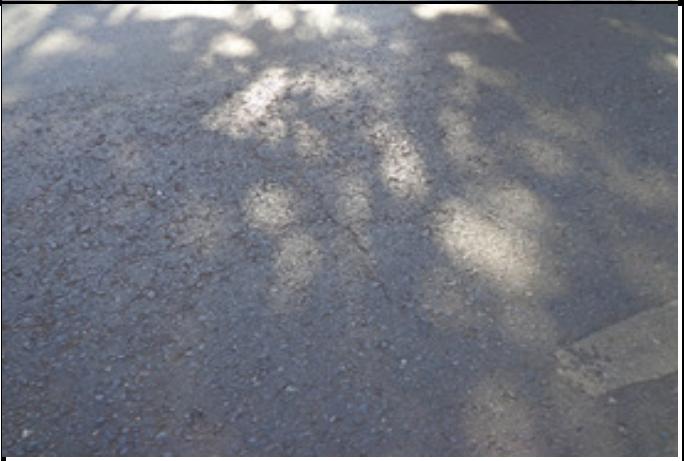
ITEM	ACHADO	FOTOGRAFIA
19	Afundamento de consolidação

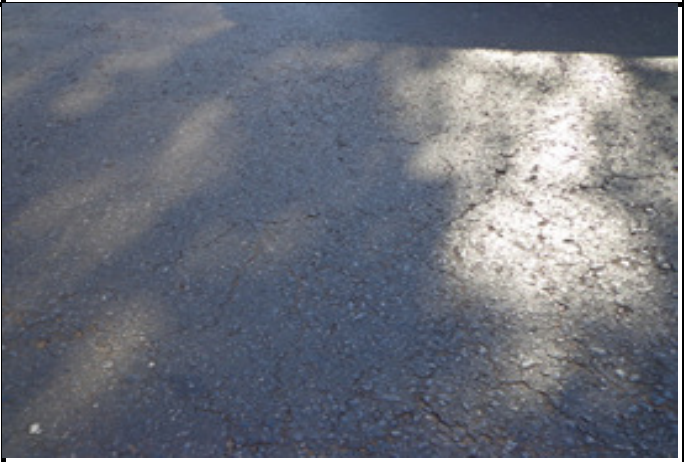
20	Fissura no pavimento asfáltico - trinca tipo "couro de jacaré"

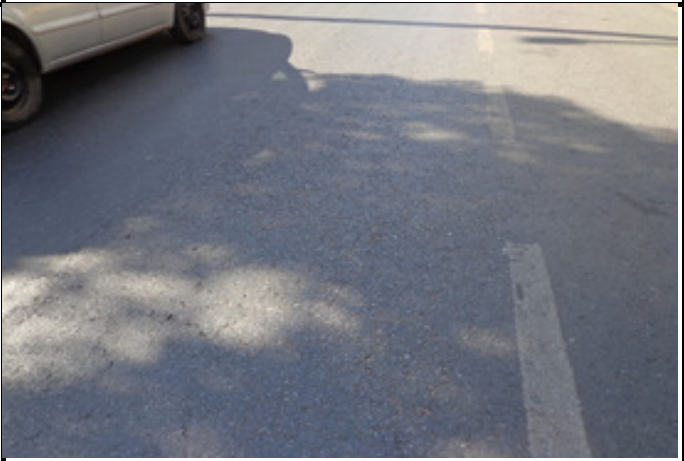
21	Afundamento de consolidação

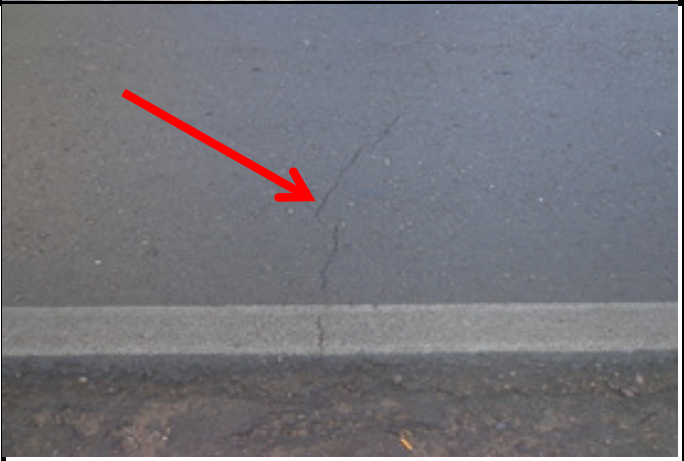
ITEM	ACHADO	FOTOGRAFIA
25	Trinca transversal

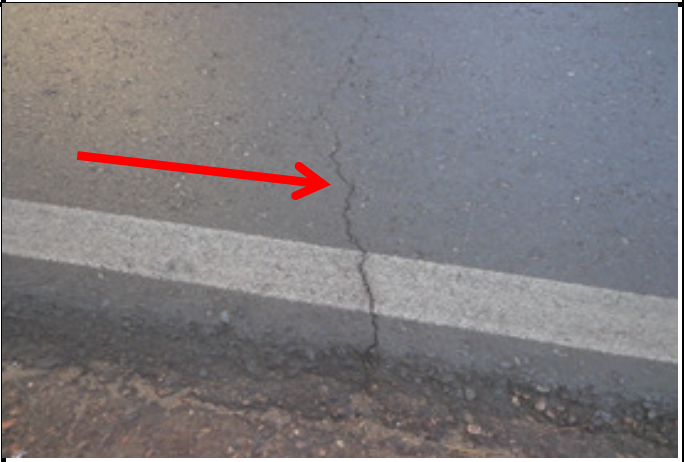
26	Trinca transversal

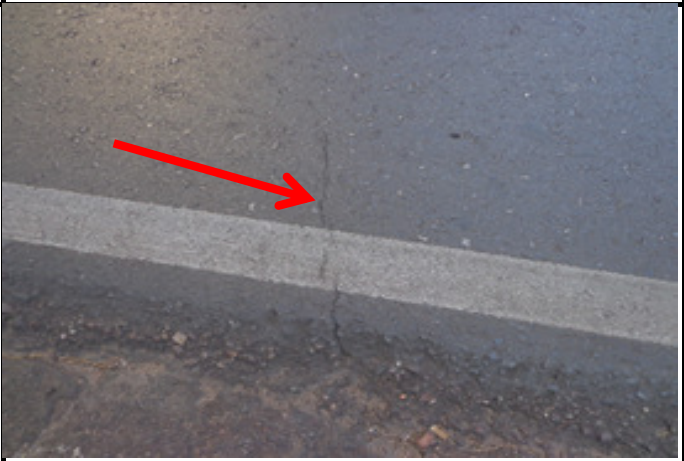
27	Trinca transversal

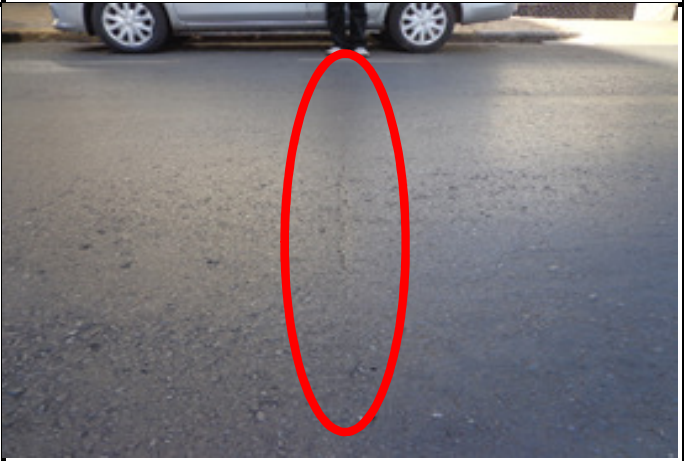
ITEM	ACHADO	FOTOGRAFIA
31	Trinca transversal	 
32	Trinca transversal	 
33	Trinca transversal

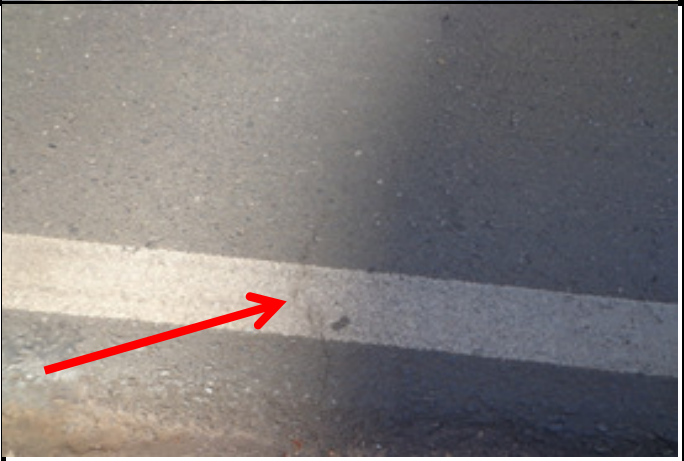
ITEM	ACHADO	FOTOGRAFIA
40	Trinca transversal

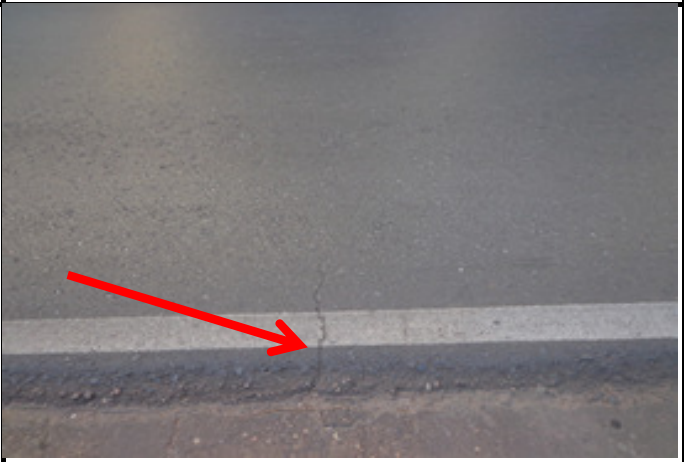
41	Trinca transversal

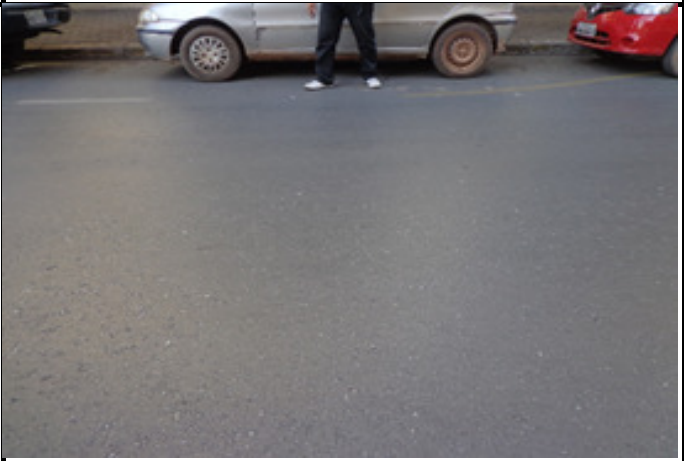
42	Segregação

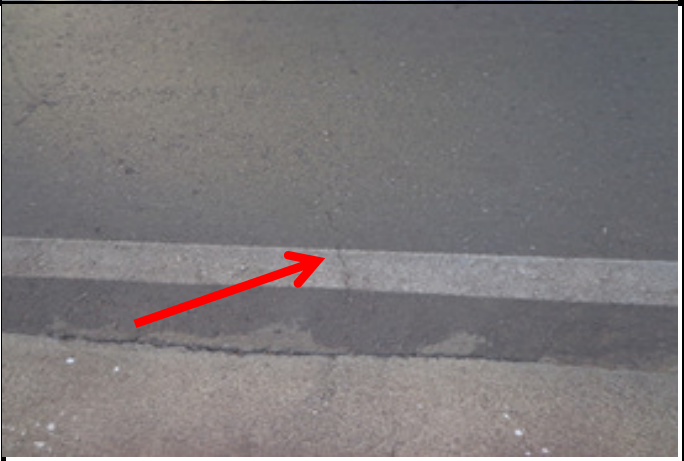
ITEM	ACHADO	FOTOGRAFIA
43	Trinca transversal

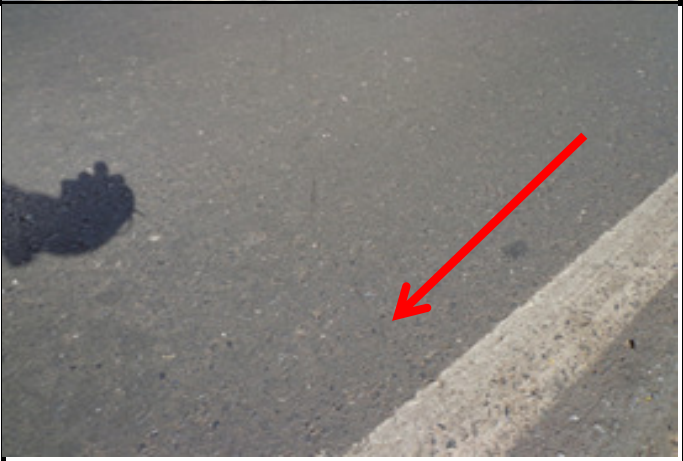
ITEM	ACHADO	FOTOGRAFIA
46	Trinca transversal

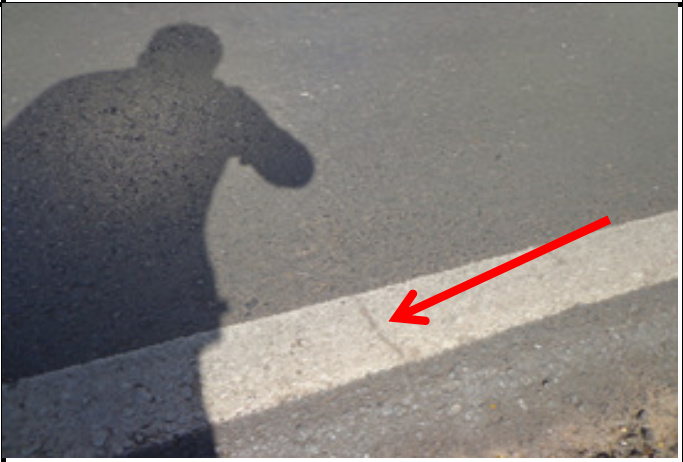
47	Trinca transversal

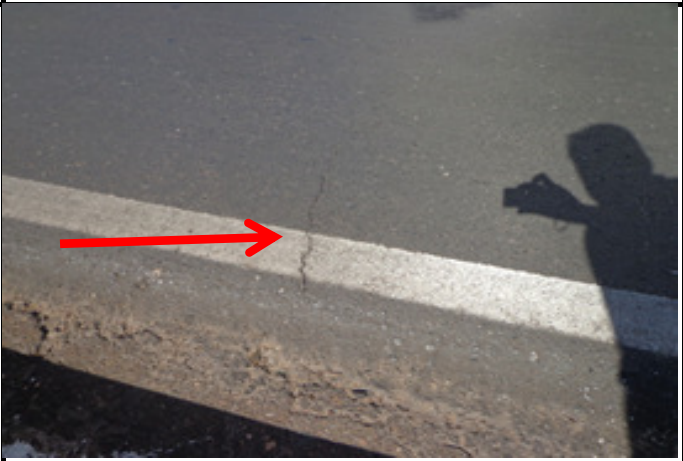
48	Trinca transversal

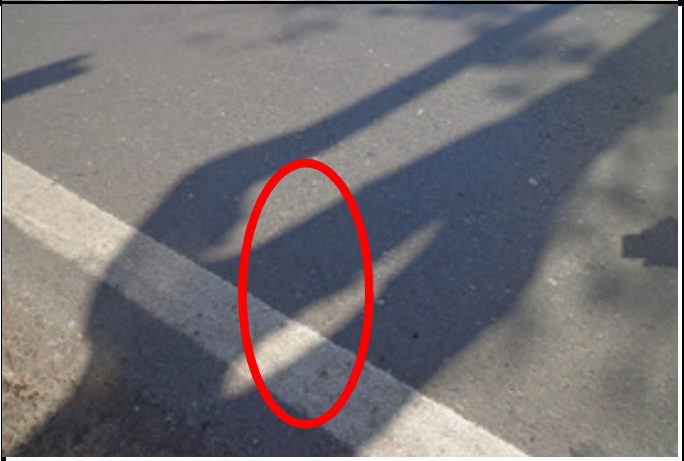
ITEM	ACHADO	FOTOGRAFIA
49	Trinca transversal

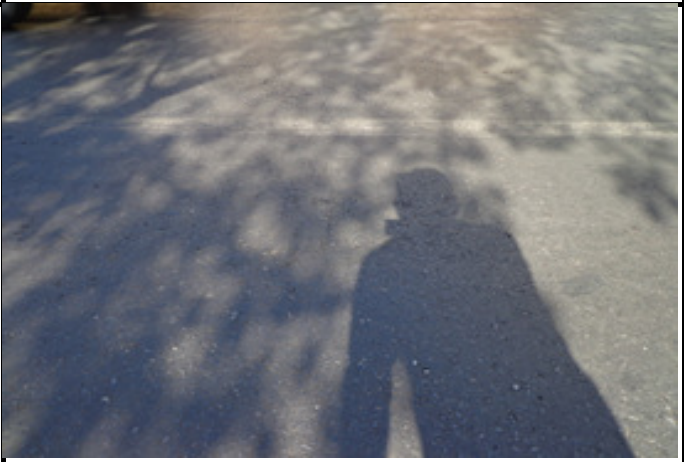
50	Segregação

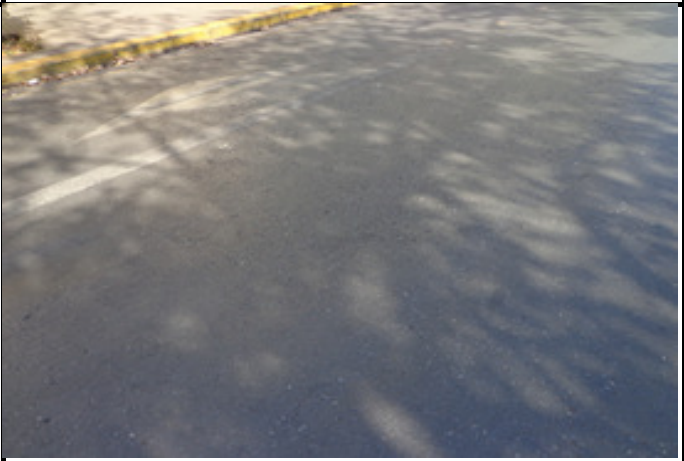
51	Segregação

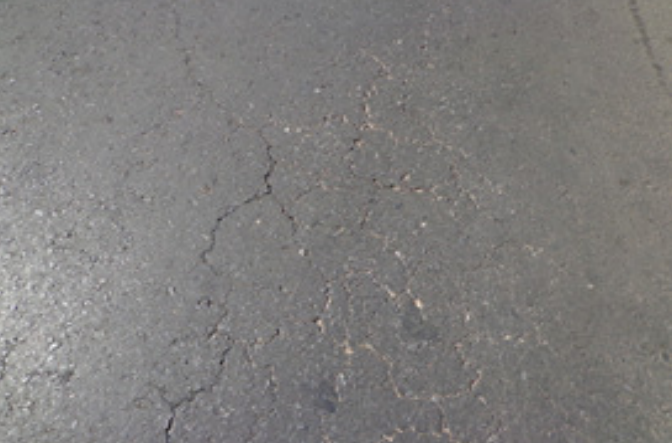
ITEM	ACHADO	FOTOGRAFIA
58	Fissura no pavimento asfáltico - trinca tipo "couro de jacaré"

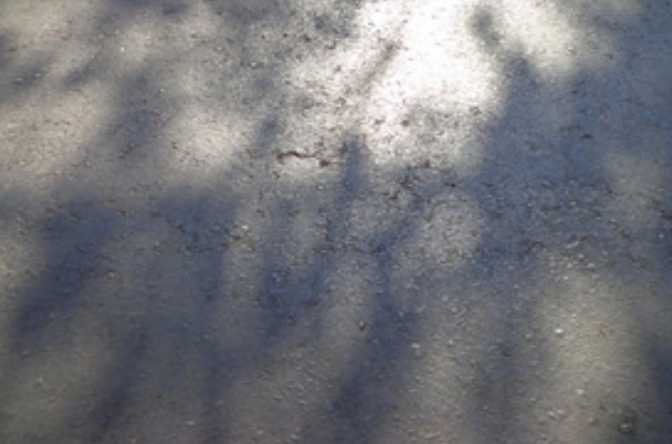
59	Fissura no pavimento asfáltico - trinca tipo "couro de jacaré"

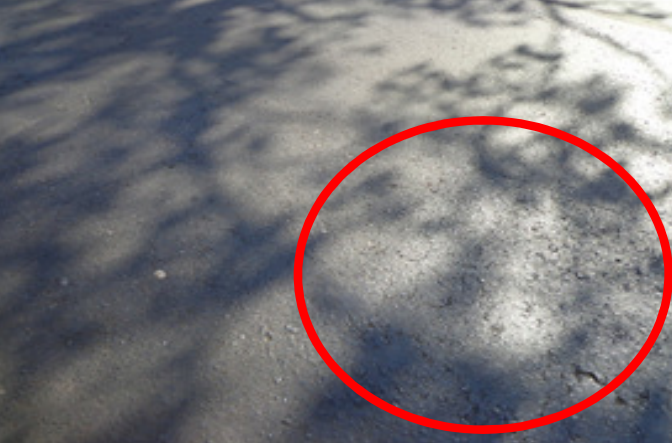
60	Fissura no pavimento asfáltico - trinca tipo "couro de jacaré"

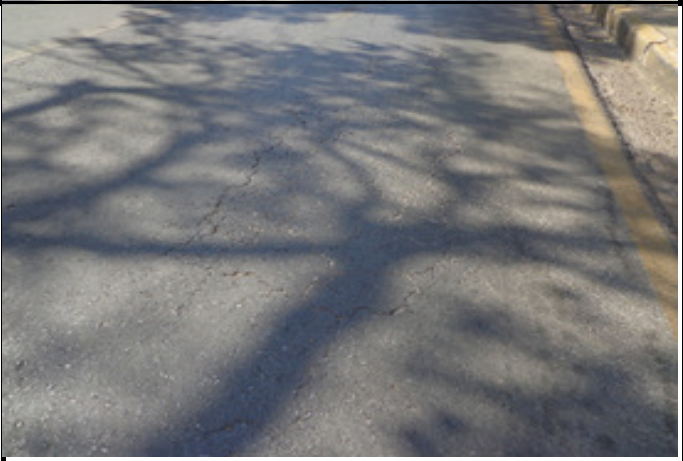
ITEM	ACHADO	FOTOGRAFIA
61	Fissura no pavimento asfáltico - trinca tipo "couro de jacaré"

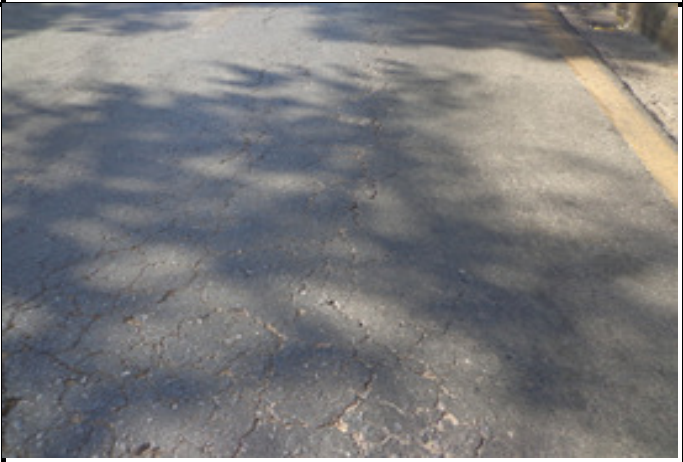
62	Fissura no pavimento asfáltico - trinca tipo "couro de jacaré"

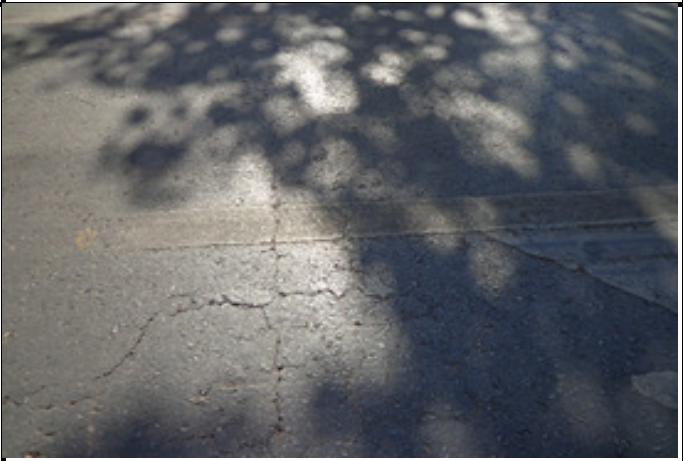
63	Fissura no pavimento asfáltico - trinca tipo "couro de jacaré"

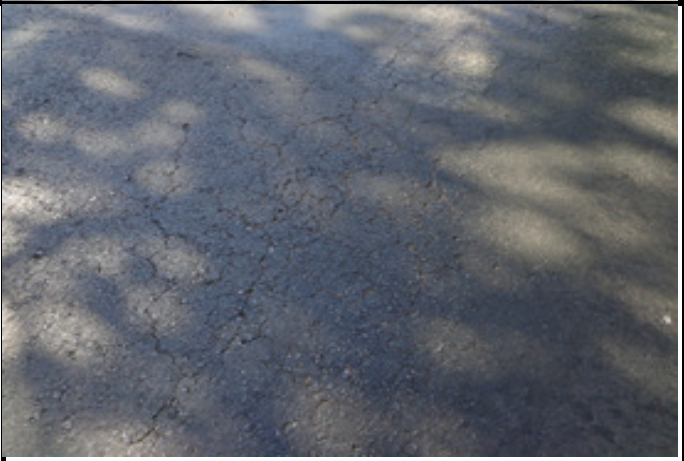
ITEM	ACHADO	FOTOGRAFIA
64	Fissura no pavimento asfáltico - trinca tipo "couro de jacaré"

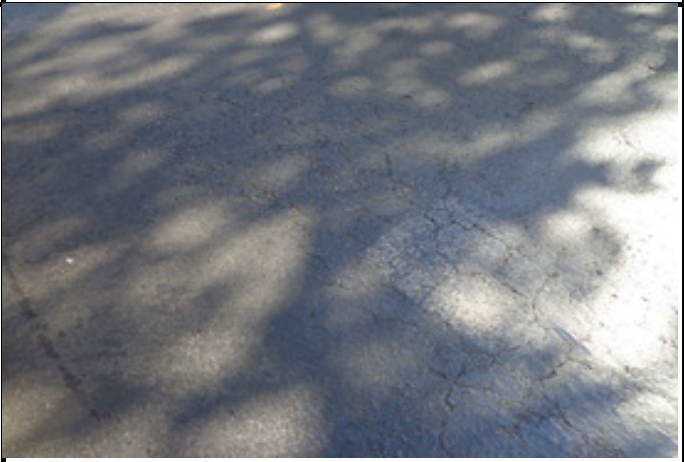
65	Fissura no pavimento asfáltico - trinca tipo "couro de jacaré"

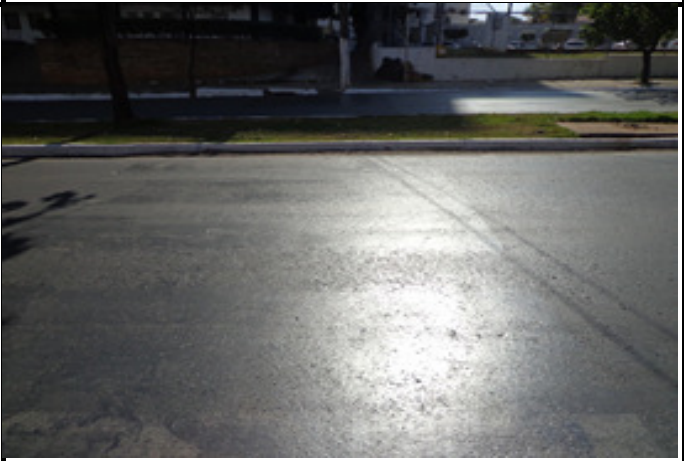
66	Segregação

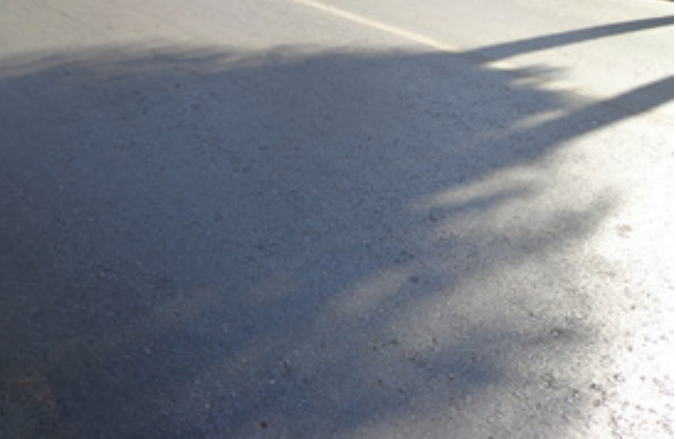
ITEM	ACHADO	FOTOGRAFIA
70	Segregação

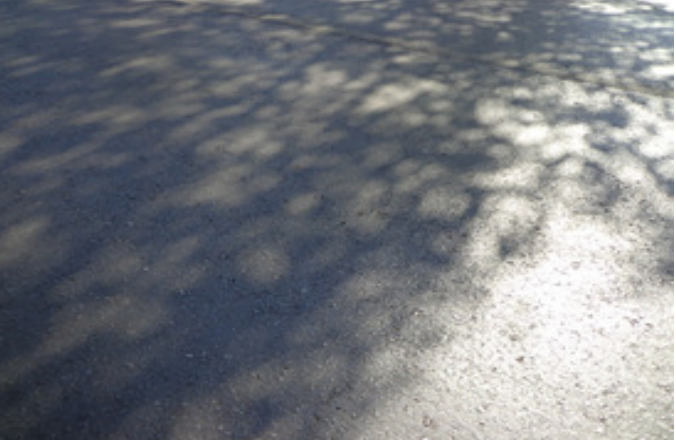
71	Segregação

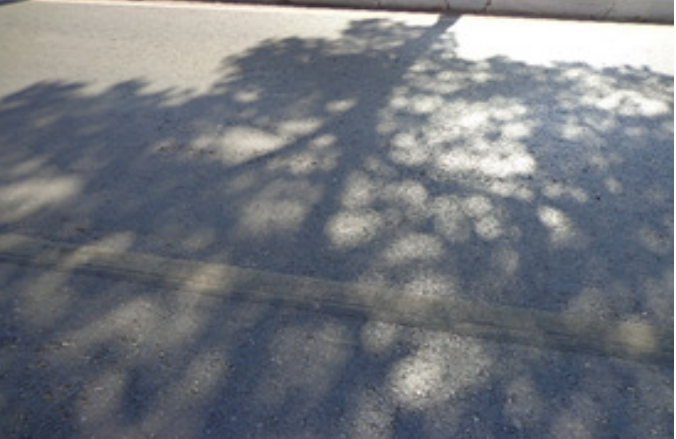
72	Segregação

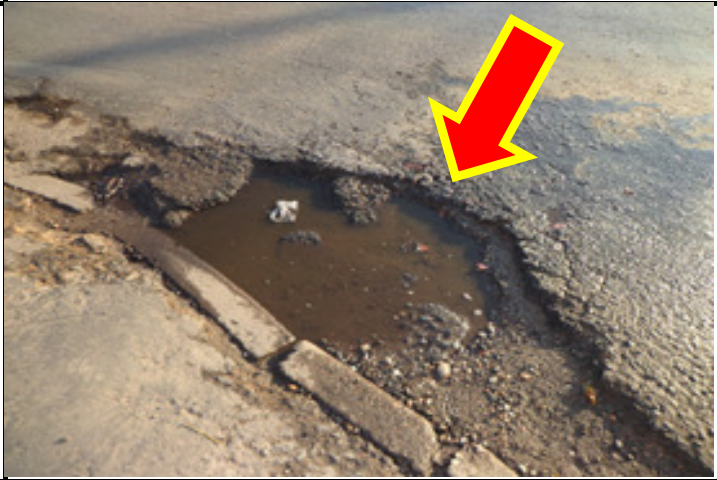
ITEM	ACHADO	FOTOGRAFIA
1	Panela ou buraco

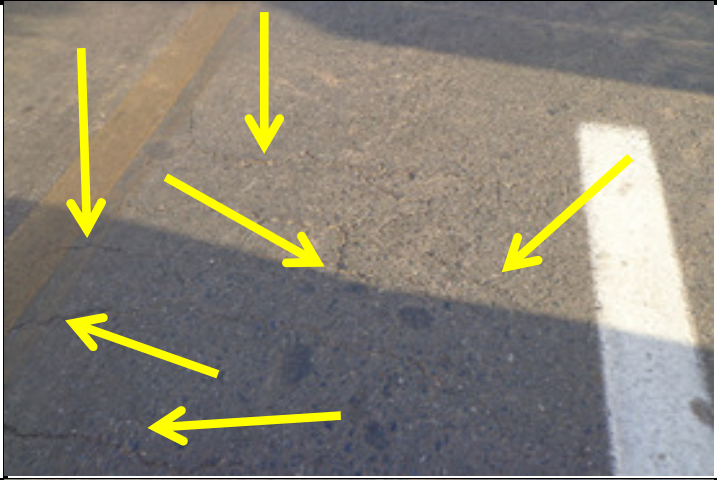
2	Fissura no pavimento asfáltico - trinca tipo "bloco"

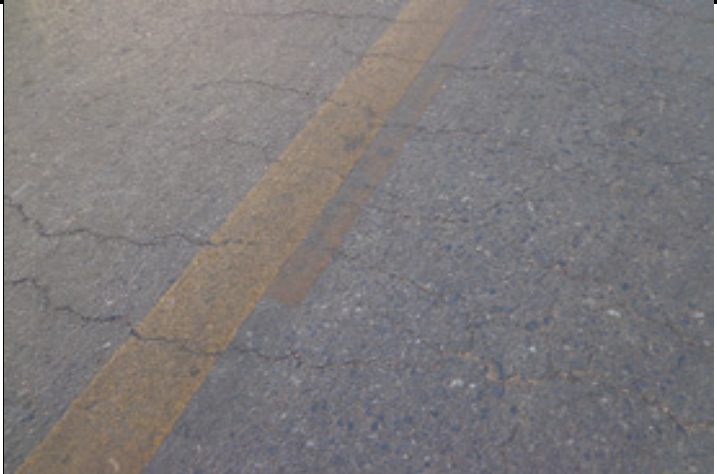
3	Fissura no pavimento asfáltico - trinca tipo "bloco"

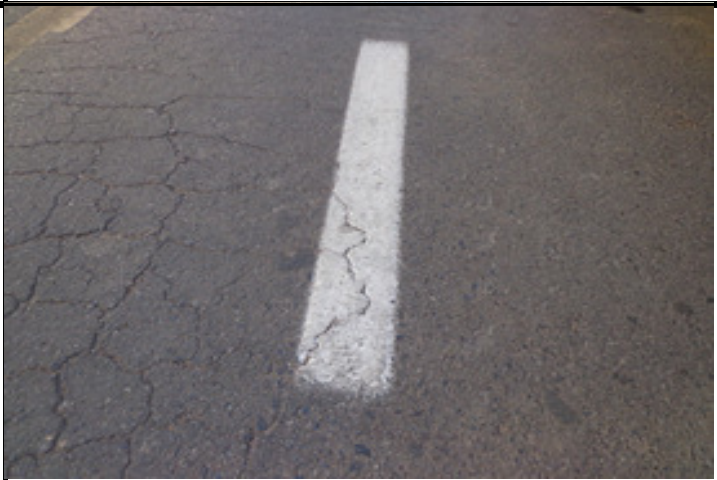
ITEM	ACHADO	FOTOGRAFIA
7	Fissura no pavimento asfáltico - trinca tipo "couro de jacaré"

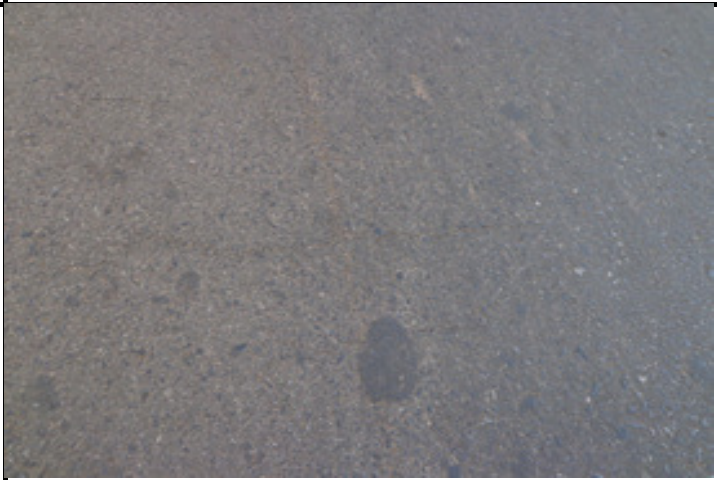
8	Segregação

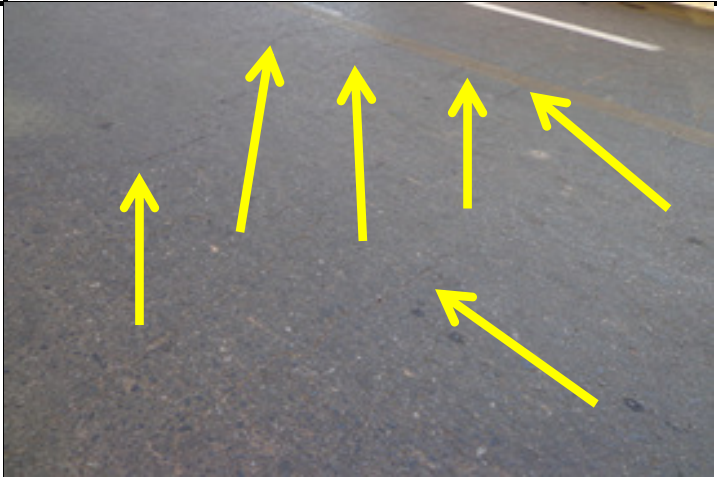
9	Trinca transversal

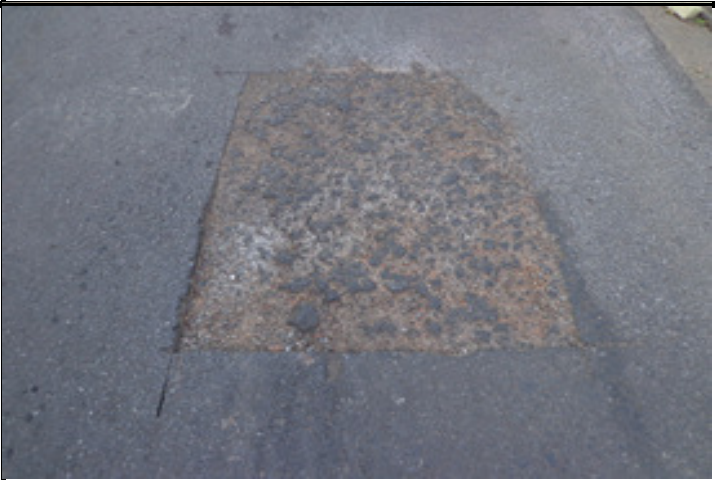
ITEM	ACHADO	FOTOGRAFIA
13	Panela ou buraco

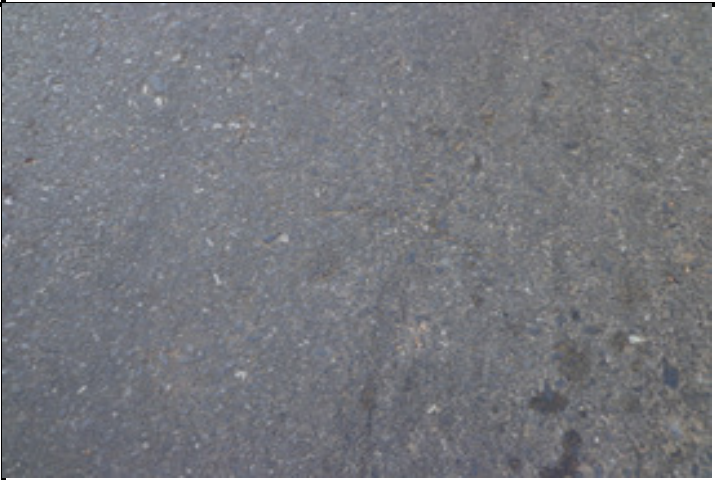
14	Segregação

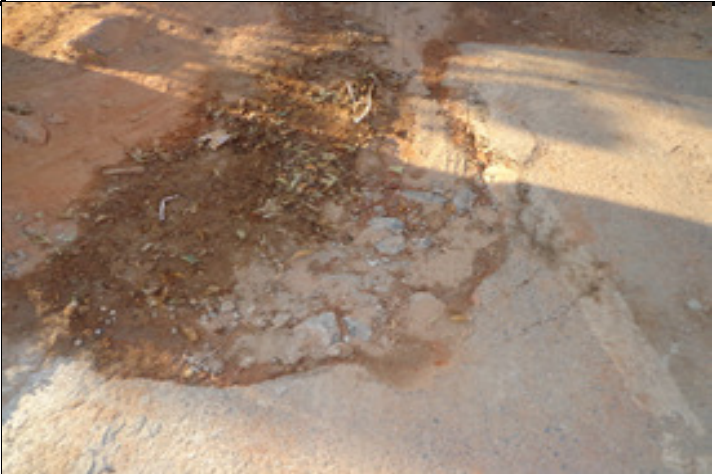
15	Panela ou buraco

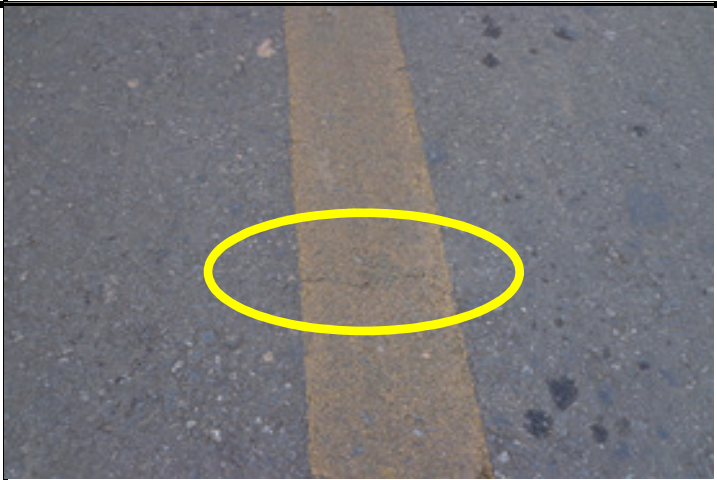
ITEM	ACHADO	FOTOGRAFIA
25	Trinca transversal

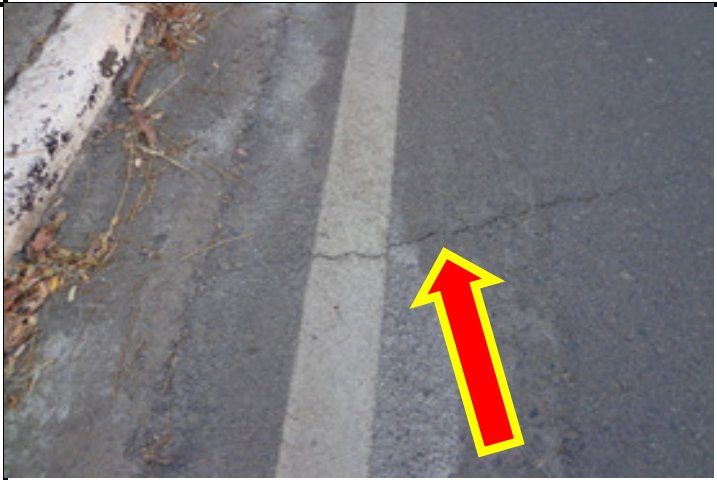
26	Trinca transversal

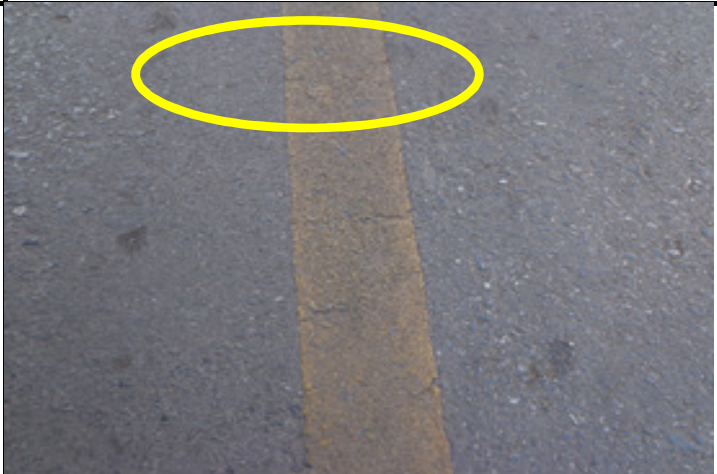
27	Trinca transversal

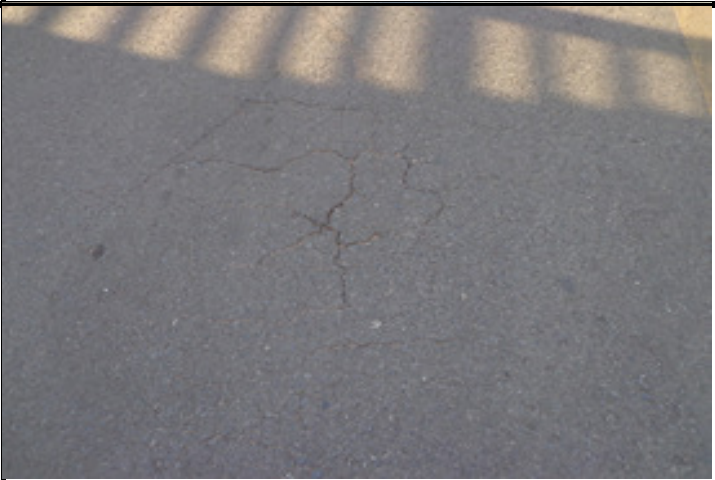
ITEM	ACHADO	FOTOGRAFIA
34	Fissura no pavimento asfáltico - trinca tipo "couro de jacaré"

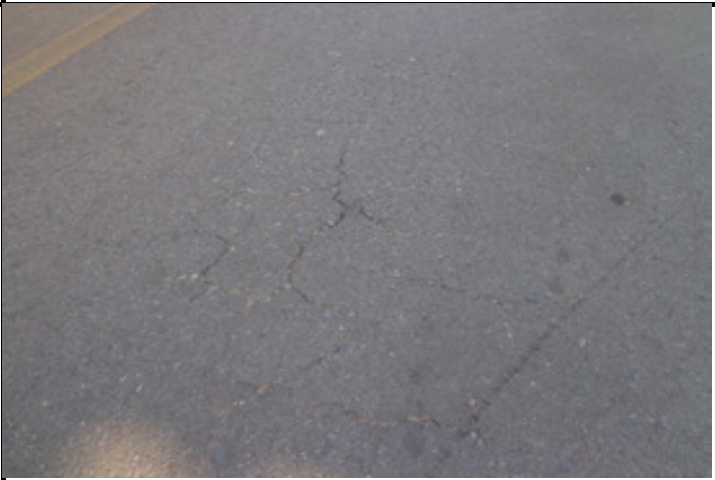
35	Fissura no pavimento asfáltico - trinca tipo "couro de jacaré"

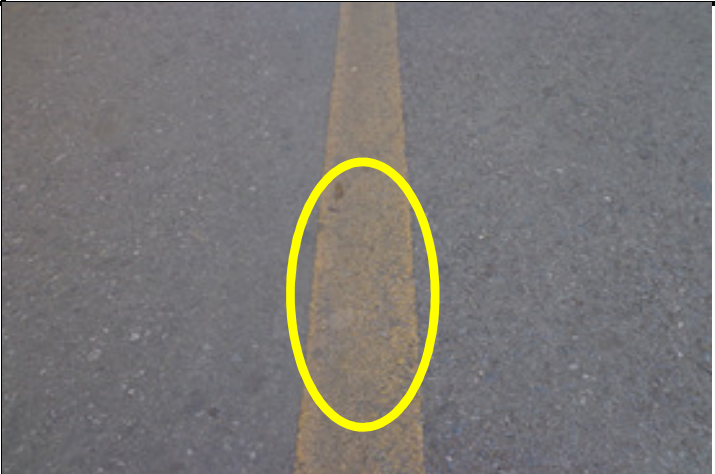
36	Trinca longitudinal

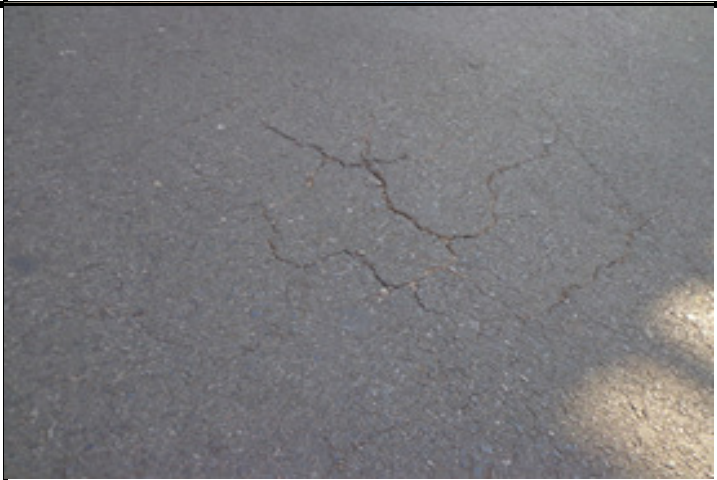
ITEM	ACHADO	FOTOGRAFIA
37	Fissura no pavimento asfáltico - trinca tipo "couro de jacaré"

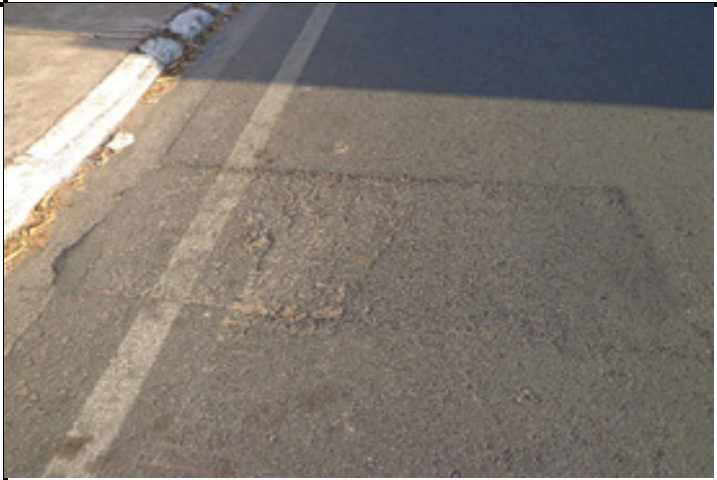
38	Remendo profundo

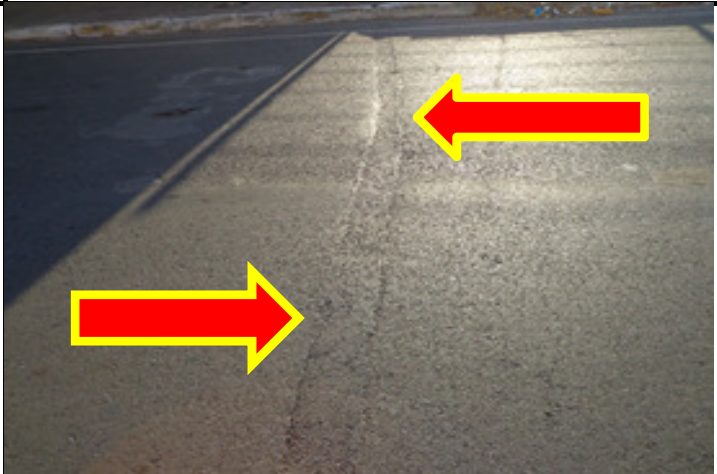
39	Remendo profundo

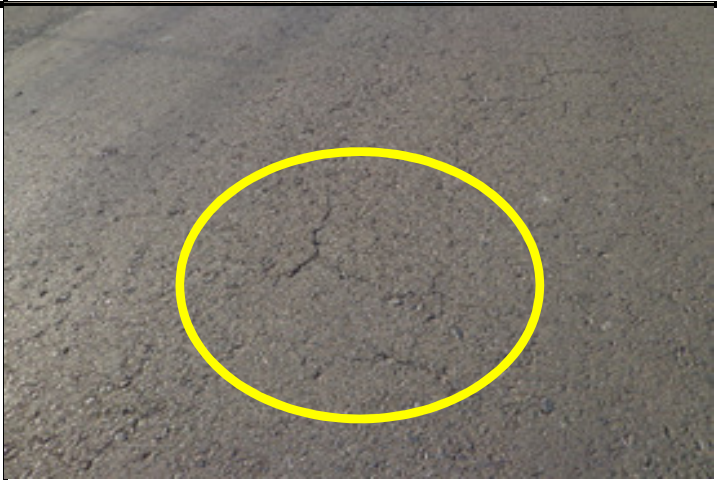
ITEM	ACHADO	FOTOGRAFIA
40	Fissura no pavimento asfáltico - trinca tipo "bloco"

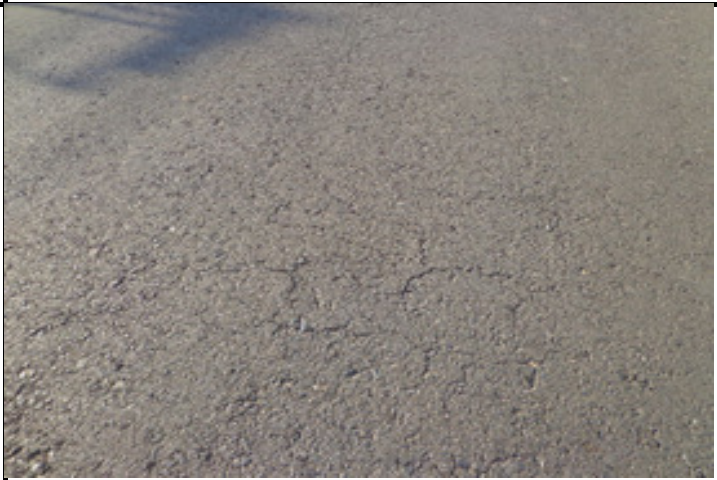
41	Fissura no pavimento asfáltico - trinca tipo "couro de jacaré"

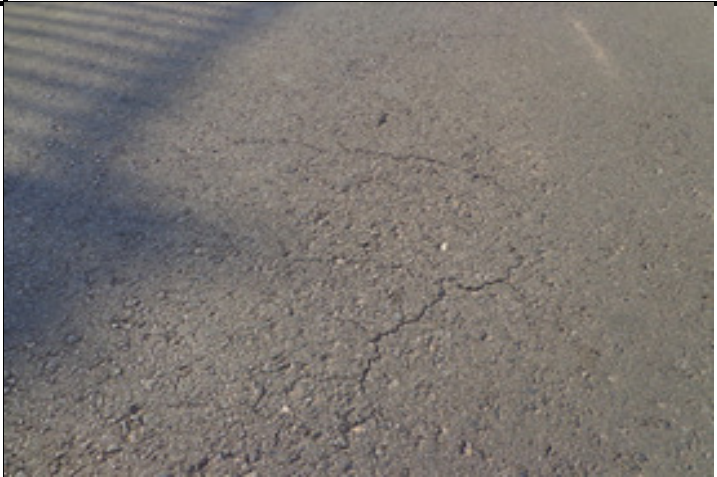
42	Fissura no pavimento asfáltico - trinca tipo "couro de jacaré"

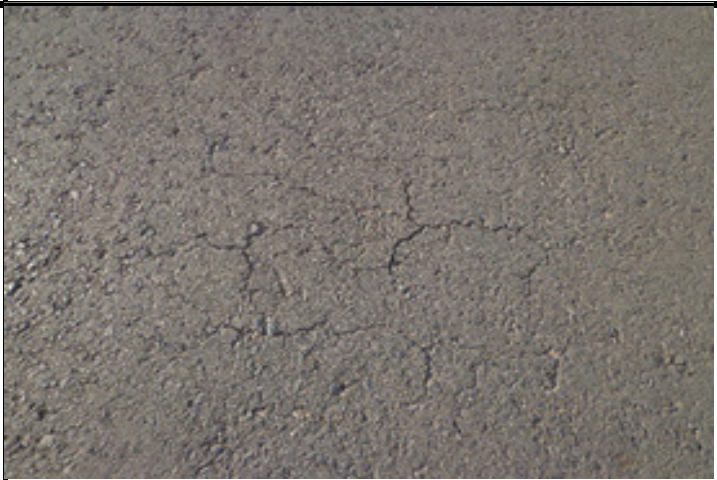
ITEM	ACHADO	FOTOGRAFIA
43	Fissura no pavimento asfáltico - trinca tipo "couro de jacaré"

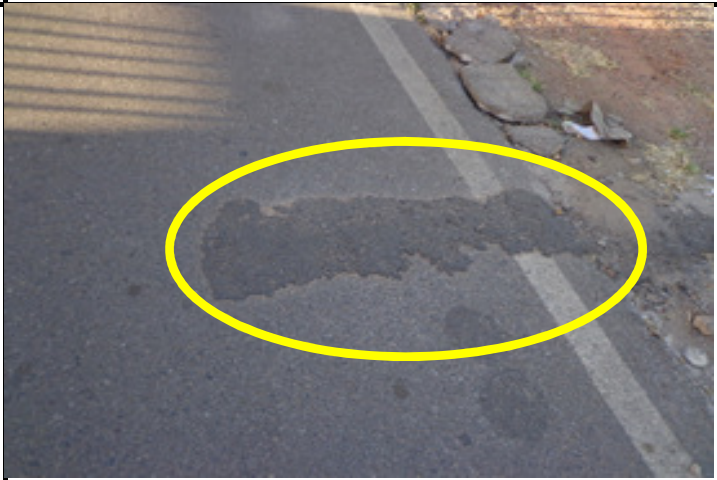
44	Remendo profundo

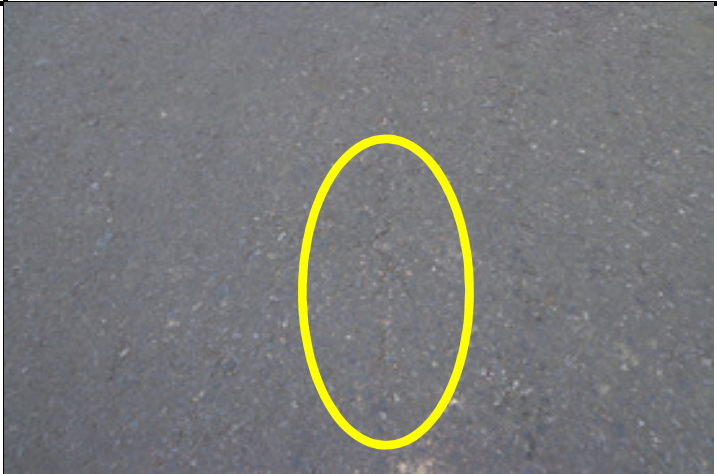
45	Trinca longitudinal

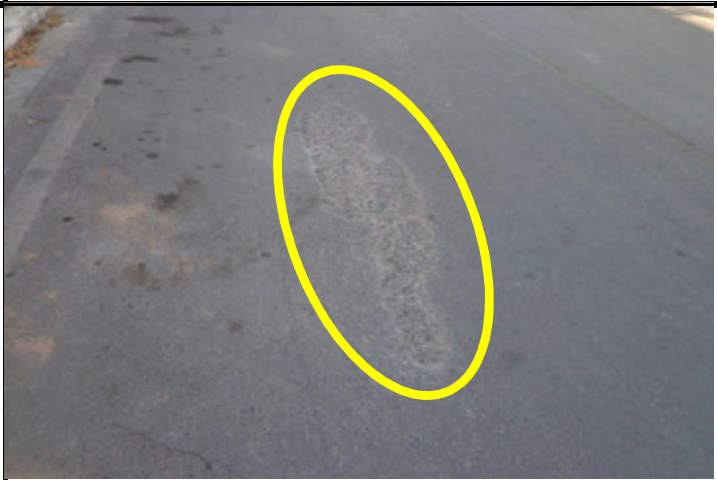
ITEM	ACHADO	FOTOGRAFIA
46	Remendo superficial

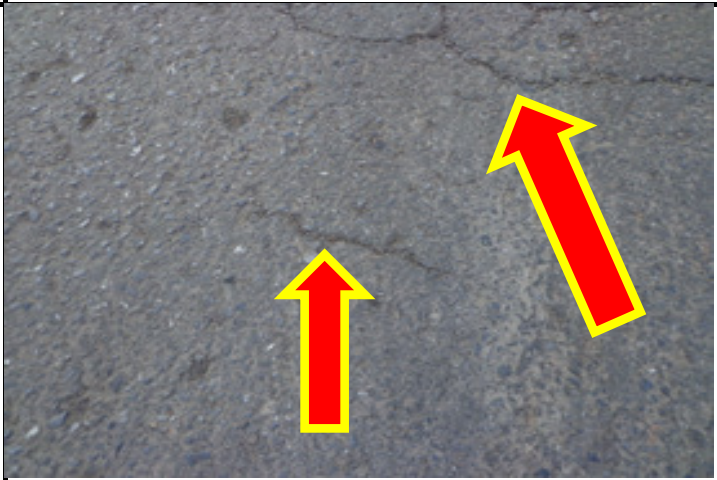
47	Fissura no pavimento asfáltico - trinca tipo "bloco"

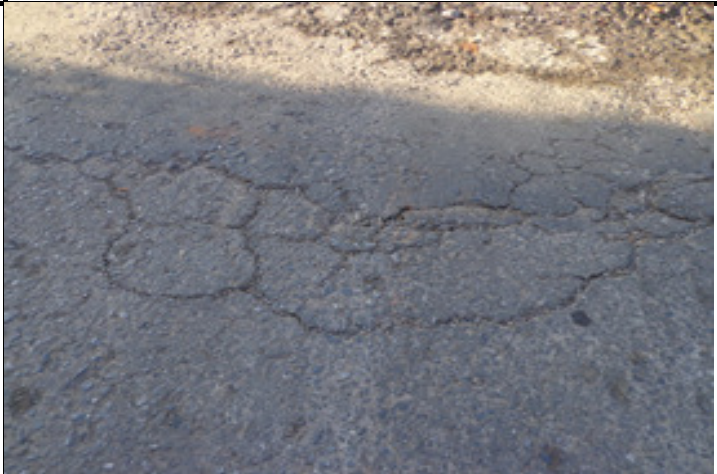
48	Fissura no pavimento asfáltico - trinca tipo "couro de jacaré"

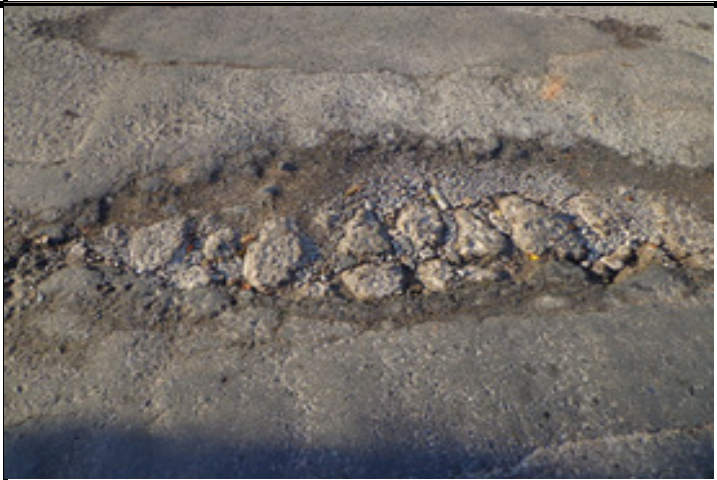
ITEM	ACHADO	FOTOGRAFIA
49	Panela ou buraco

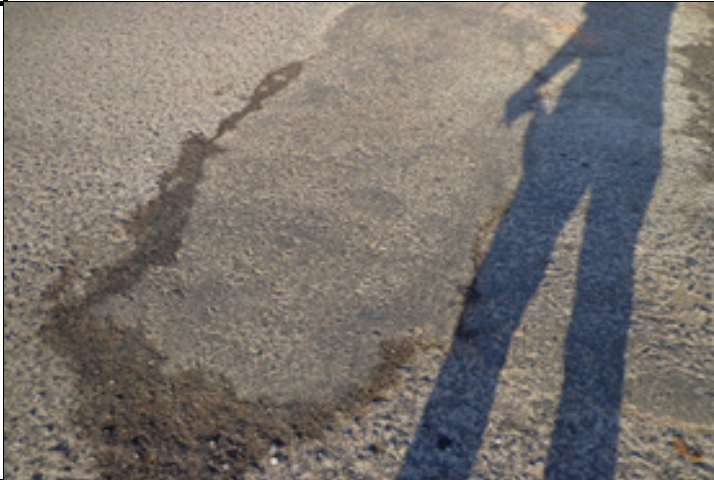
ITEM	ACHADO	FOTOGRAFIA
1	Remendo profundo

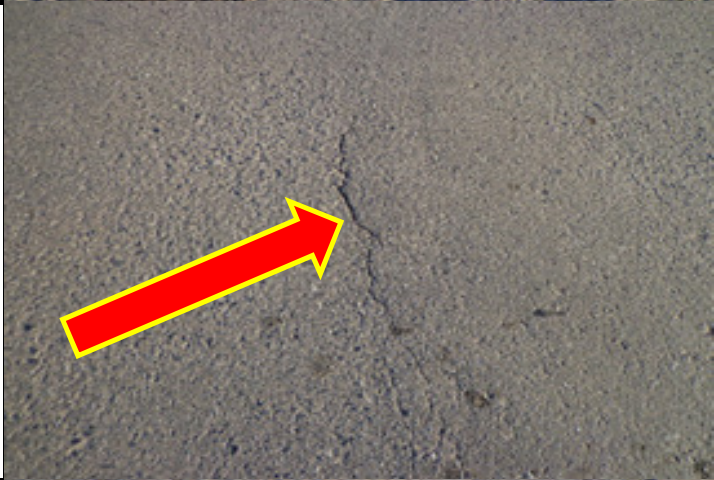
2	Trinca longitudinal

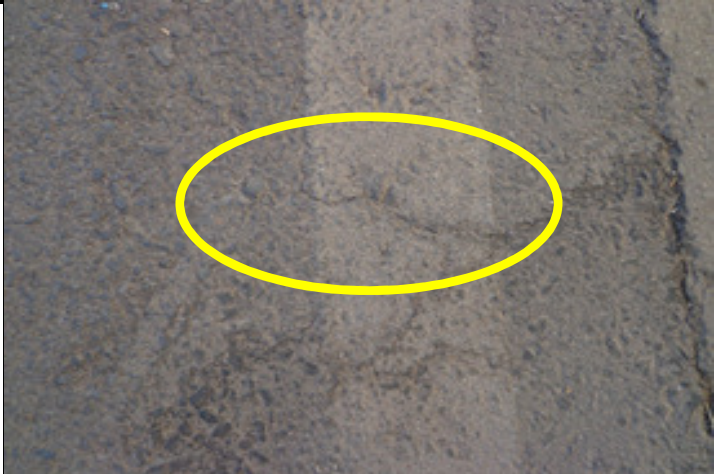
3	Trinca transversal

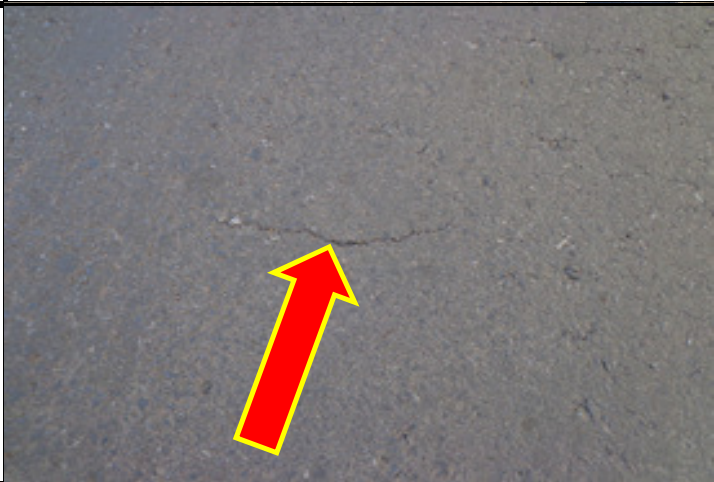
ITEM	ACHADO	FOTOGRAFIA
4	Trinca transversal

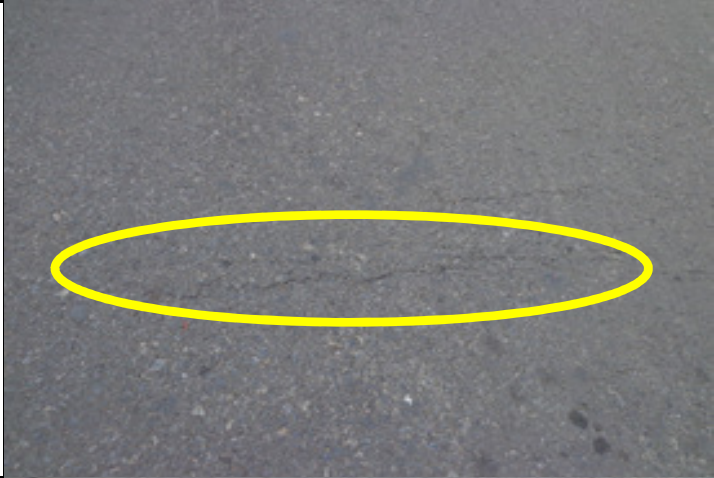
35	Trinca transversal

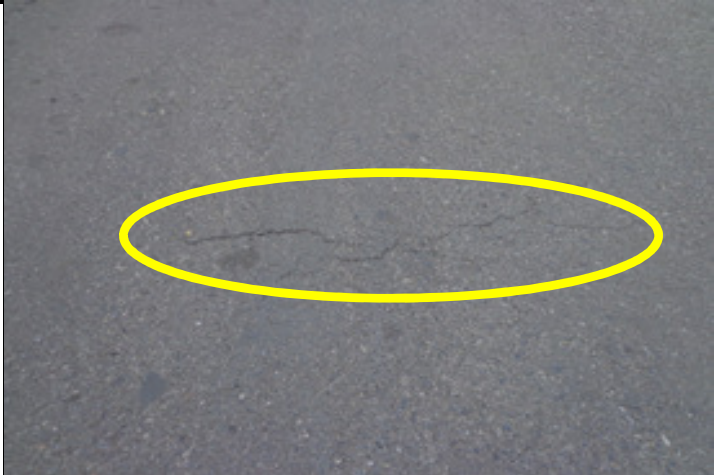
36	Trinca transversal

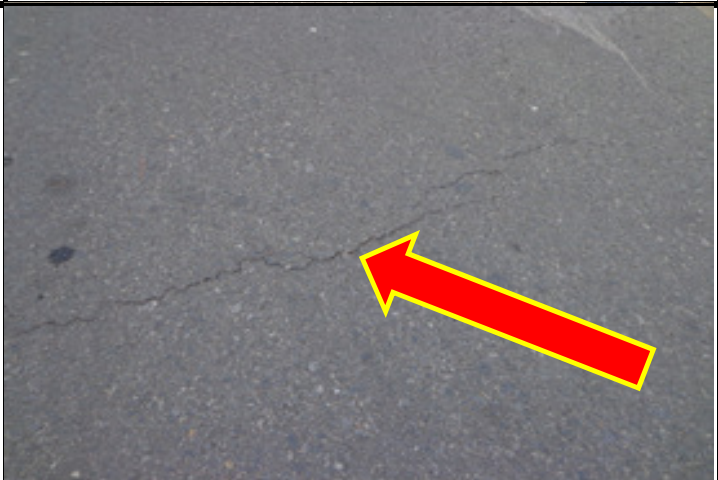
ITEM	ACHADO	FOTOGRAFIA
37	Trinca transversal

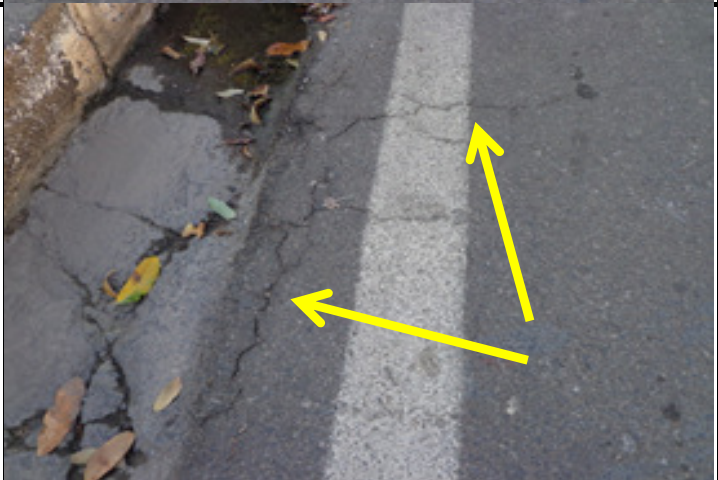
38	Trinca longitudinal e transversal

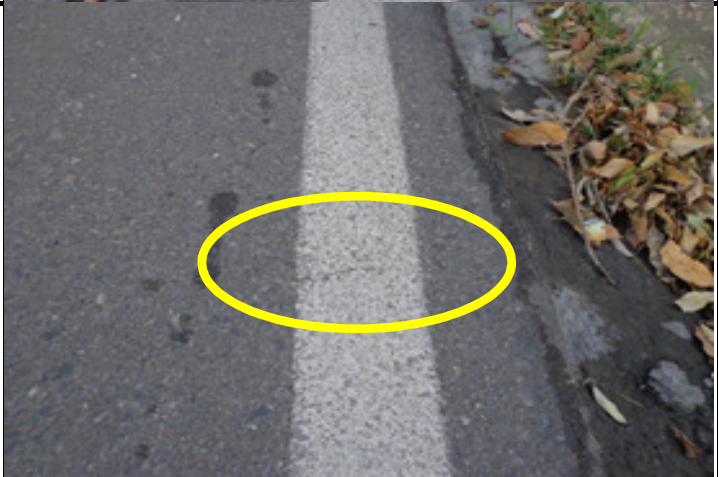
39	Trinca transversal

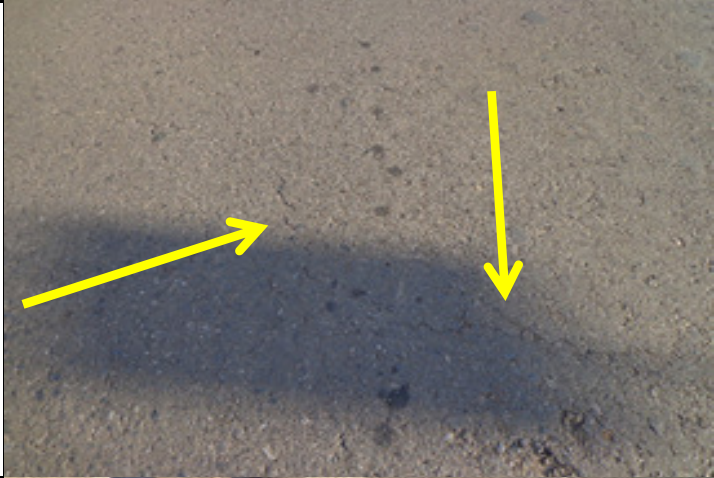
44	Trinca longitudinal e transversal

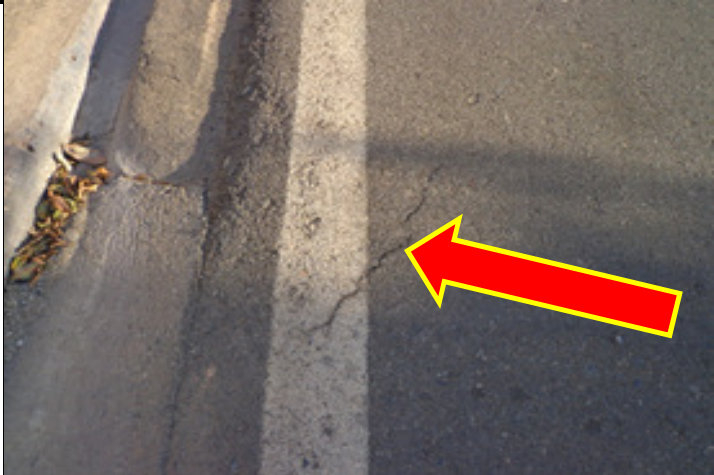
45	Trinca longitudinal
