ANEXO 13 (a) –
RELATÓRIO FOTOGRÁFICO ELABORADO
PELA EQUIPE DE FISCALIZAÇÃO DA SECID
ACERCA DAS INCONFORMIDADES
CONSTATADAS NA EXECUÇÃO DO
CONTRATO Nº 060/2012/SECOA
(PARTE 1)

INCONFORMIDADES CONTRATO 060 / 2012

AVENIDA LAVA PÉS

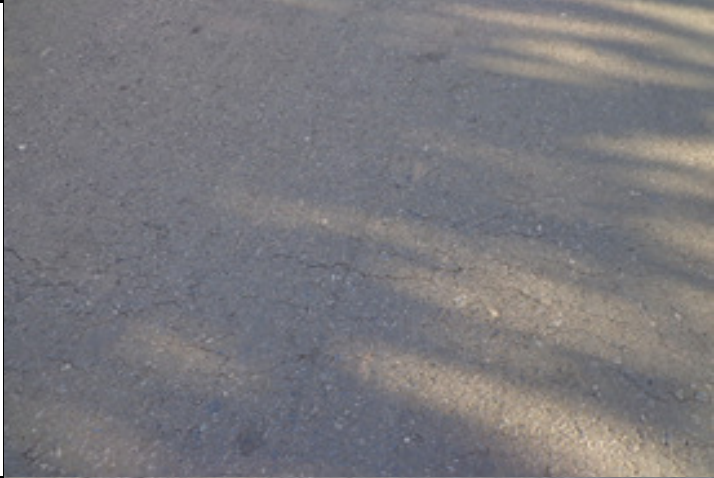
53	Fissura no pavimento asfáltico - trinca tipo "bloco"

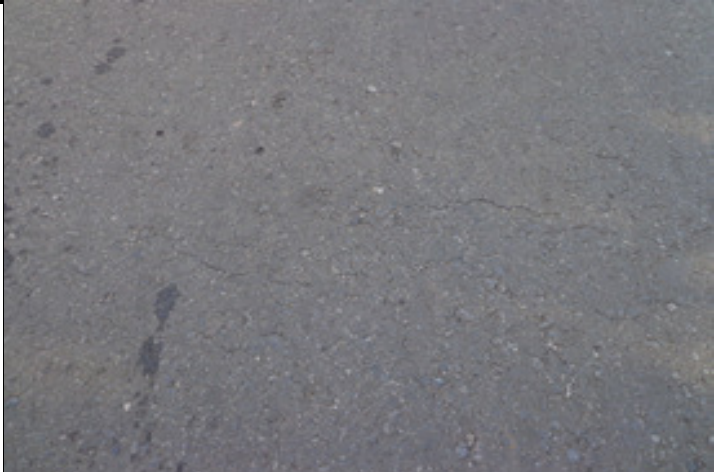
54	Fissura no pavimento asfáltico - trinca tipo "bloco"

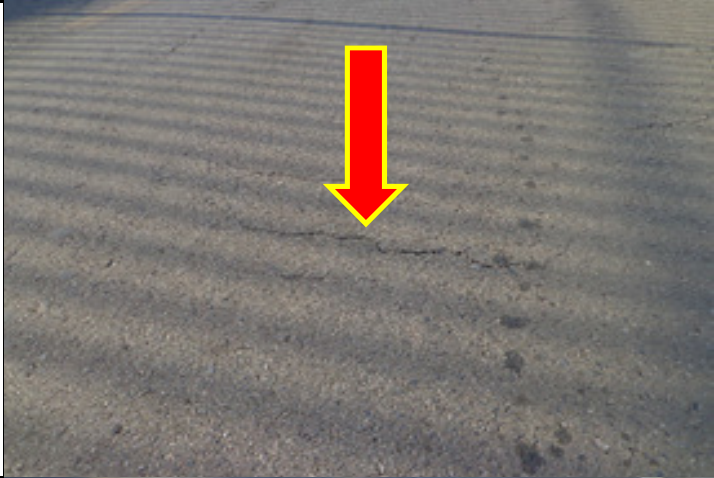
59	Trinca transversal

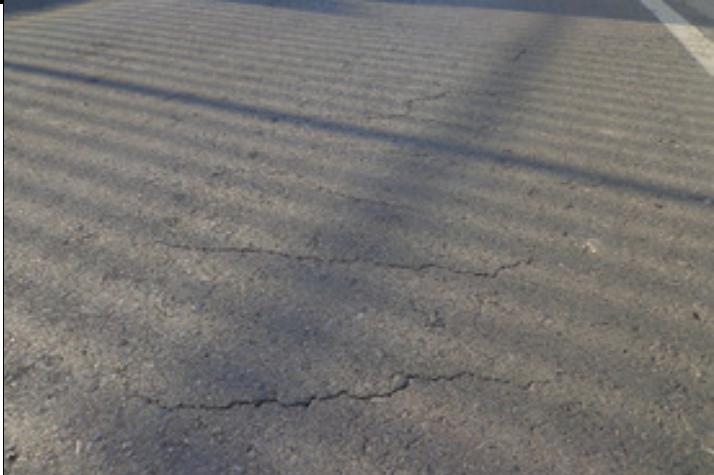
60	Fissura no pavimento asfáltico - trinca tipo "bloco"

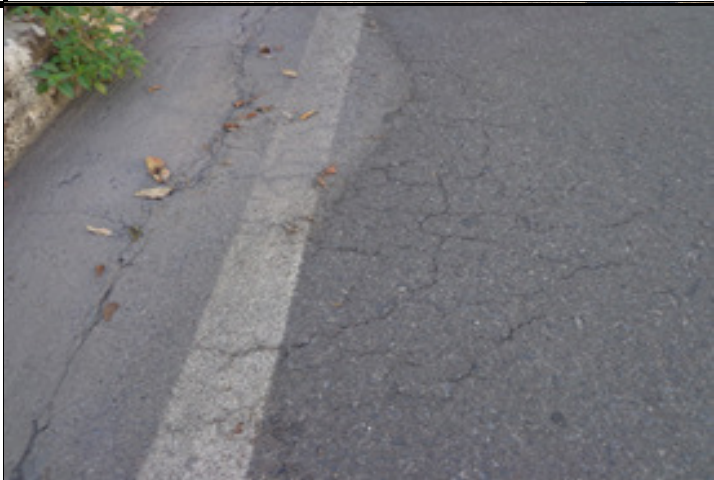
ITEM	ACHADO	FOTOGRAFIA
64	Fissura no pavimento asfáltico - trinca tipo "couro de jacaré"

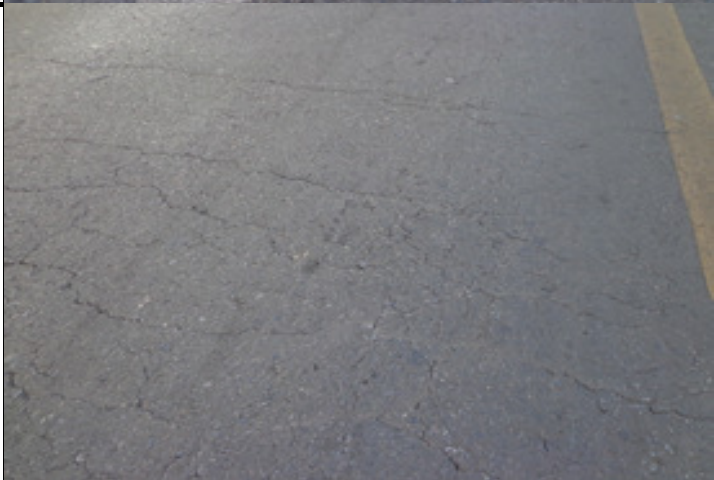
65	Fissura no pavimento asfáltico - trinca tipo "bloco"

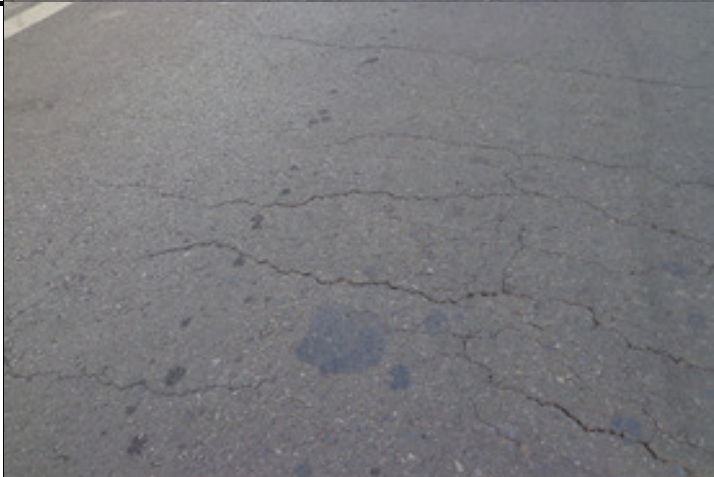
66	Fissura no pavimento asfáltico - trinca tipo "bloco"

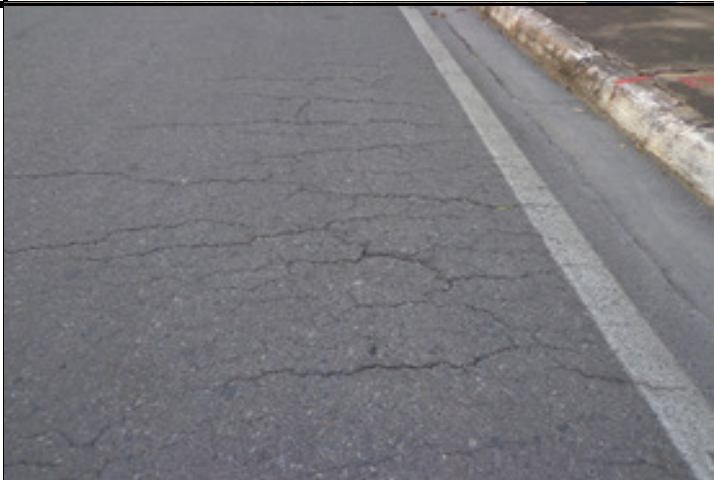
ITEM	ACHADO	FOTOGRAFIA
76	Fissura no pavimento asfáltico - trinca tipo "couro de jacaré"

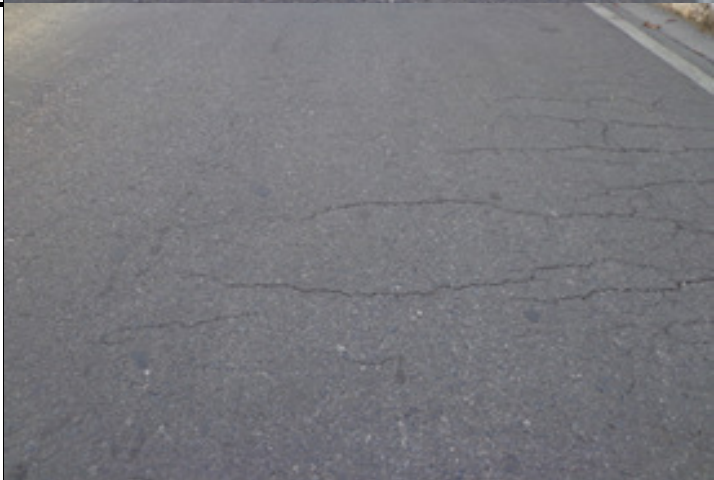
77	Fissura no pavimento asfáltico - trinca tipo "bloco"

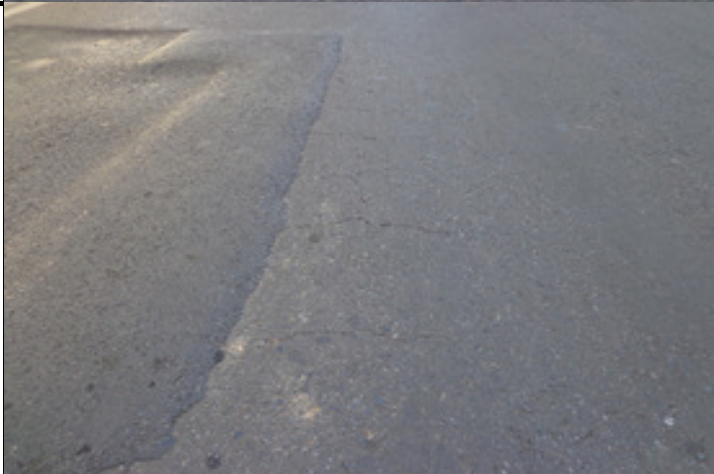
78	Remendo profundo

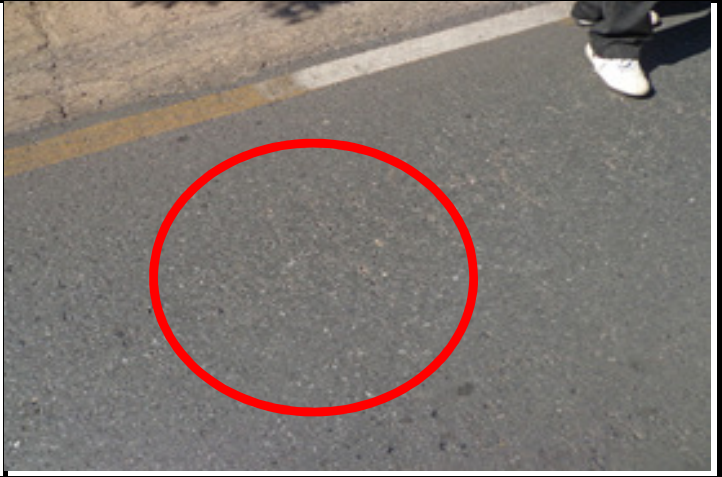
ITEM	ACHADO	FOTOGRAFIA
4	Trinca transversal

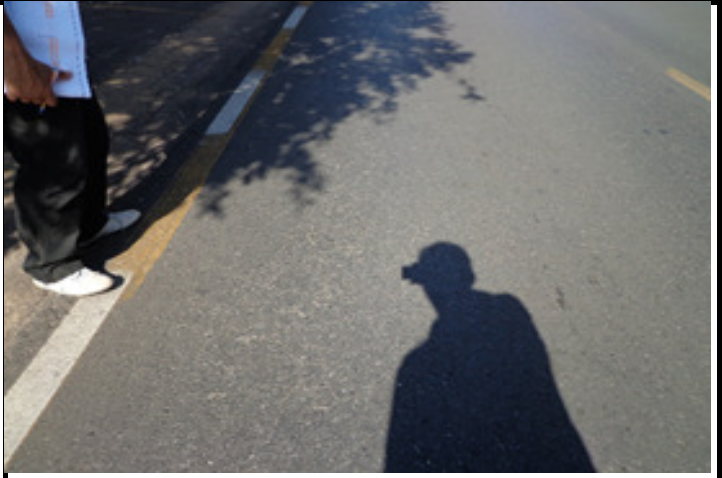
5	Segregação

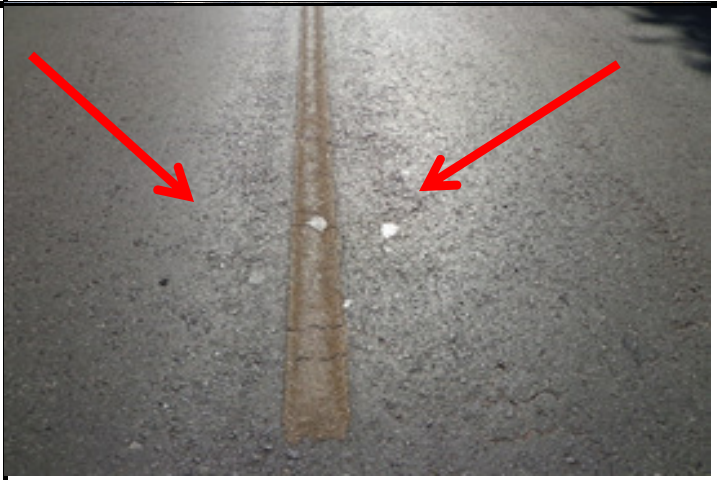
ITEM	ACHADO	FOTOGRAFIA
7	Afundamento de consolidação

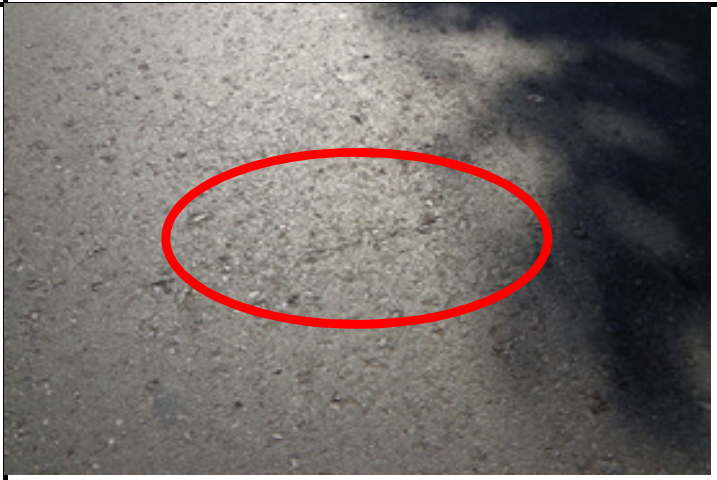
8	Trinca transversal

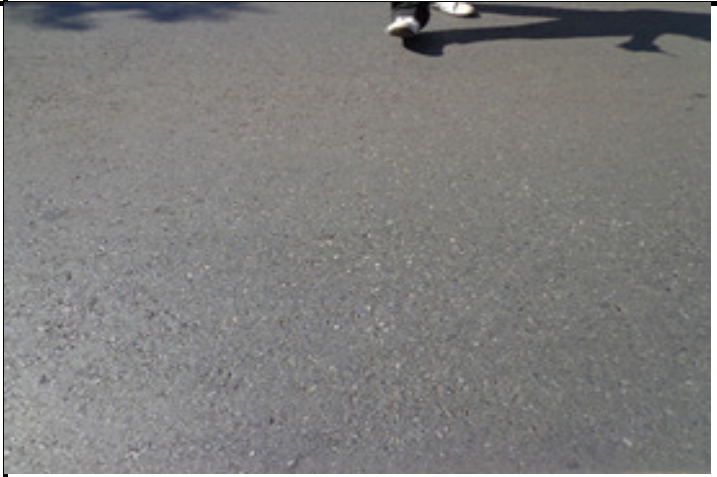
9	Segregação

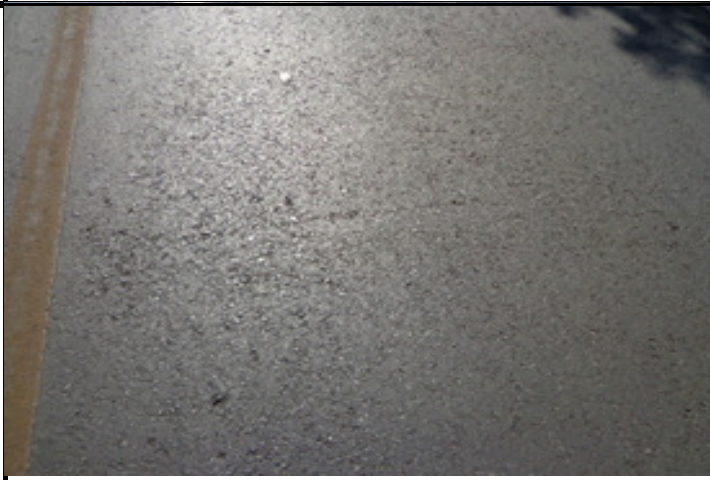
ITEM	ACHADO	FOTOGRAFIA
10	Segregação

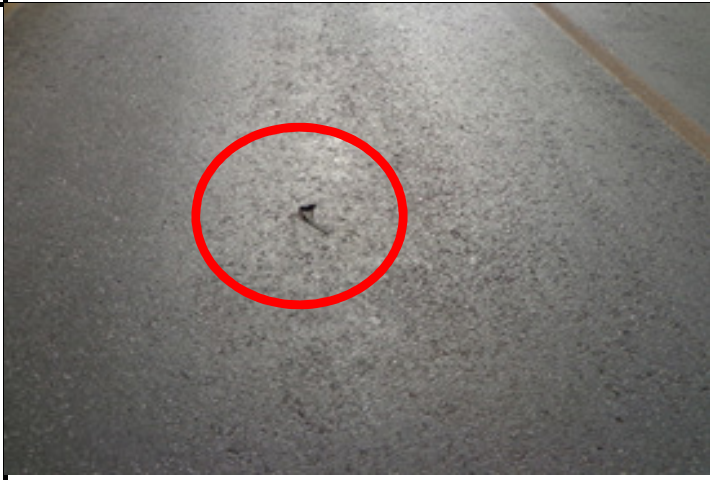
11	Panela ou buraco

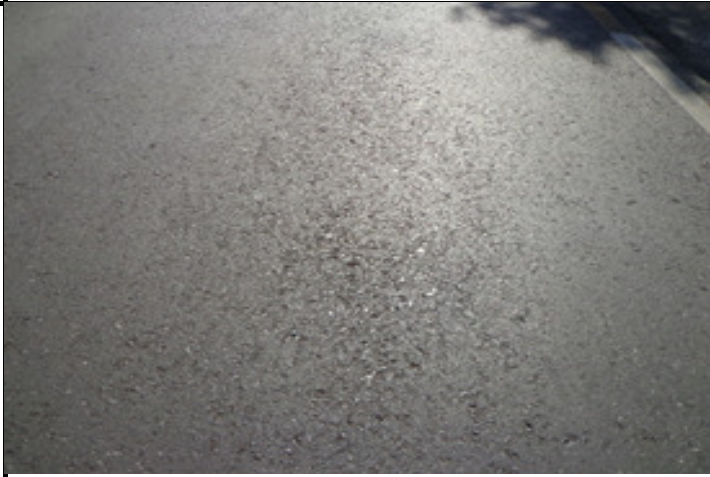
12	Segregação

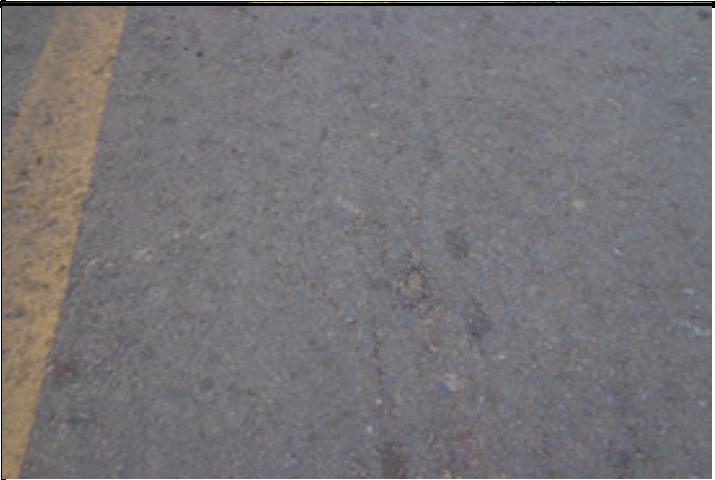
ITEM	ACHADO	FOTOGRAFIA
4	Segregação
