ANEXO 13 (b) –  
RELATÓRIO FOTOGRÁFICO ELABORADO  
PELA EQUIPE DE FISCALIZAÇÃO DA SECID  
ACERCA DAS INCONFORMIDADES  
CONSTATADAS NA EXECUÇÃO DO  
CONTRATO Nº 060/2012/SECOPA  
(PARTE 1)

# INCONFORMIDADES CONTRATO 060 / 2012

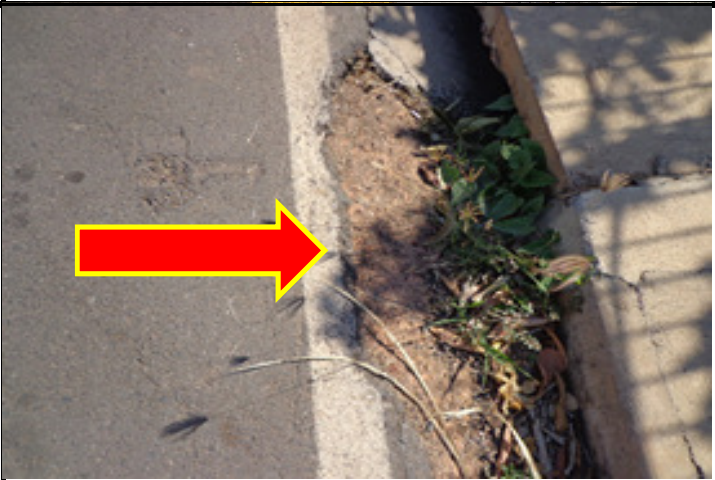
ITEM	ACHADO	FOTOGRAFIA
34	Panela ou buraco

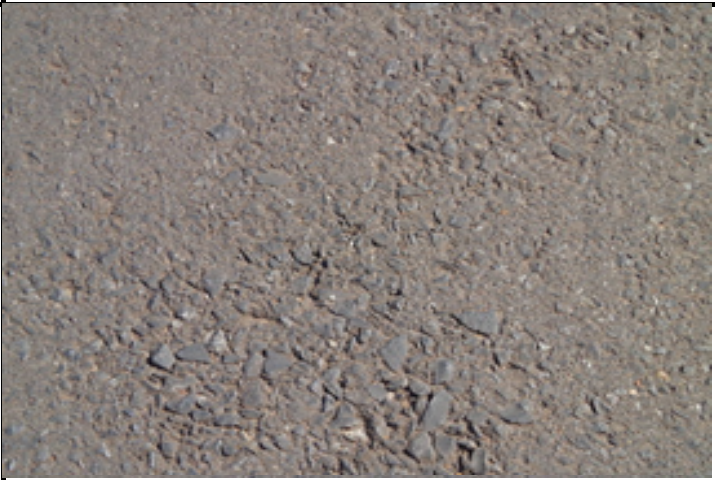
35	Segregação

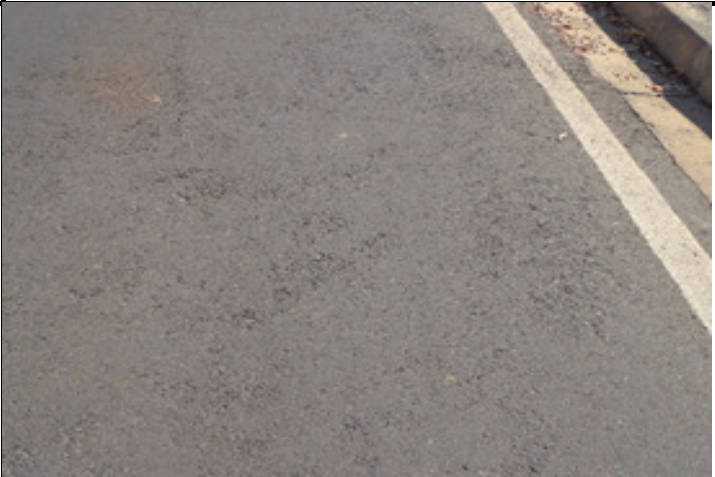
36	Segregação

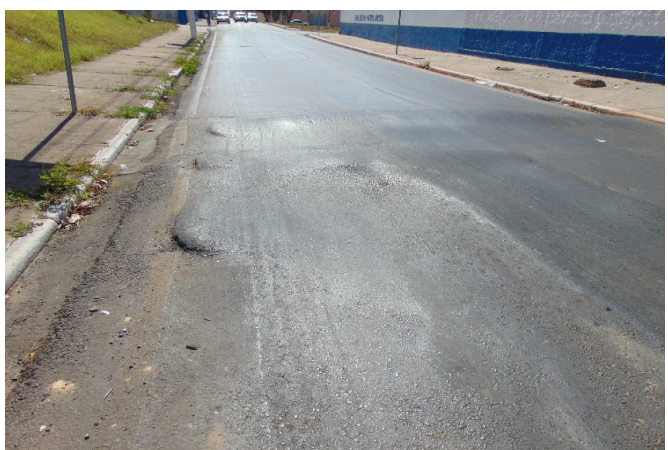
ITEM	ACHADO	FOTOGRAFIA
5	Ondulação e Escorregamento de massa

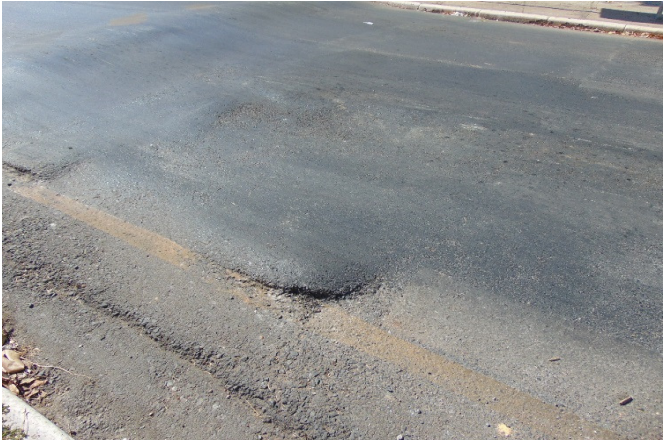
6	Ondulação e Escorregamento de massa

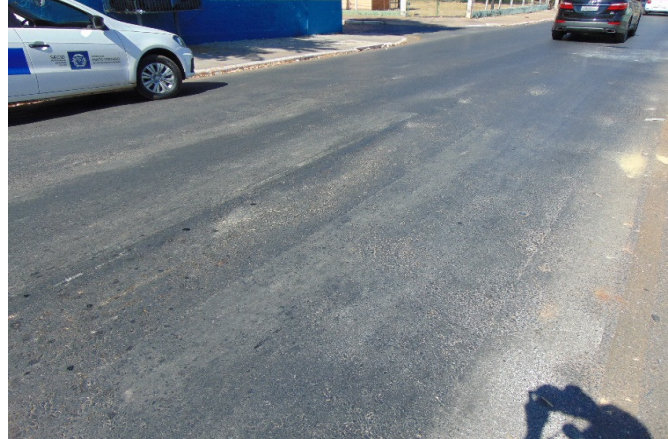
7	Ondulação e Escorregamento de massa

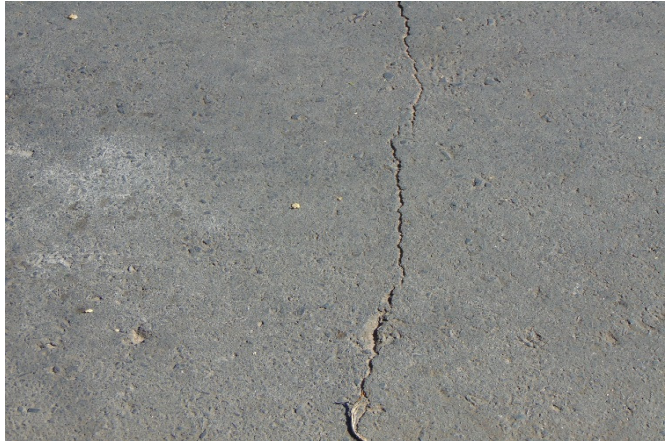
ITEM	ACHADO	FOTOGRAFIA
11	Trincas Longitudinais

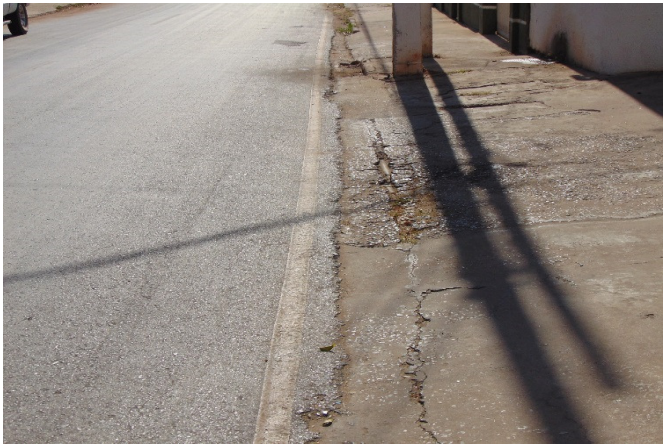
13	Inexecução de sargeta

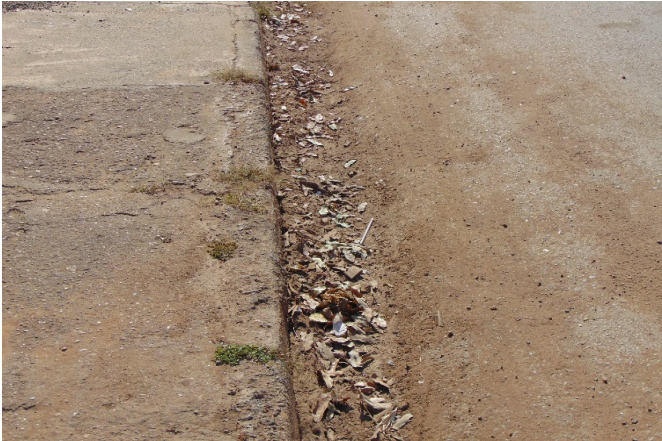
ITEM	ACHADO	FOTOGRAFIA
17	Inexecução de sargeta

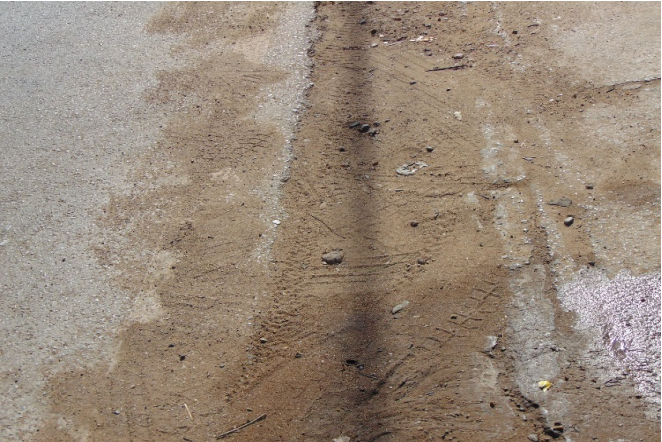
18	Inexecução de sargeta

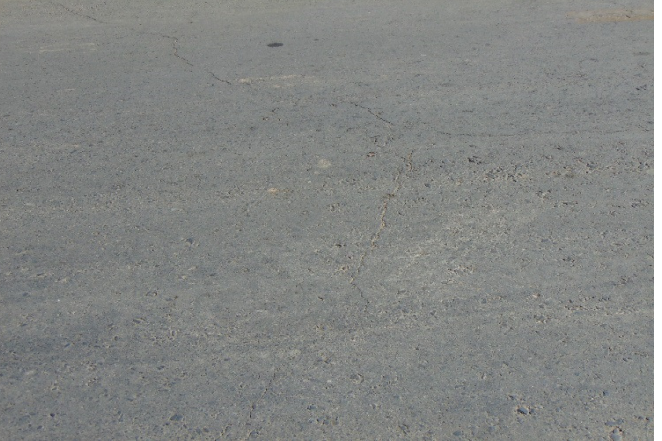
19	Trincas Longitudinais

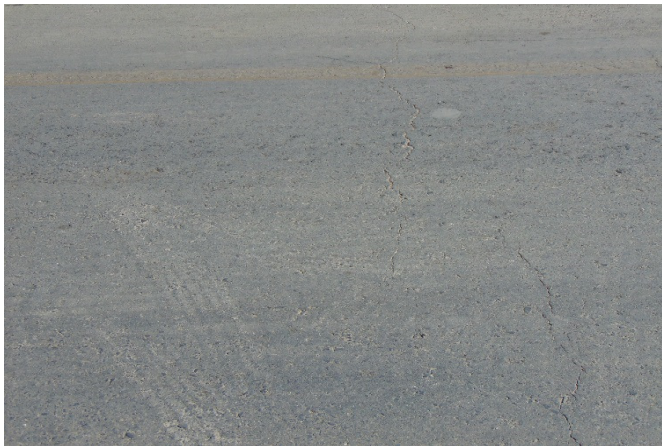
ITEM	ACHADO	FOTOGRAFIA
20	Trincas Longitudinais

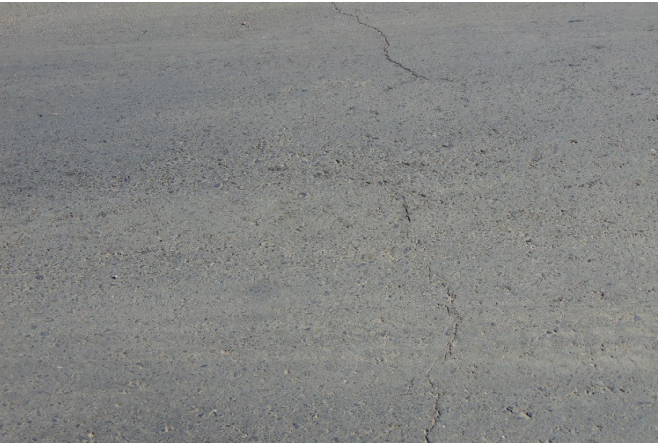
22	Trincas Longitudinais

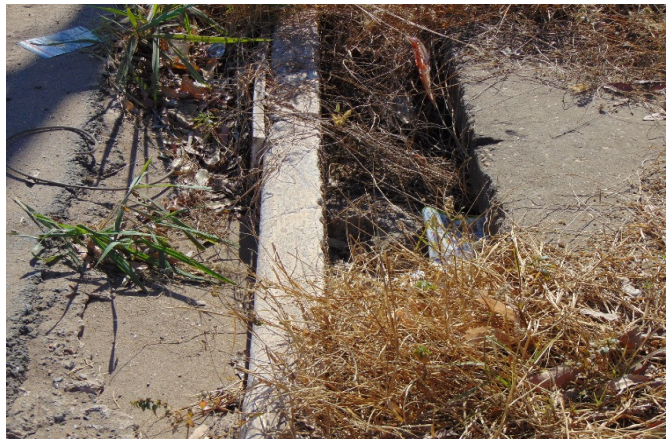
25	Tampa de boca de lobo quebrada

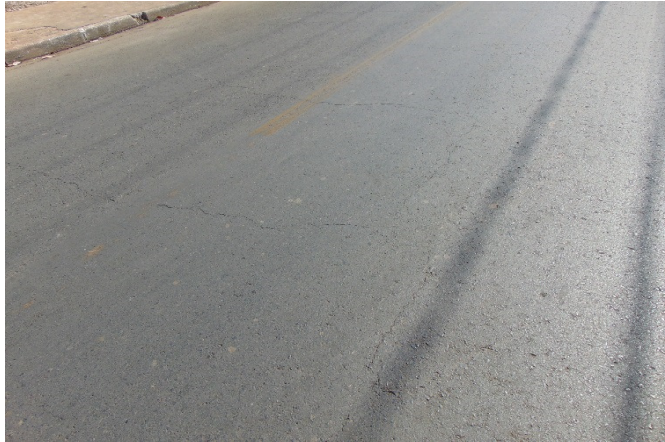
ITEM	ACHADO	FOTOGRAFIA
32	Trincas Transversais

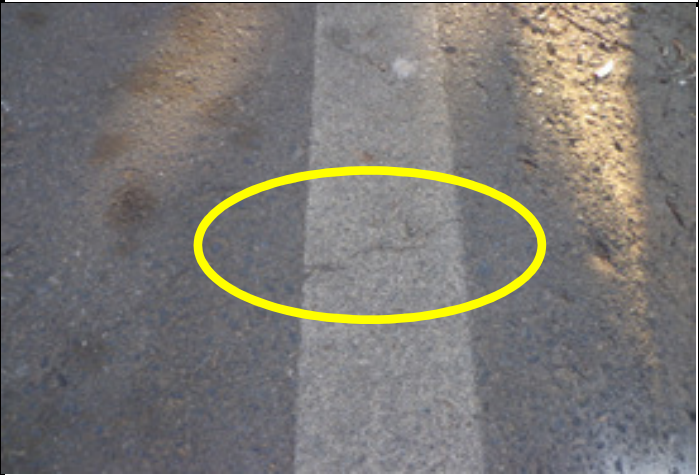
21	Trinca transversal

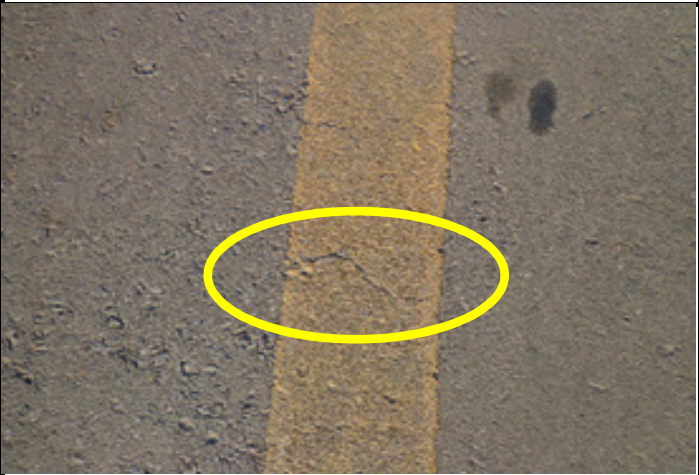
24	Trinca transversal

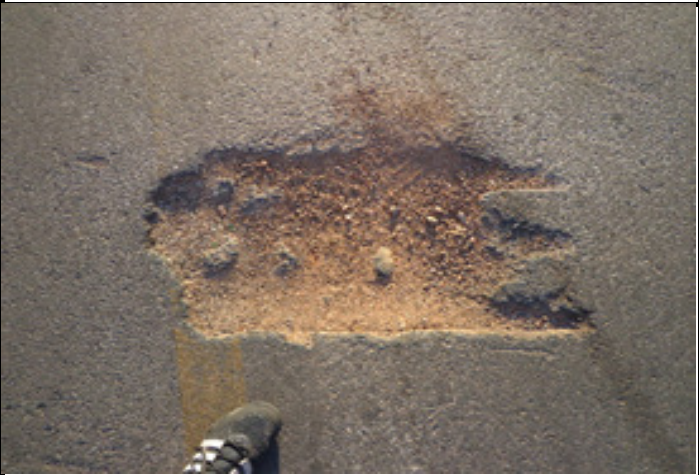
36	Panela ou buraco

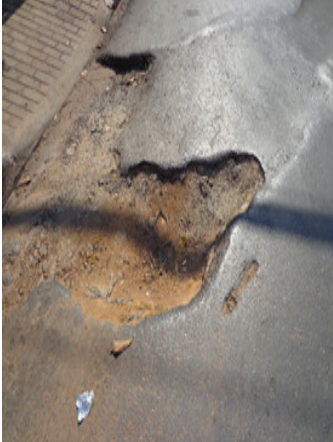
ITEM	ACHADO	FOTOGRAFIA
1	Panela ou buraco

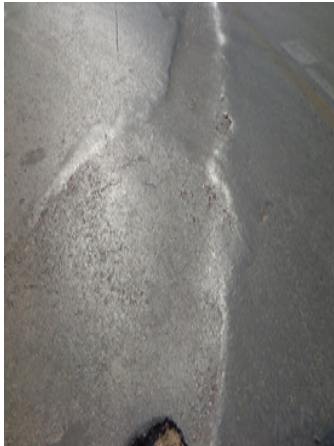
ITEM	ACHADO	FOTOGRAFIA
2	Afundamento de consolidação

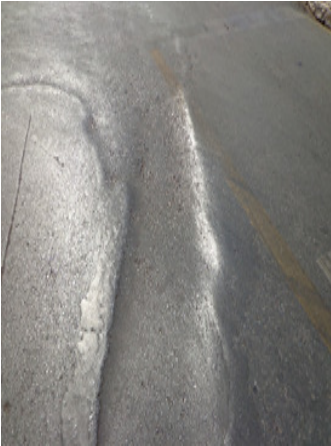
ITEM	ACHADO	FOTOGRAFIA
3	Afundamento de consolidação

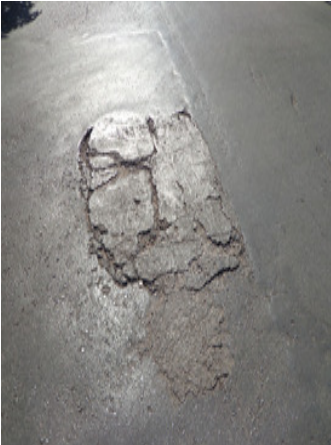
ITEM	ACHADO	FOTOGRAFIA
4	Afundamento de consolidação

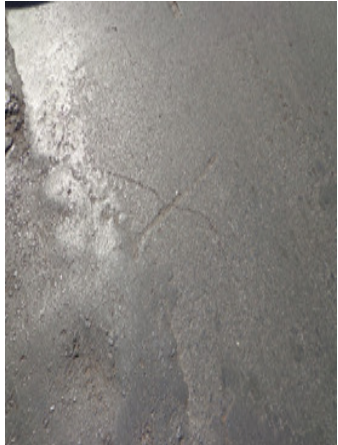
ITEM	ACHADO	FOTOGRAFIA
5	Trinca transversal

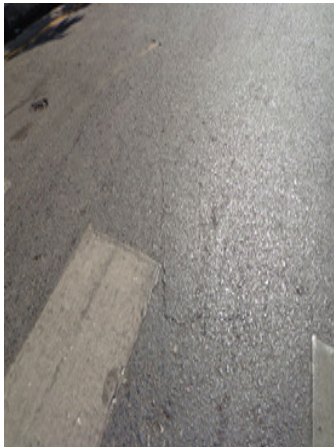
ITEM	ACHADO	FOTOGRAFIA
6	Trinca longitudinal

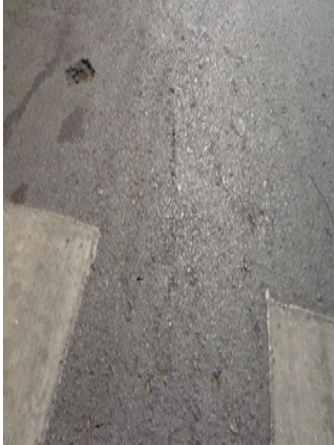
ITEM	ACHADO	FOTOGRAFIA
7	Trinca longitudinal

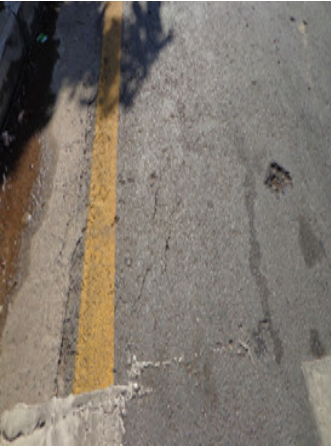
ITEM	ACHADO	FOTOGRAFIA
8	Afundamento de consolidação

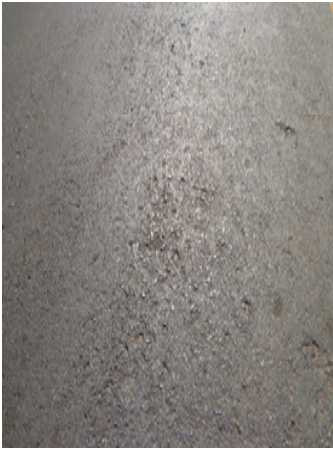
ITEM	ACHADO	FOTOGRAFIA
9	Segregação

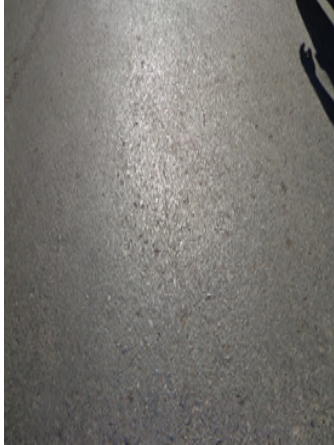
ITEM	ACHADO	FOTOGRAFIA
11	Segregação

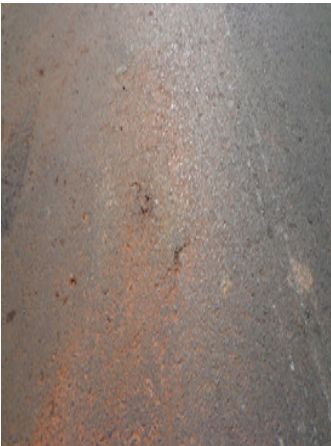
ITEM	ACHADO	FOTOGRAFIA
12	Fissura no pavimento asfáltico - trinca tipo "couro de jacaré"

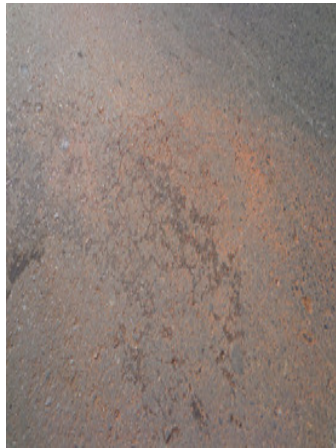
ITEM	ACHADO	FOTOGRAFIA
13	Fissura no pavimento asfáltico - trinca tipo "couro de jacaré"

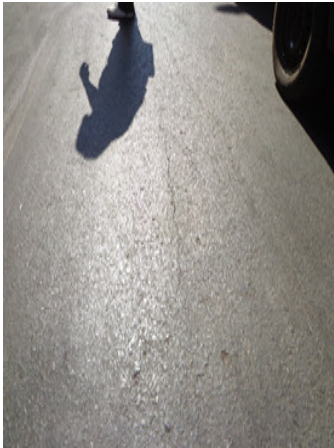
ITEM	ACHADO	FOTOGRAFIA
14	Trinca longitudinal

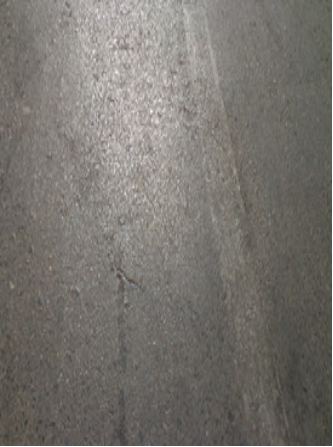
ITEM	ACHADO	FOTOGRAFIA
15	Trinca longitudinal

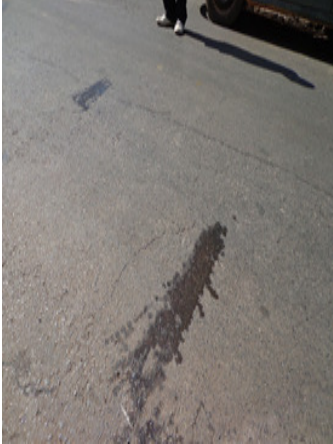
ITEM	ACHADO	FOTOGRAFIA
16	Trinca transversal

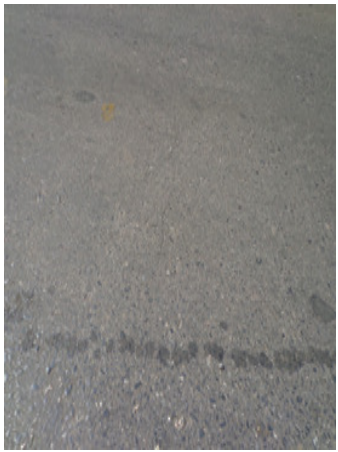
ITEM	ACHADO	FOTOGRAFIA
17	Trinca transversal

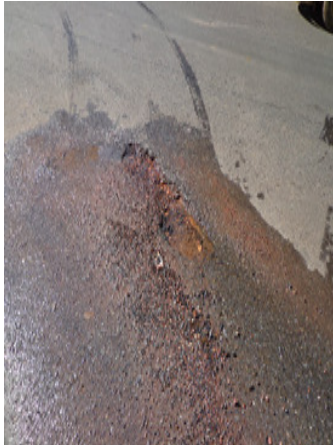
ITEM	ACHADO	FOTOGRAFIA
18	Panela ou buraco

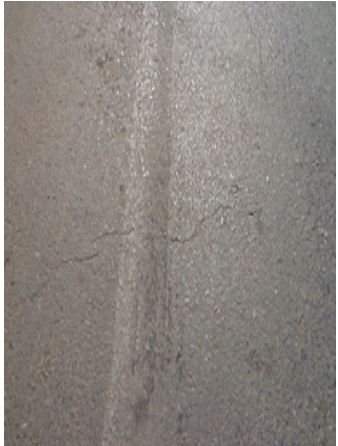
ITEM	ACHADO	FOTOGRAFIA
19	Trinca transversal

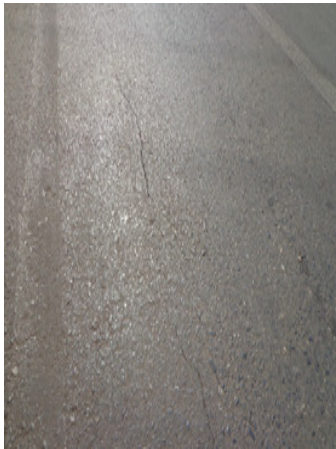
ITEM	ACHADO	FOTOGRAFIA
20	Trinca longitudinal

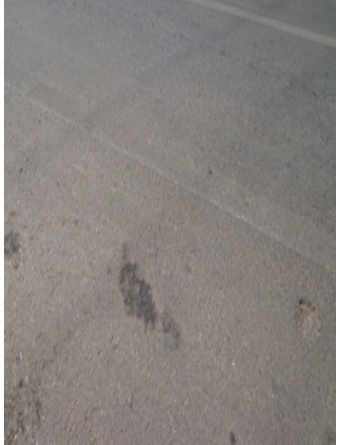
ITEM	ACHADO	FOTOGRAFIA
21	Trinca longitudinal e transversal

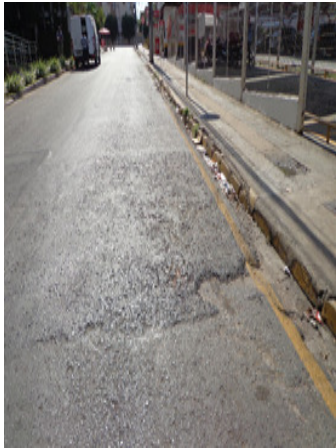
<b>ITEM</b>	<b>ACHADO</b>	<b>FOTOGRAFIA</b>
22	Remendo

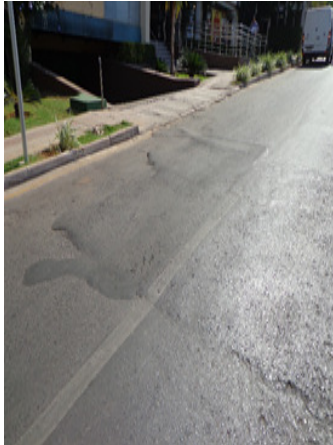
ITEM	ACHADO	FOTOGRAFIA
23	Ondulação ou corrugação

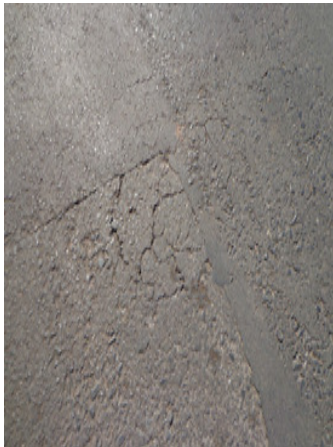
ITEM	ACHADO	FOTOGRAFIA
24	Fissura no pavimento asfáltico - trinca tipo "couro de jacaré"

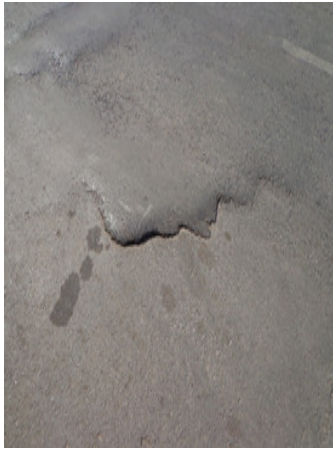
ITEM	ACHADO	FOTOGRAFIA
25	Ondulação ou corrugação

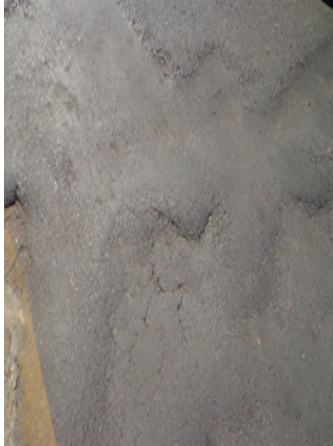
ITEM	ACHADO	FOTOGRAFIA
26	Ondulação ou corrugação

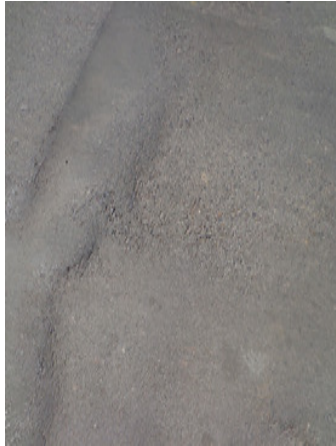
ITEM	ACHADO	FOTOGRAFIA
27	Afundamento de consolidação

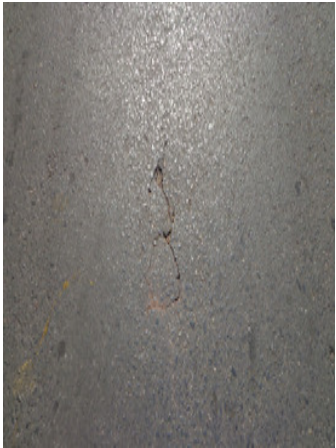
ITEM	ACHADO	FOTOGRAFIA
28	Trinca longitudinal

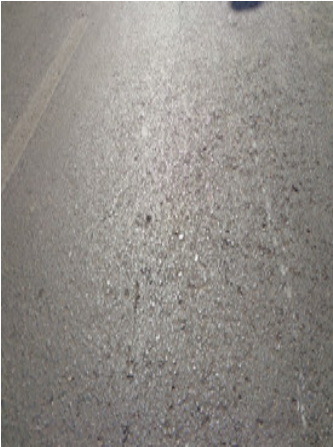
ITEM	ACHADO	FOTOGRAFIA
29	Segregação

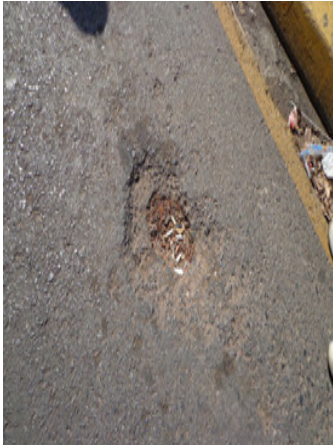
ITEM	ACHADO	FOTOGRAFIA
30	Panela ou buraco

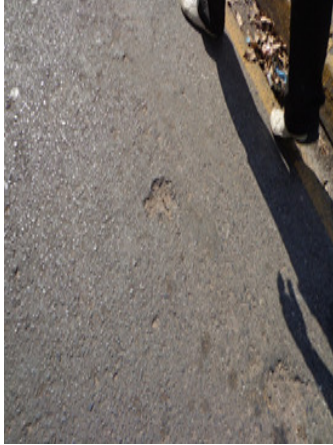
ITEM	ACHADO	FOTOGRAFIA
31	Panela ou buraco

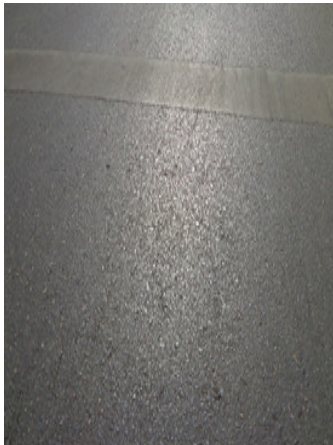
ITEM	ACHADO	FOTOGRAFIA
32	Trinca transversal

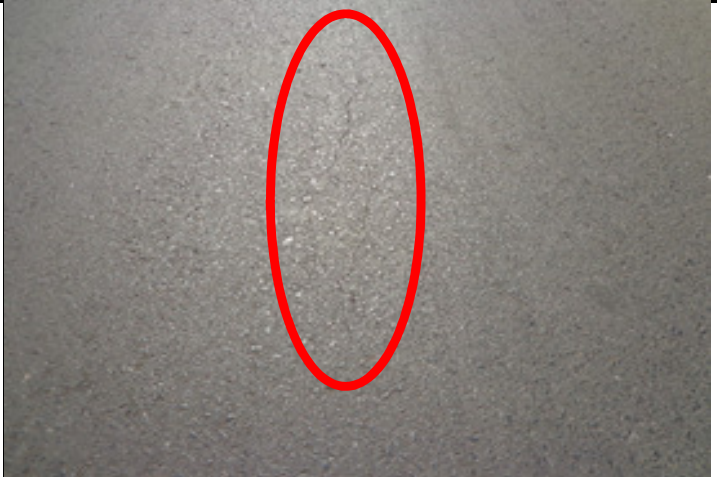
3	Trinca longitudinal

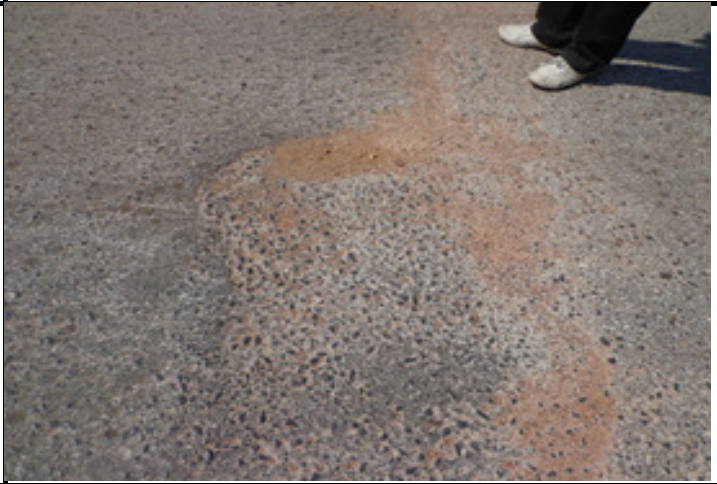
5	Afundamento de consolidação

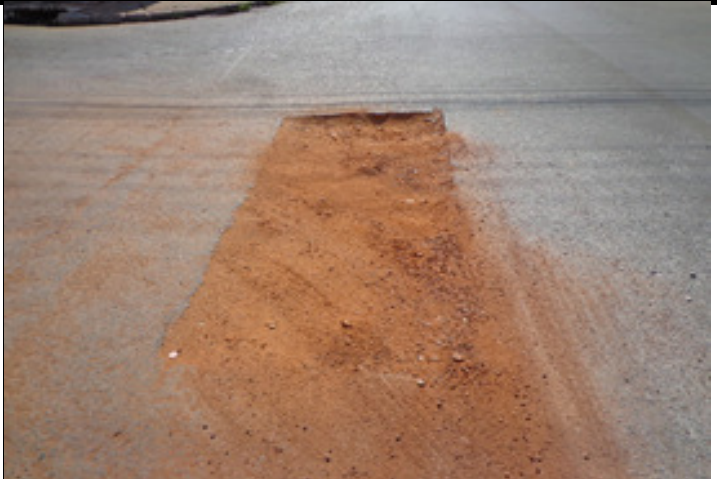
6	Panela ou buraco

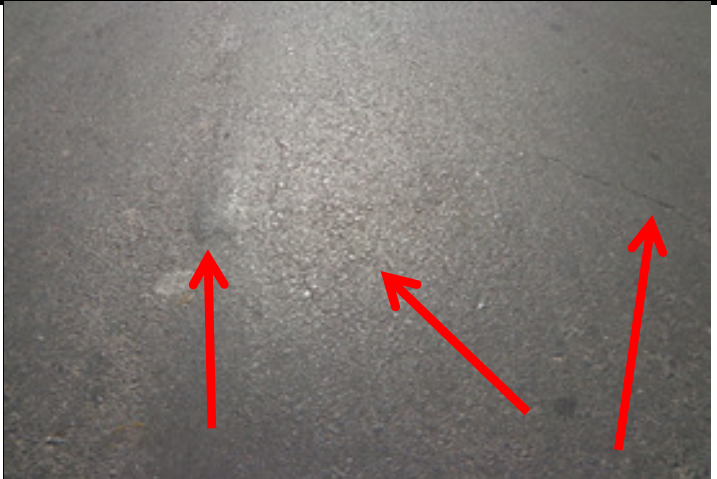
9	Trinca transversal
